Report on the earthquake impact to Kashiwazaki-Kariwa NPP

Senior Regulators' Meeting
September 20, 2007

Akira Fukushima
Deputy Director-General for Safety Examination
Nuclear and Industrial Safety Agency

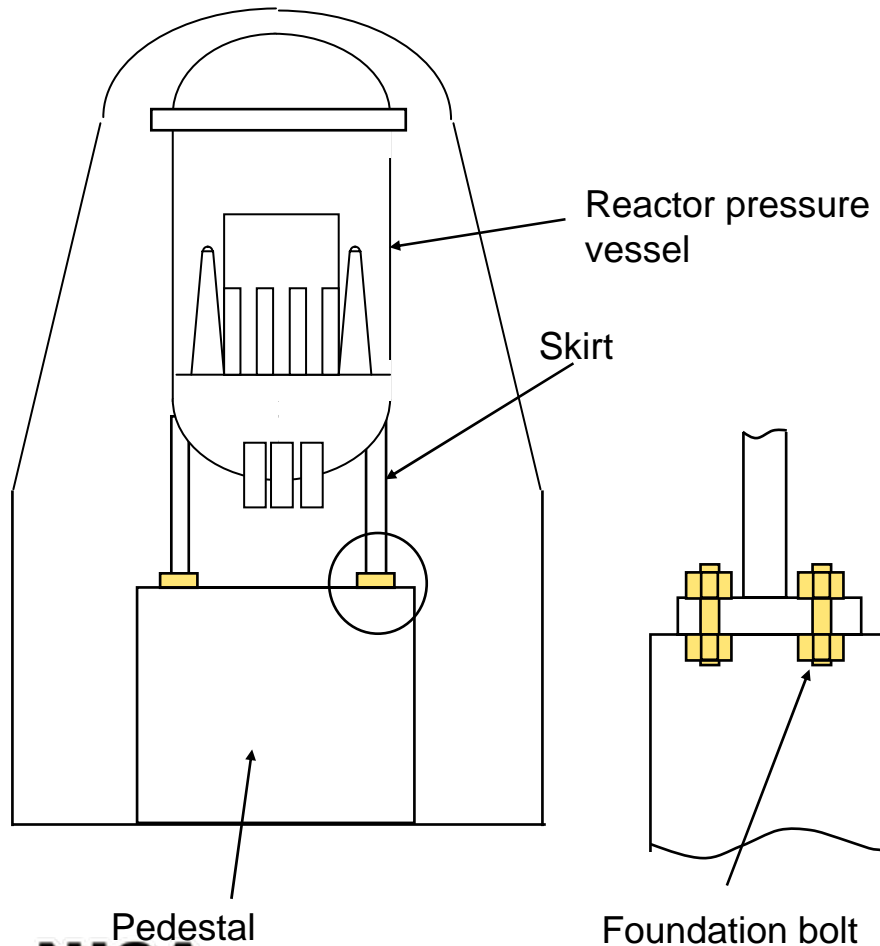
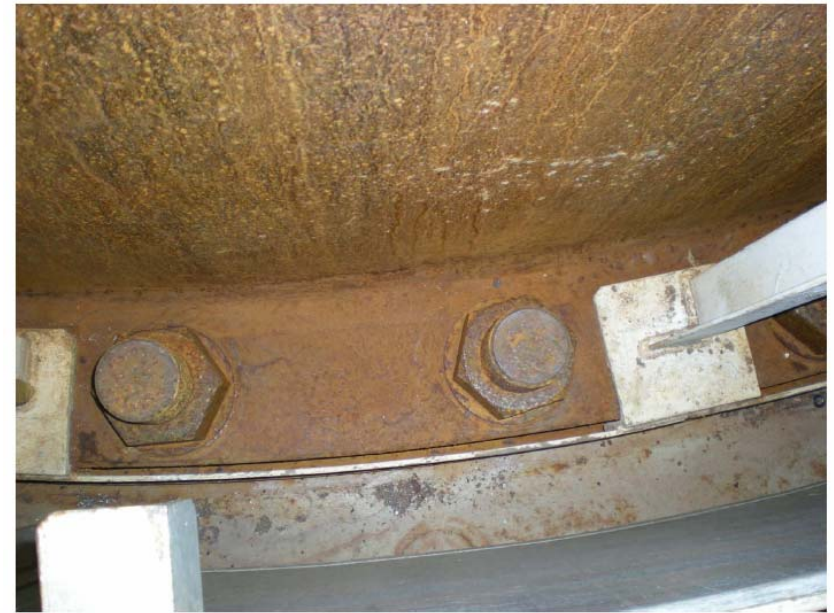
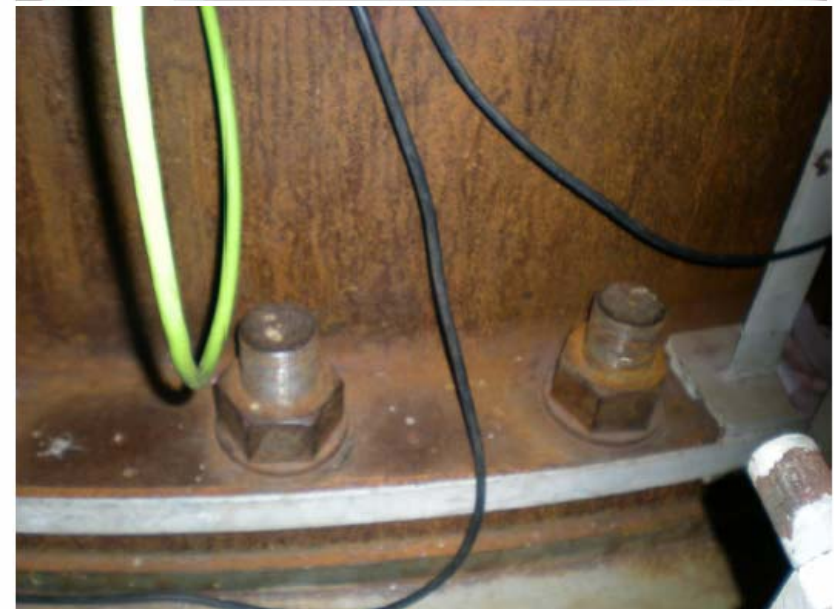
Foundation bolt for the reactor pressure vessel at Unit 1

- Visual check of the foundation bolt for the reactor pressure vessel at Unit 1 (peripheral side).

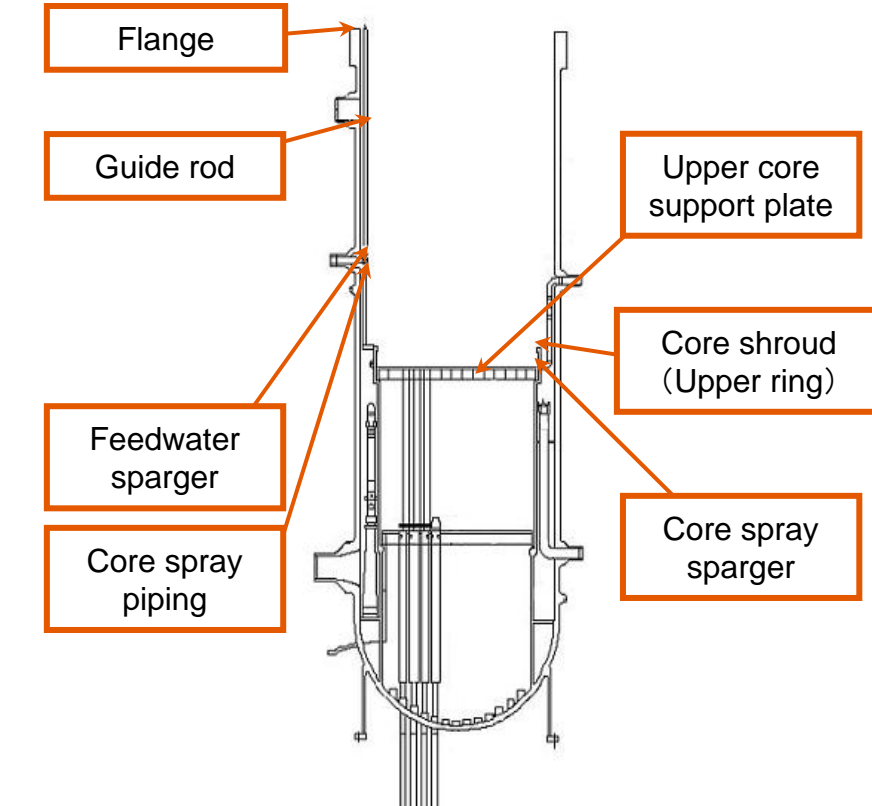
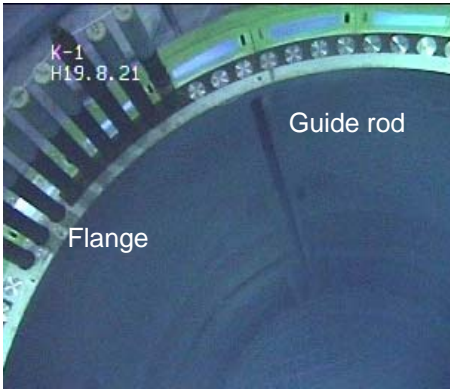
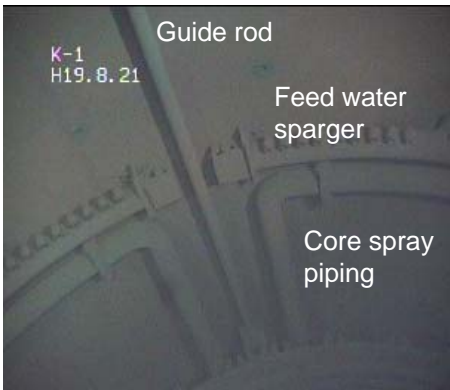
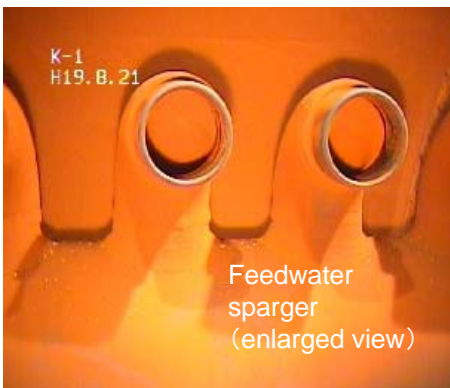
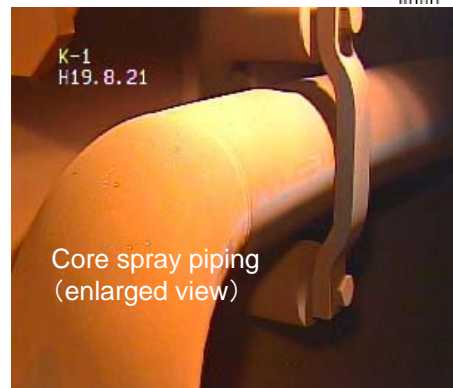
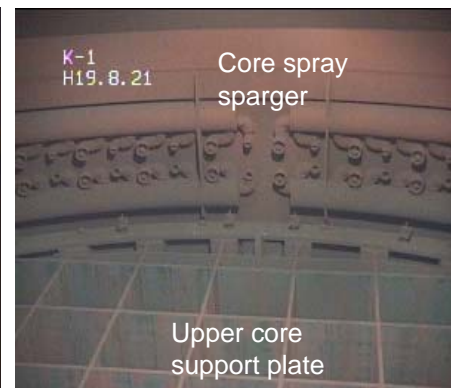
Upper reactor pressure vessel at Unit 1

No anomaly such as damage, deformation and dropout has been identified from the inspection by under water camera.

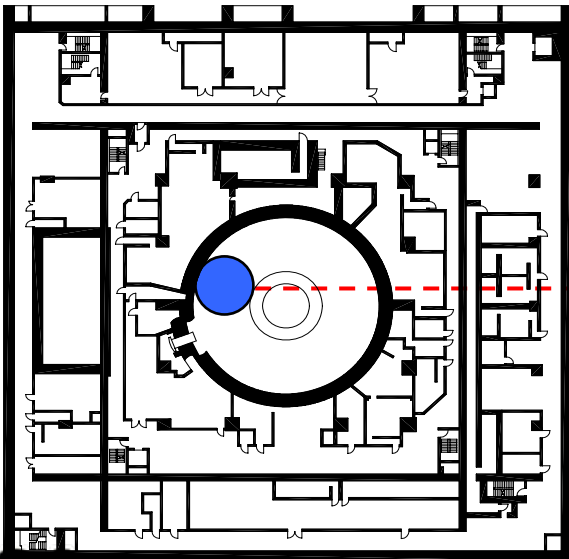
Main steam isolation valve (In the primary containment vessel).

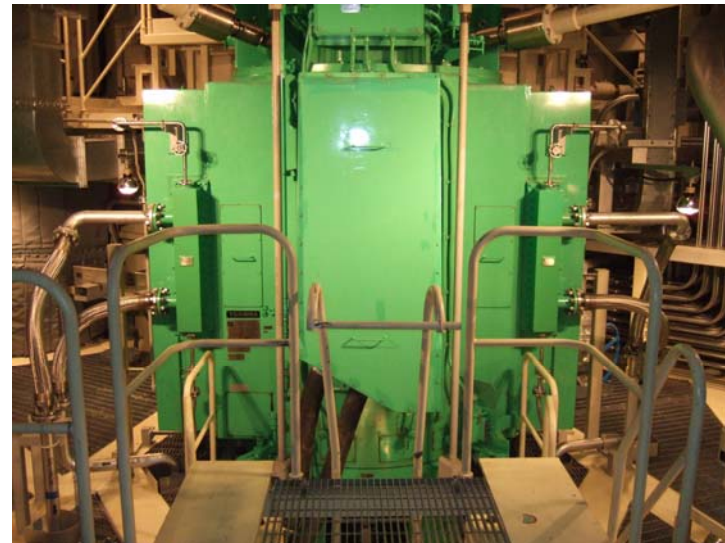
PLR pump (In the primary containment vessel).

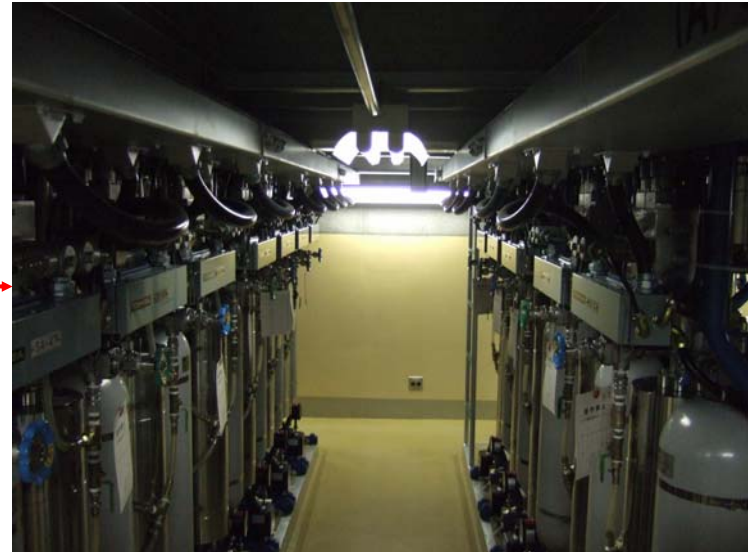
Hydraulic Control Unit (B1F in the reactor building).

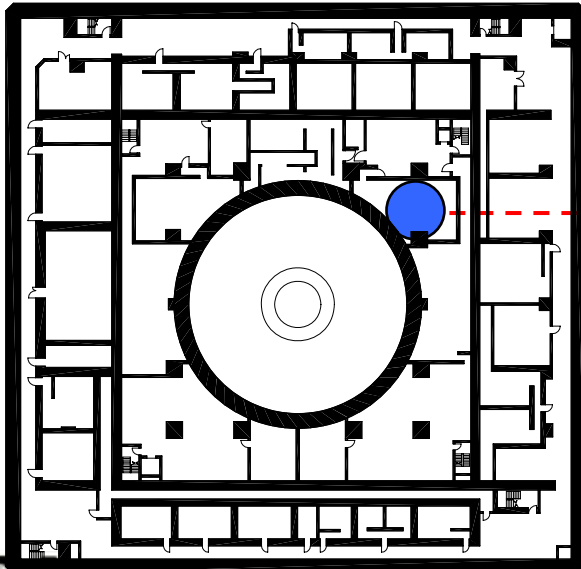
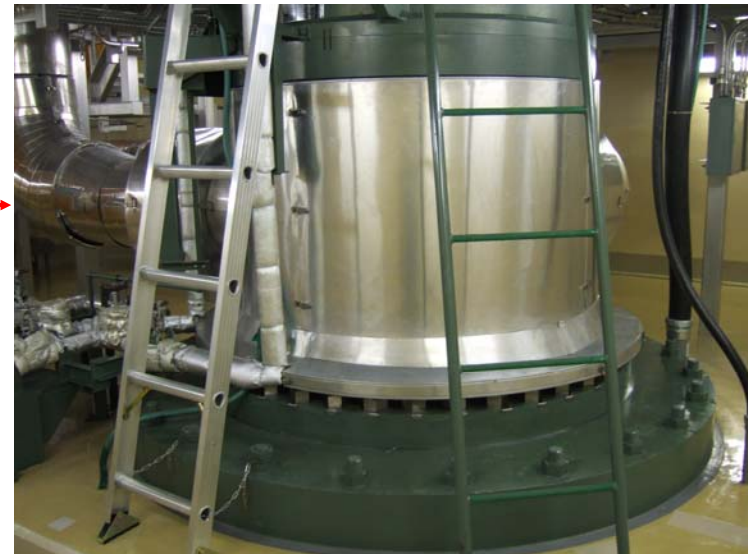
Residual Heat Removal Pump (B5F in the reactor building).

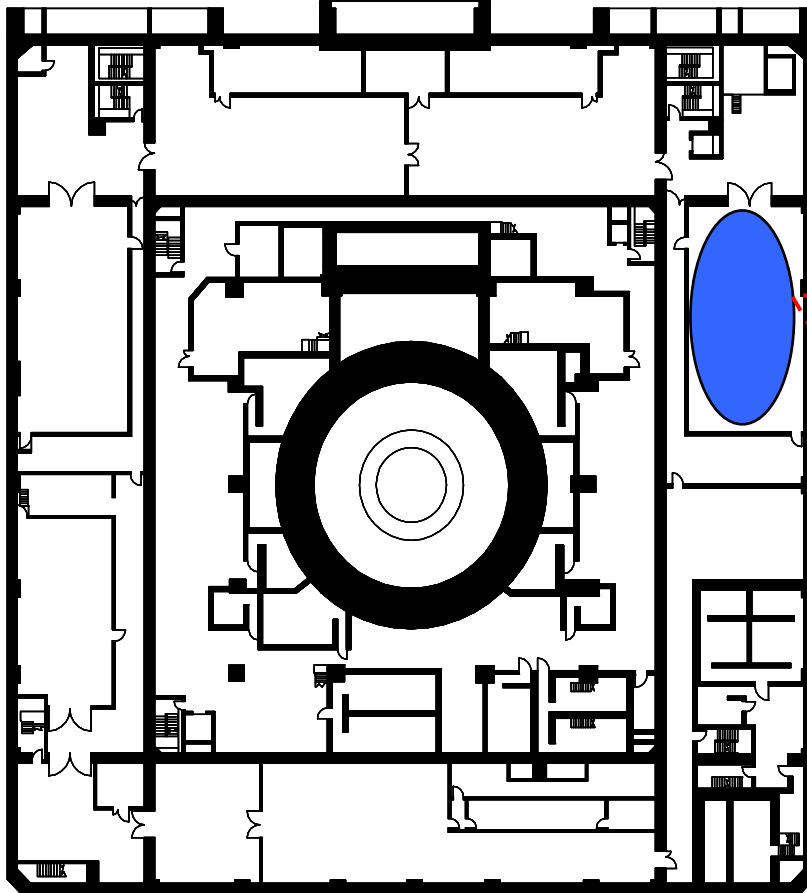
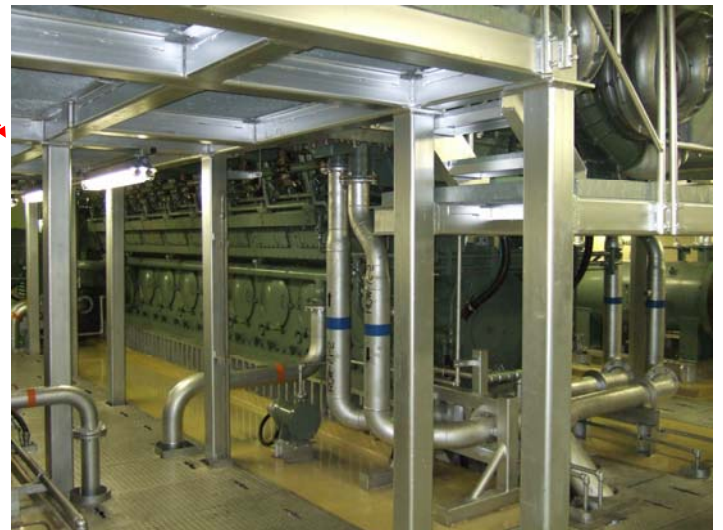
Emergency diesel generator at Unit 3

B1F in the annex of the reactor building.

Upper side of the emergency diesel generator.

Lower side of the emergency diesel generator.

The 20 emergency diesel generators at units 1 to 7 underwent a manual startup test from July 25 to 27 to confirm their availability.

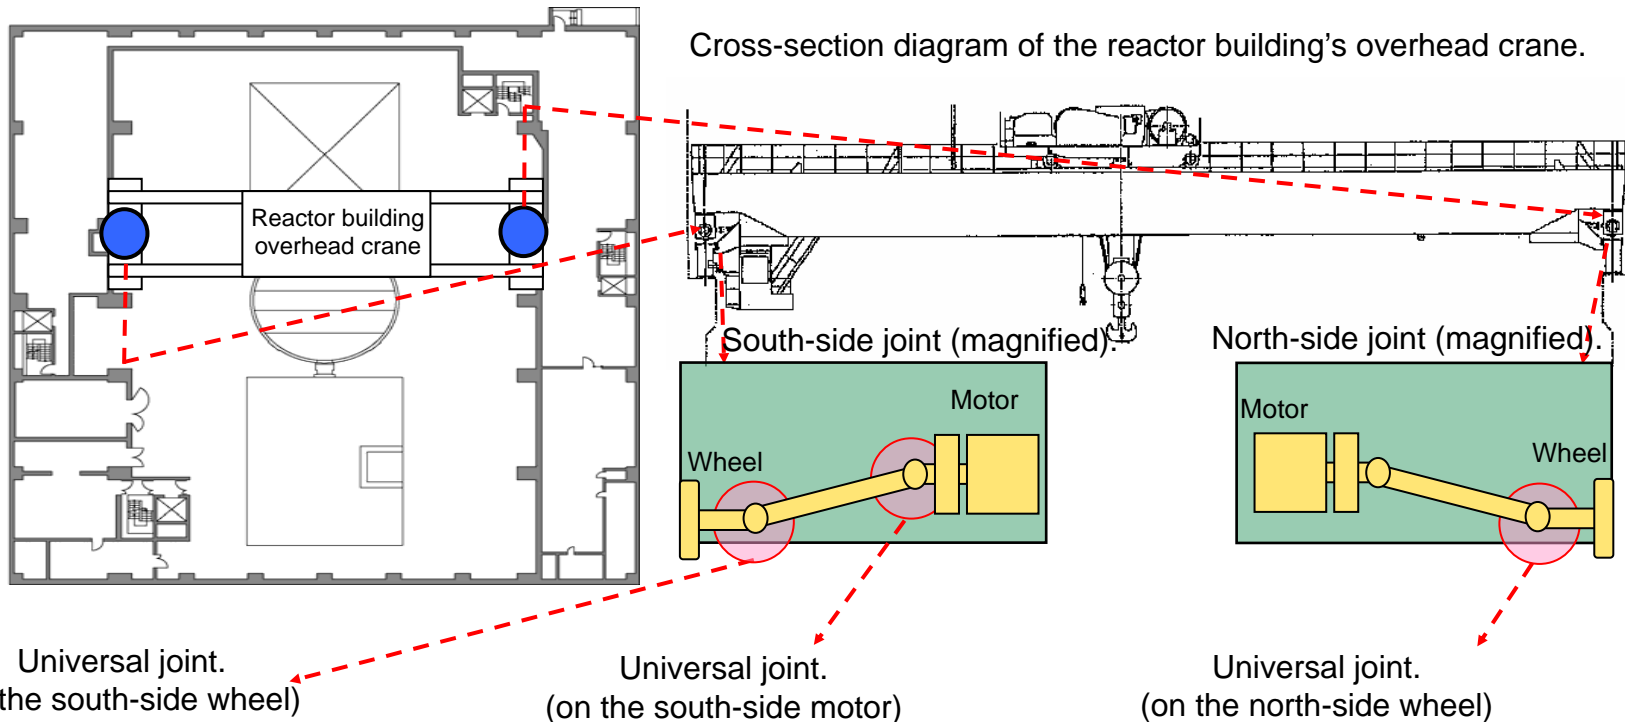
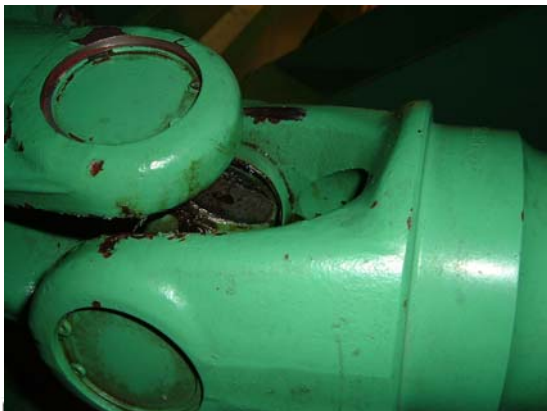
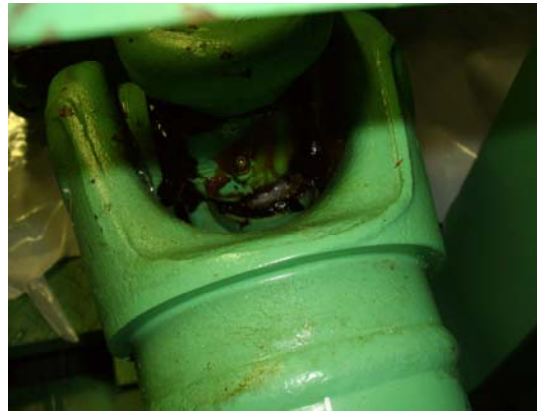
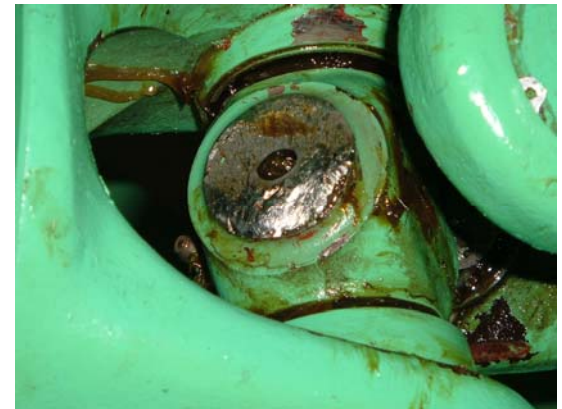
Overhead crane of the reactor building at Unit 6

Overhead crane of the reactor building on the refueling floor (4th floor) at Unit 6.

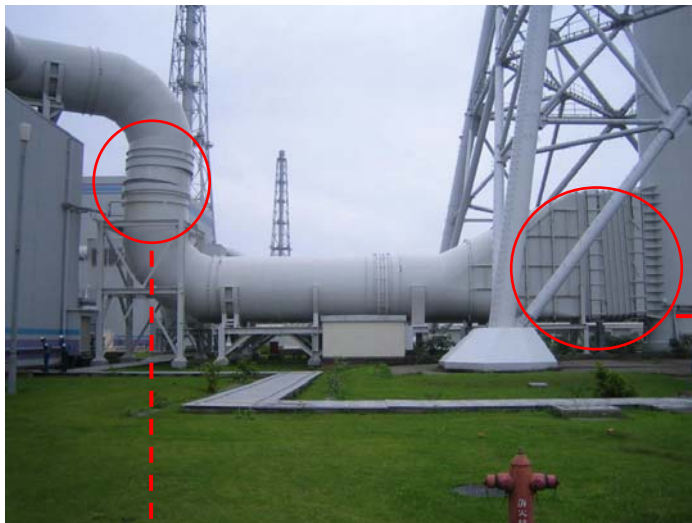
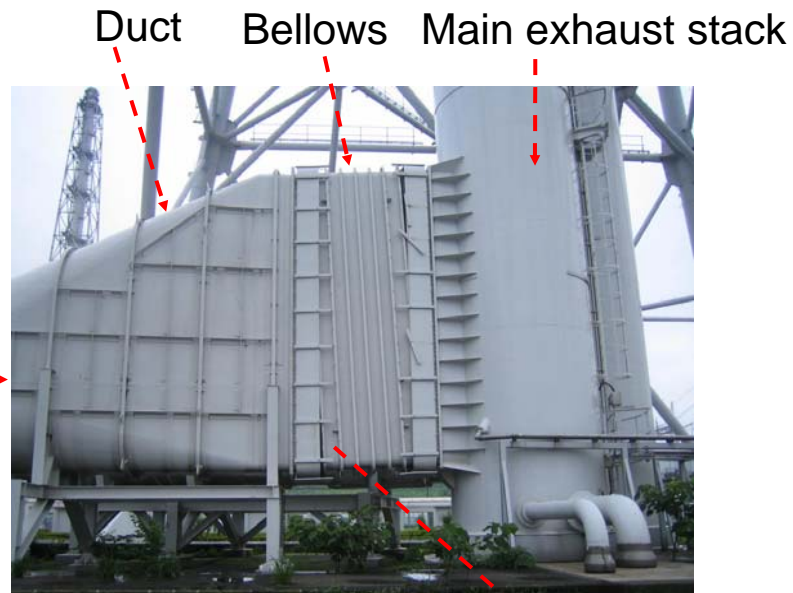
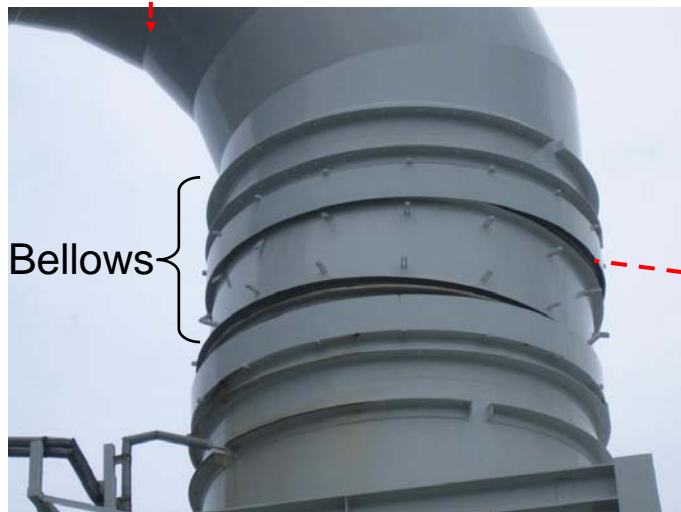
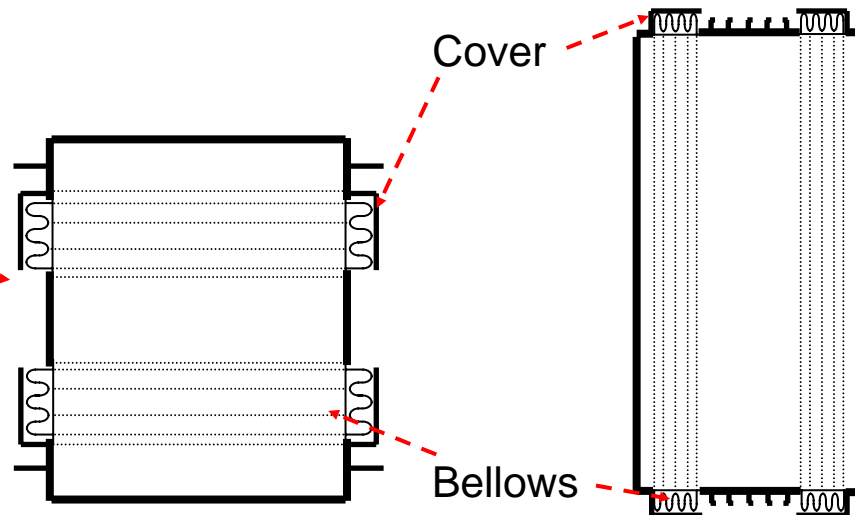
Exhaust duct at Unit 1

- Displacement of exhaust duct at Unit 1.

Duct displacement

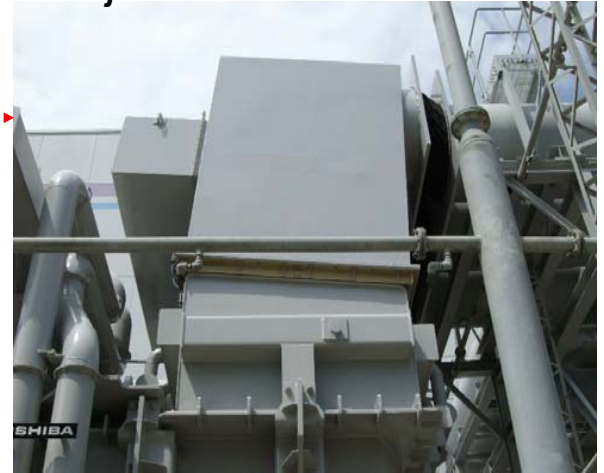
■ Displacement at the primary-side joint .

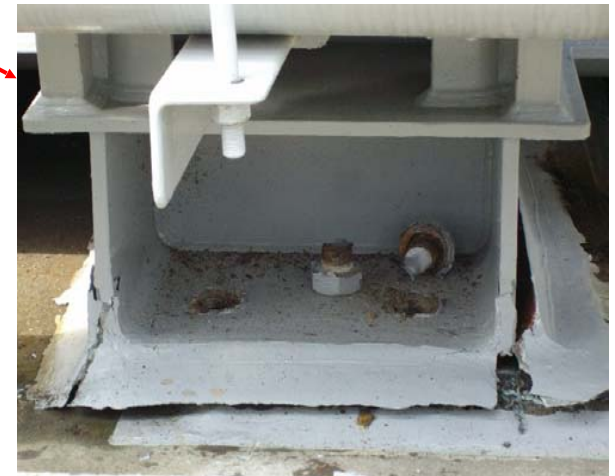
■ Breakage of foundation bolts.

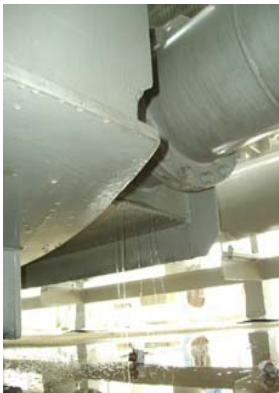
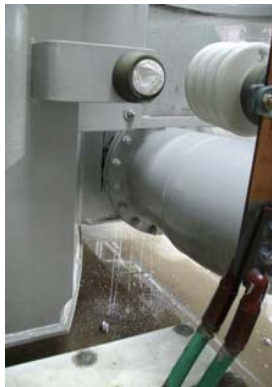
■ Oil leakage.

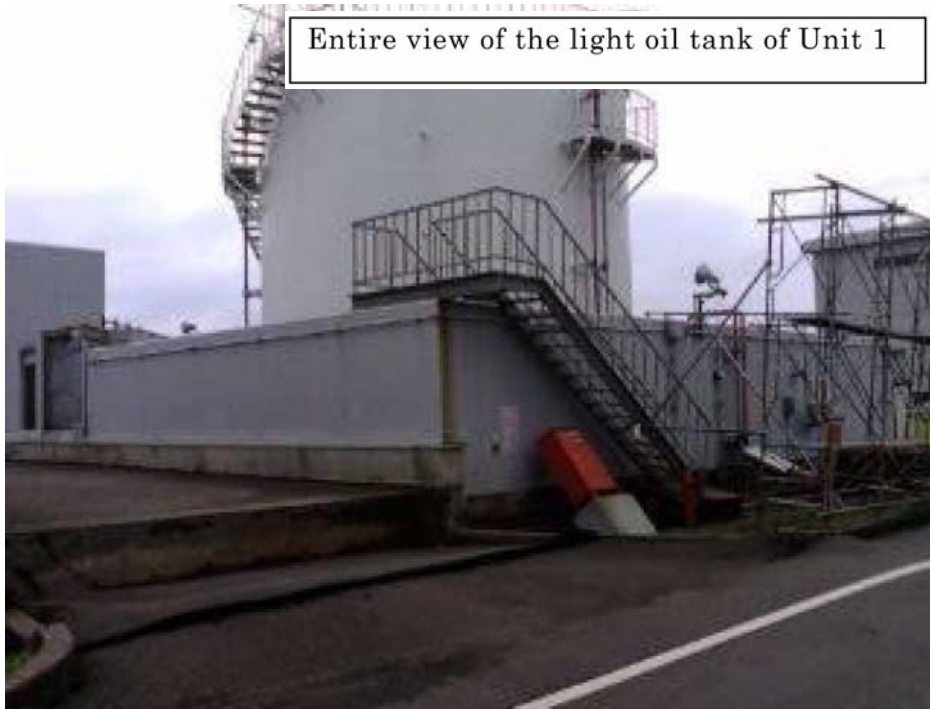
Entire view of the light oil tank of Unit 1

It has been confirmed that the light oil tank is free from oil leakage or deformation and any structural problems.

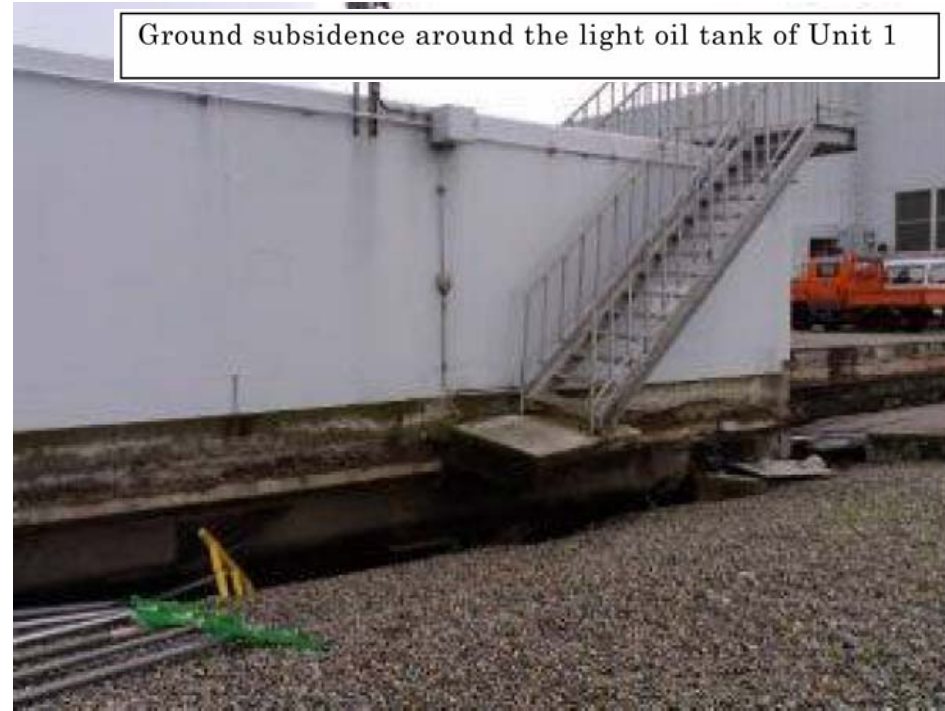
Ground subsidence around the light oil tank of Unit 1

Ground subsidence around the light oil tank

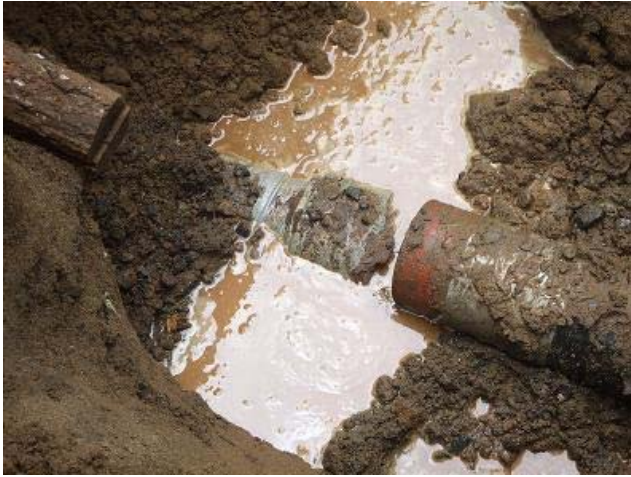
- Flooding caused by a fire protection pipe rupture.

Status of damage.

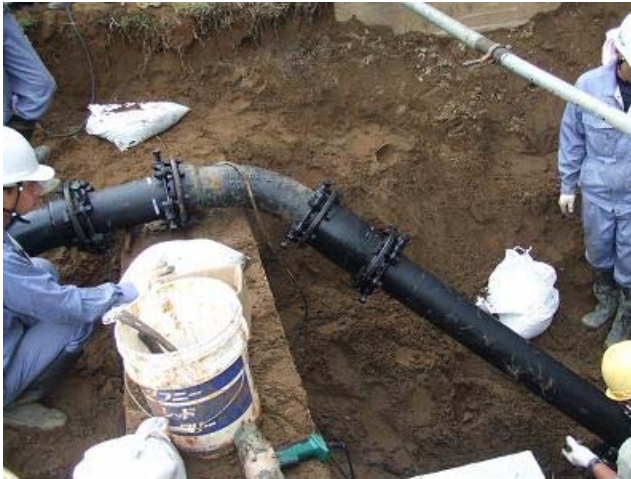
Status of restoration.

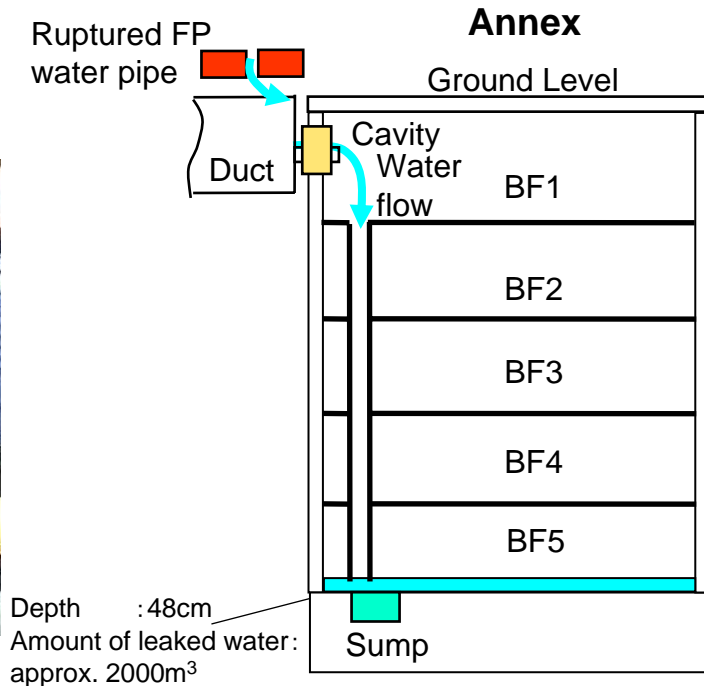
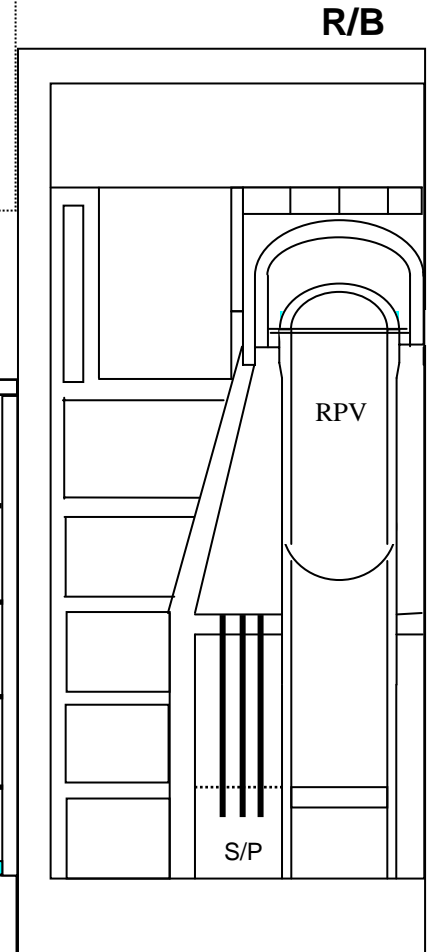
- The flooding affected radioactive waste processing equipment on BF5 of the Annex.

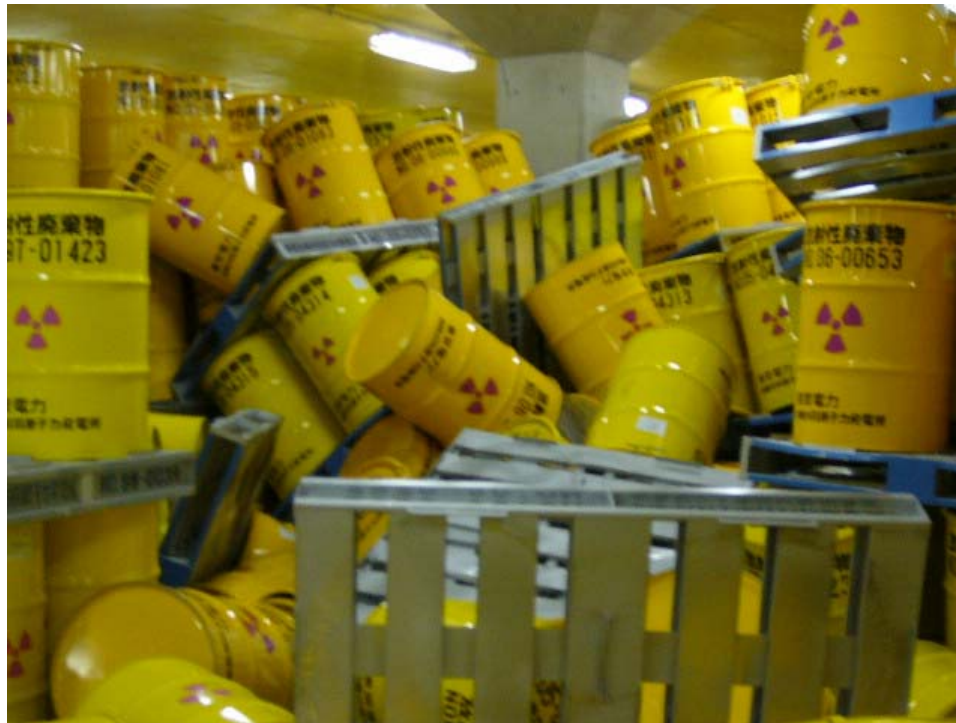
Solid waste storage facility

- Tumbling of drums at the solid waste storage facility.
 - As of now, 438 drums are confirmed to have fallen over, and 41 of them had the lid open as a result.
 - No radioactive substances were detected in the measurement of atmospheric radioactive substance concentration in the facility. Radiation was also not detected from leaked water.

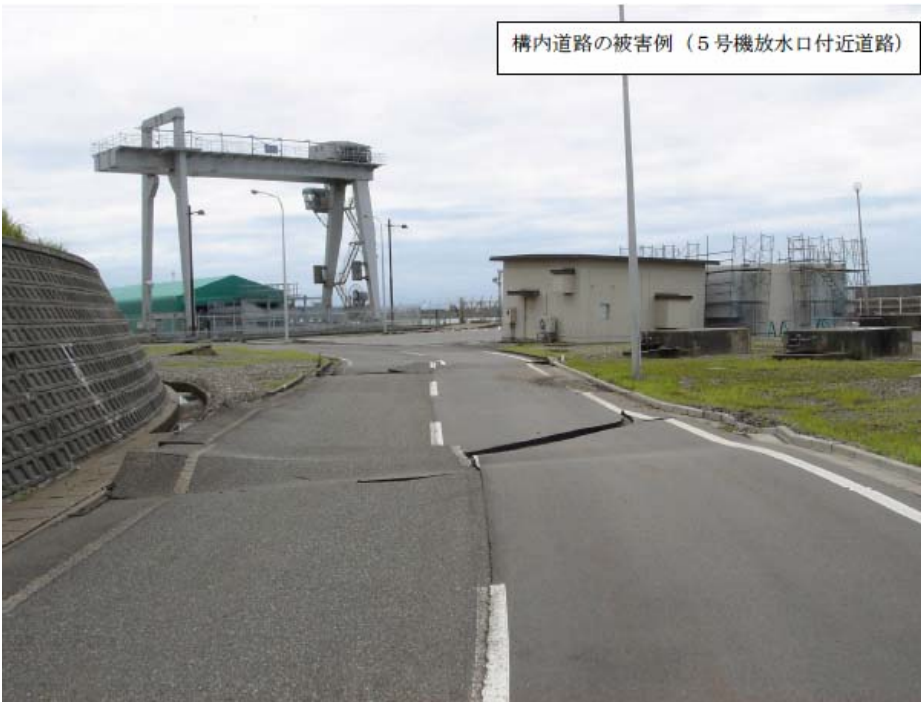
- Road damage near Unit 5.

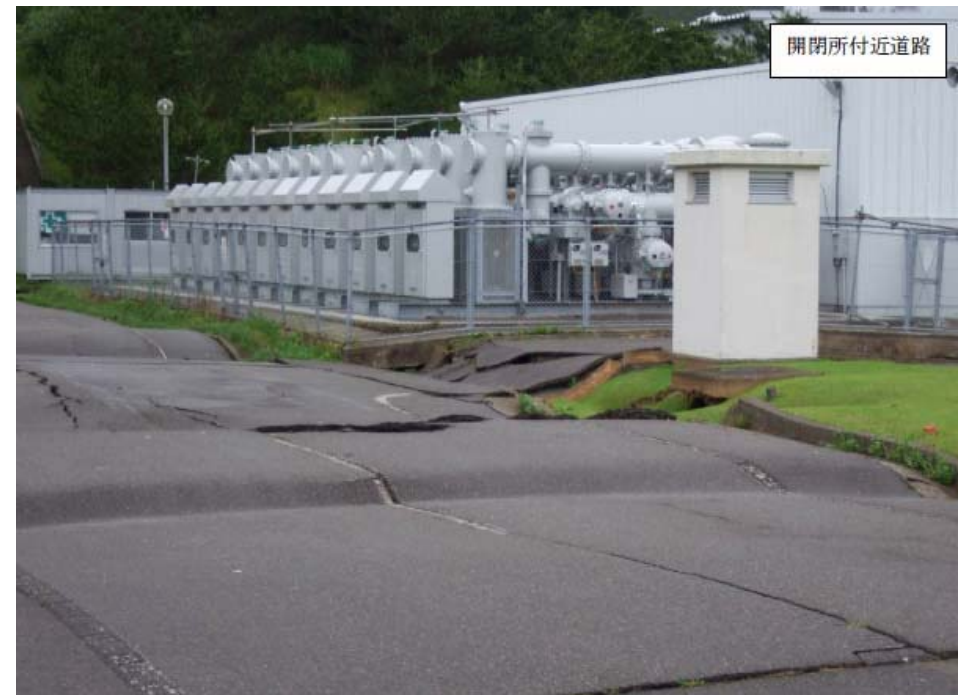
- Road damage near Switch Yard.

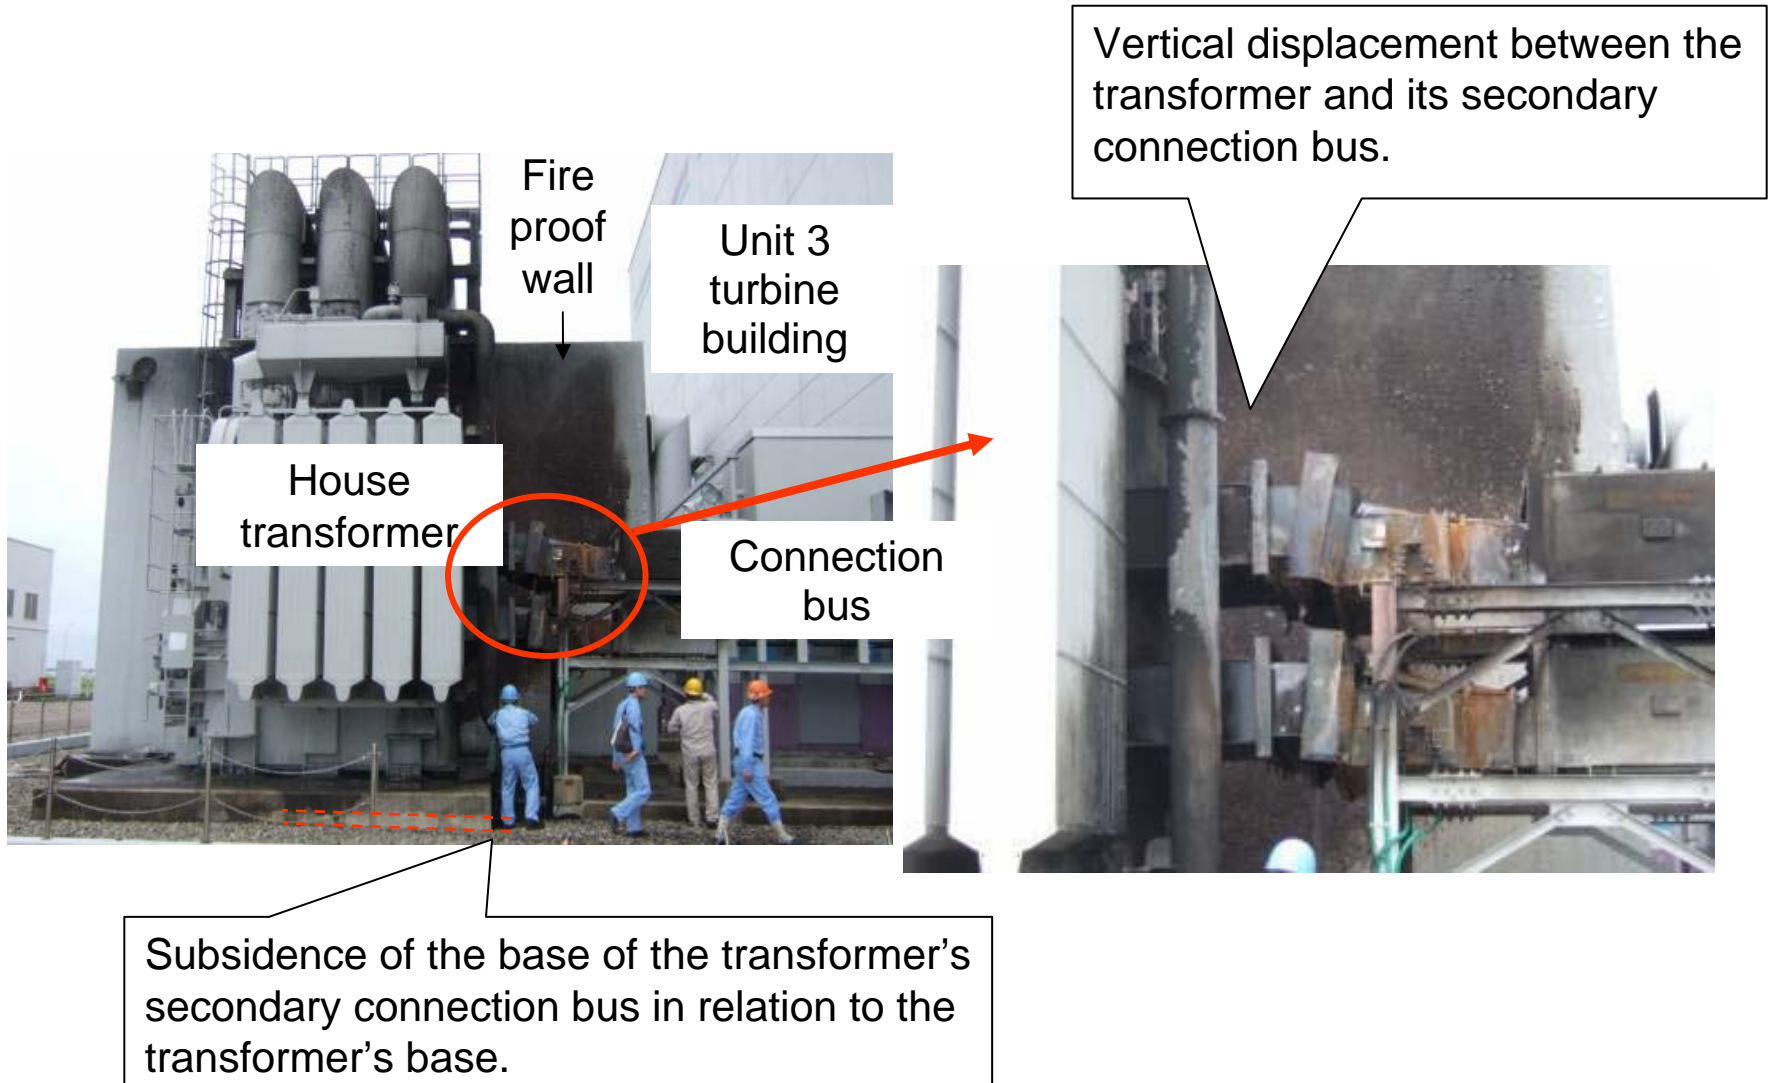
House transformer fire at Unit 3

- The fire continues 2 hours before extinction.

Water could not be sprayed from the fire hydrant due to pipe breakage.

- The fire protection wall prevented the fire from spreading to other areas.
- The cause is presumed to be such that: Because of soil deformation, the duct dropped and came in contact with the connecting terminals and the bushing was damaged and caused oil leakage. In such a situation, oil was ignited by sparks generated by the contact.

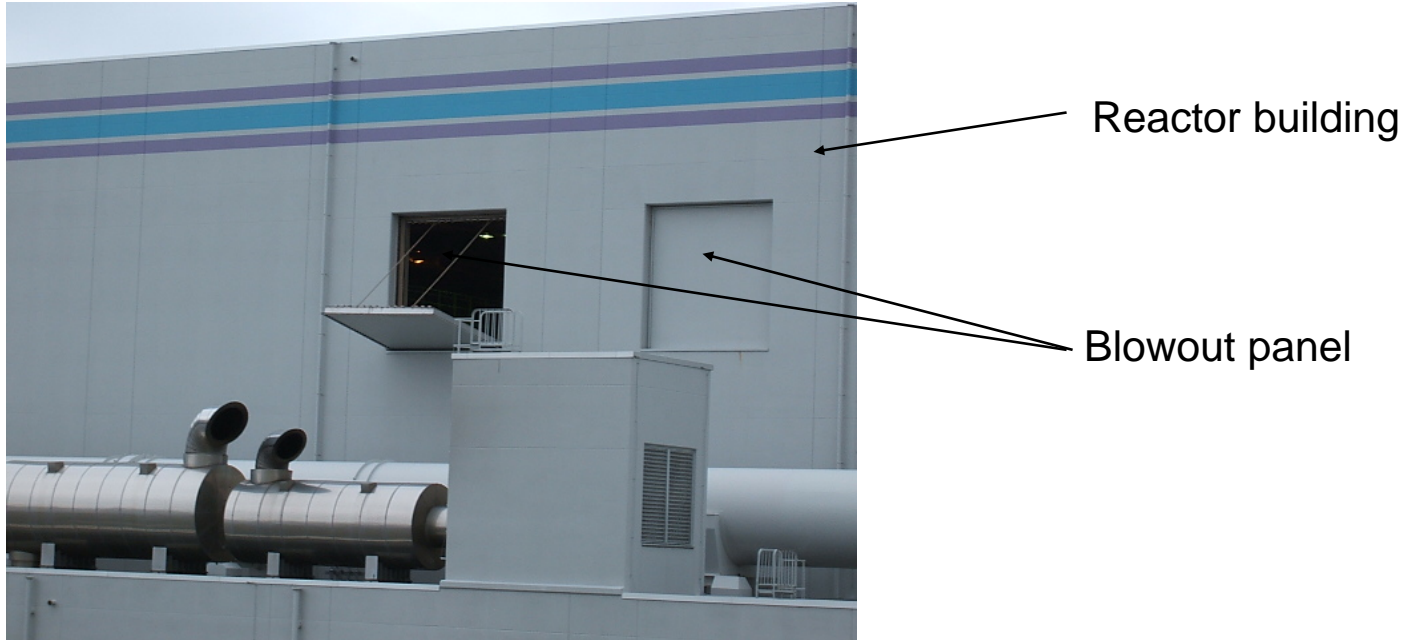
■ Opening of a Unit 3 blowout panel

- It is presumed that the reactor building blowout panel came off due to the earthquake.

- Departure from the LCO* due to displacement of the reactor building blowout panel was declared (15:37) and returning to within the LCO was declared (23:07) after the unit came to a cold shutdown condition.
(Departure from the LCO was declared since it was considered that the negative pressure would not be maintained. Actually, however, the negative pressure remained maintained.)
- The blowout panel will be restored prior to fuel transfer work.

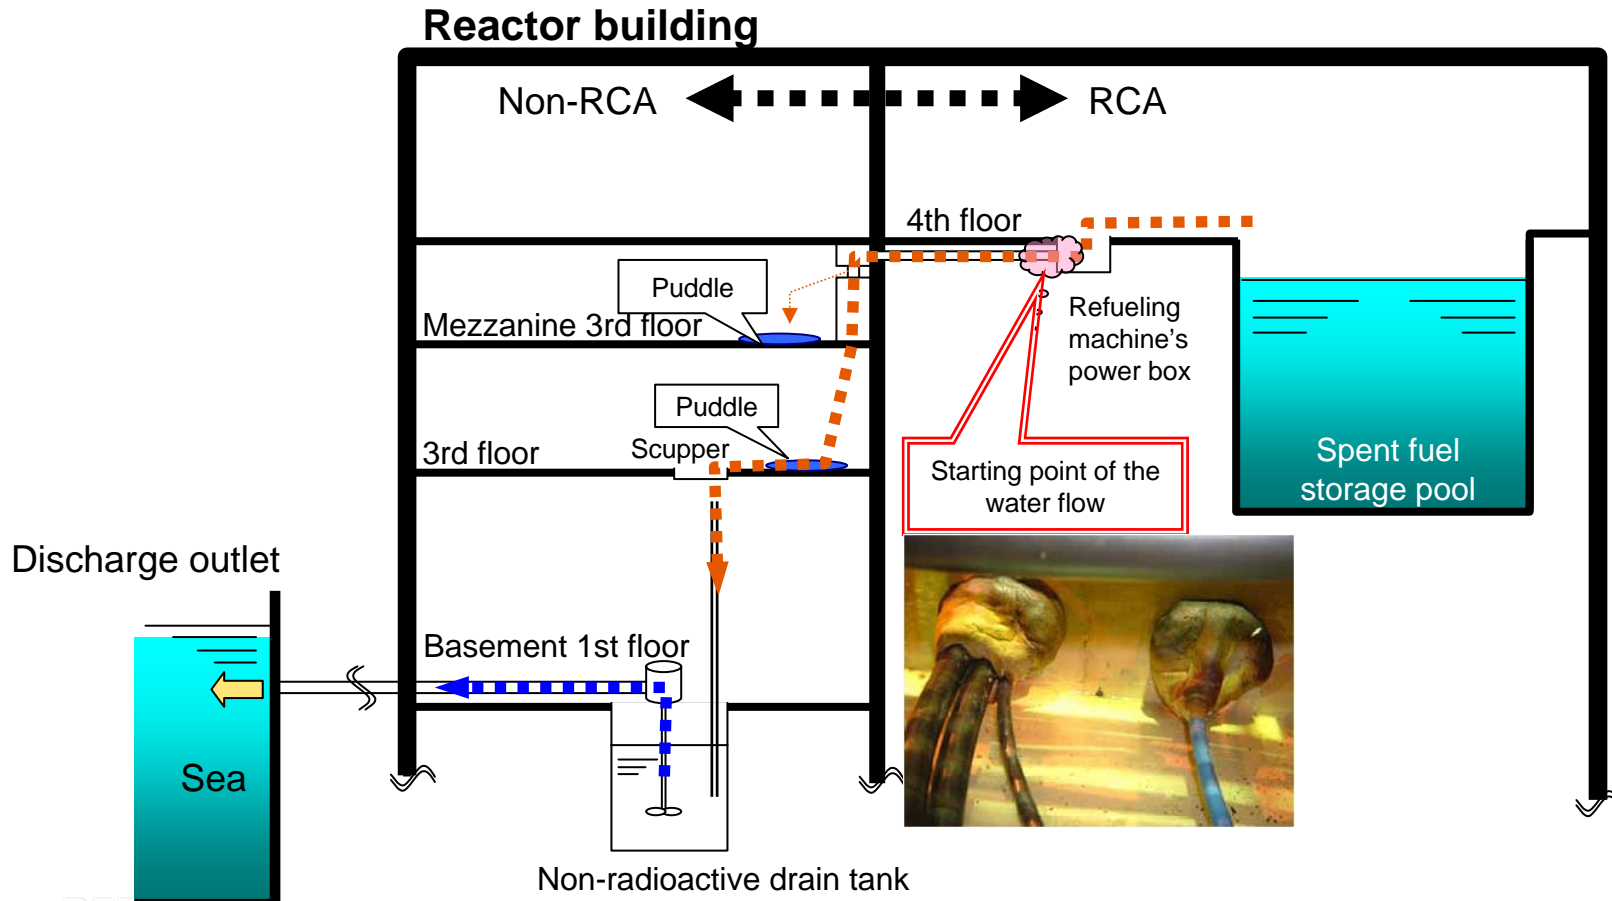
Radioactive leakage at Unit 6

- Water leakage and subsequent release of radioactive substances into the sea.
 - Amount of water discharged: 1.2 m³.
 - Radiation dose: 2×10^{-9} mSv \ll 1 mSv (public dose limit).

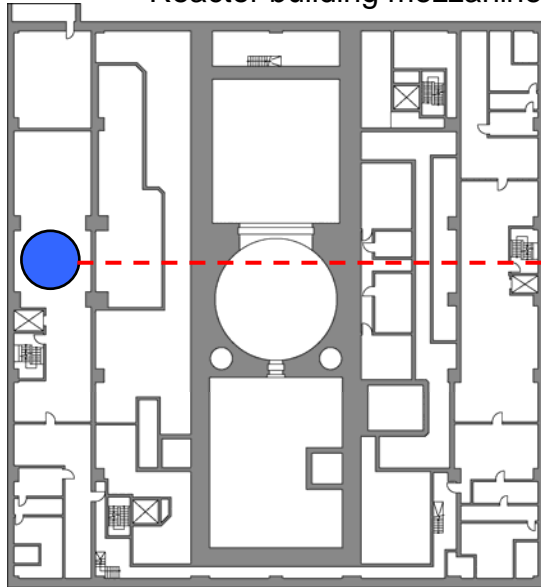
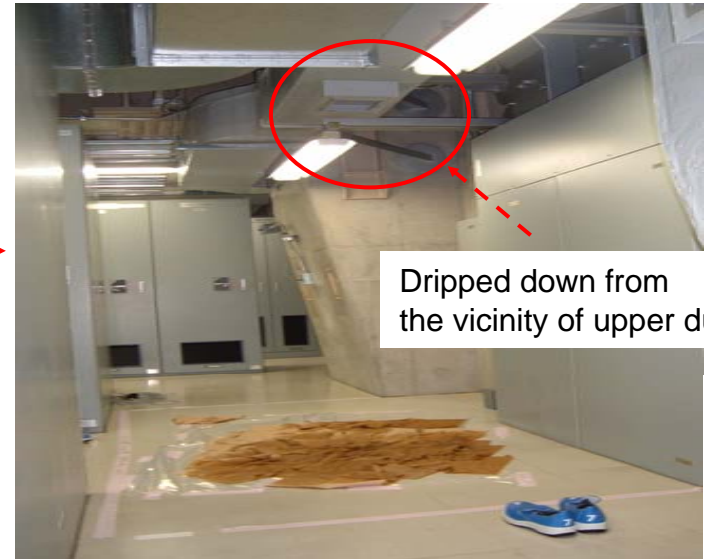
Reactor building mezzanine 3rd floor where leakage water dripped down (non controlled area)

Dripped down from the vicinity of upper duct

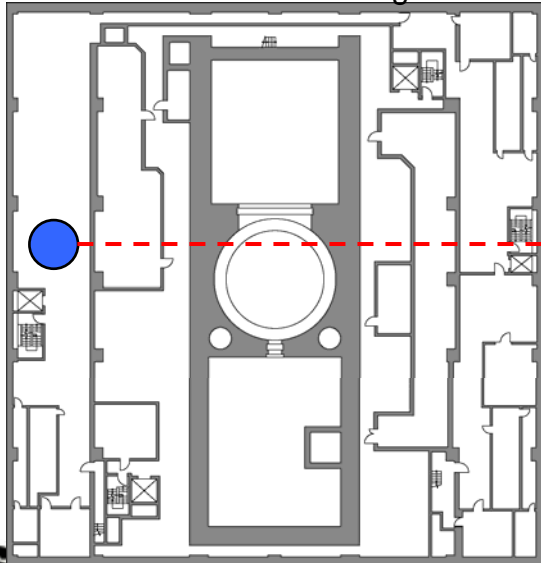
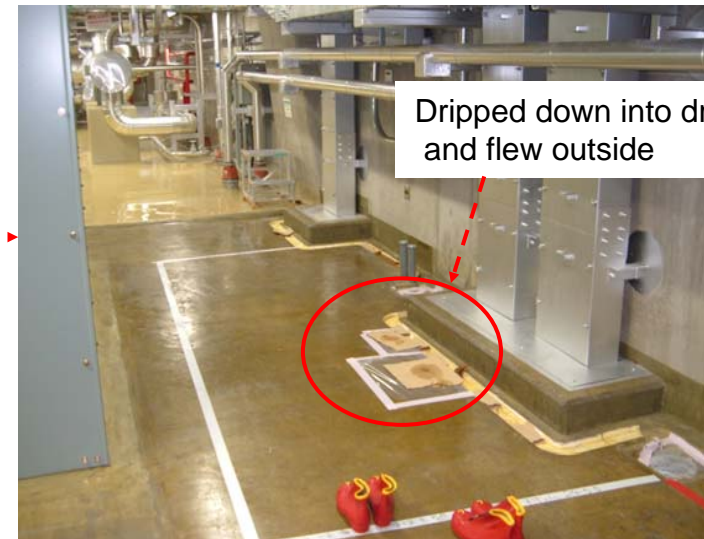
Reactor building 3rd floor where leakage water dripped down (non controlled area)

Dripped down into drain funnel and flew outside

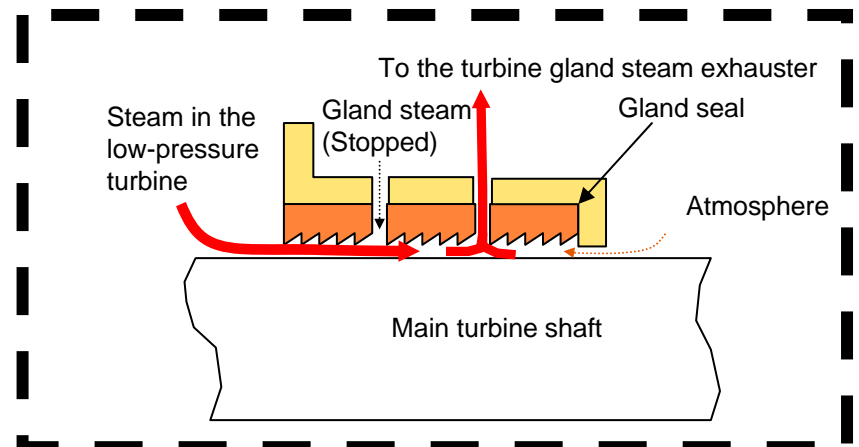
Condition after the earthquake
