Enhancing Operational Experience Feedback: Regulatory control during outages and refueling

Senior Regulators' Meeting
September 20, 2007

Akira Fukushima
Deputy Director-General for Safety Examination
Nuclear and Industrial Safety Agency

Outline of the Shika NPP Unit 1 accident

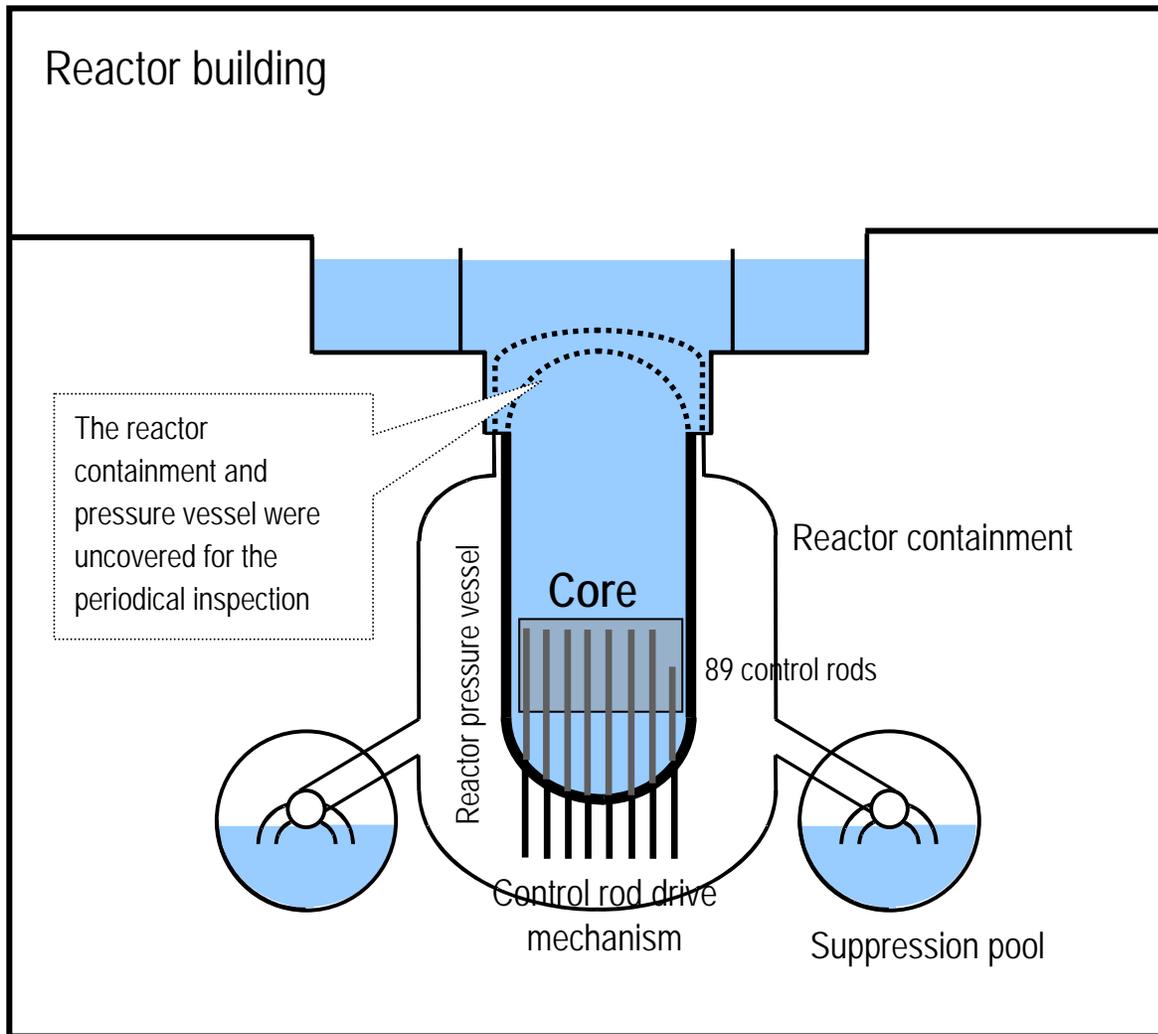
State of the reactor when the control rods slipped

- On June 18, 1999, construction works were done to enhance reactor shutdown redundancy for Shika Unit 1. Valves related to the CRD were operated as a preparatory work for the function verification test.
- Then three control rods partially slipped, and the reactor went into a critical state.
- As the reactor went into a critical state, the reactor automatic stop signal was issued, and the slipping of the control rod stopped. However, the control rods were not inserted back immediately.
- It took about 15 minutes to insert the three control rods completely by opening the valves that had been closed for the preparatory work.

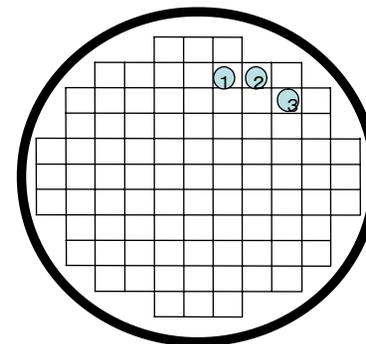
Locations of the control rods that slipped

- ① Control rod [26-39]
Position 16 (about 1/3)
 - { 0: fully inserted
 - { 48: fully withdrawn
- ② Control rod [30-39]
Position 20 (about 2/5)
- ③ Control rod [34-35]
Position 8 (about 1/6)

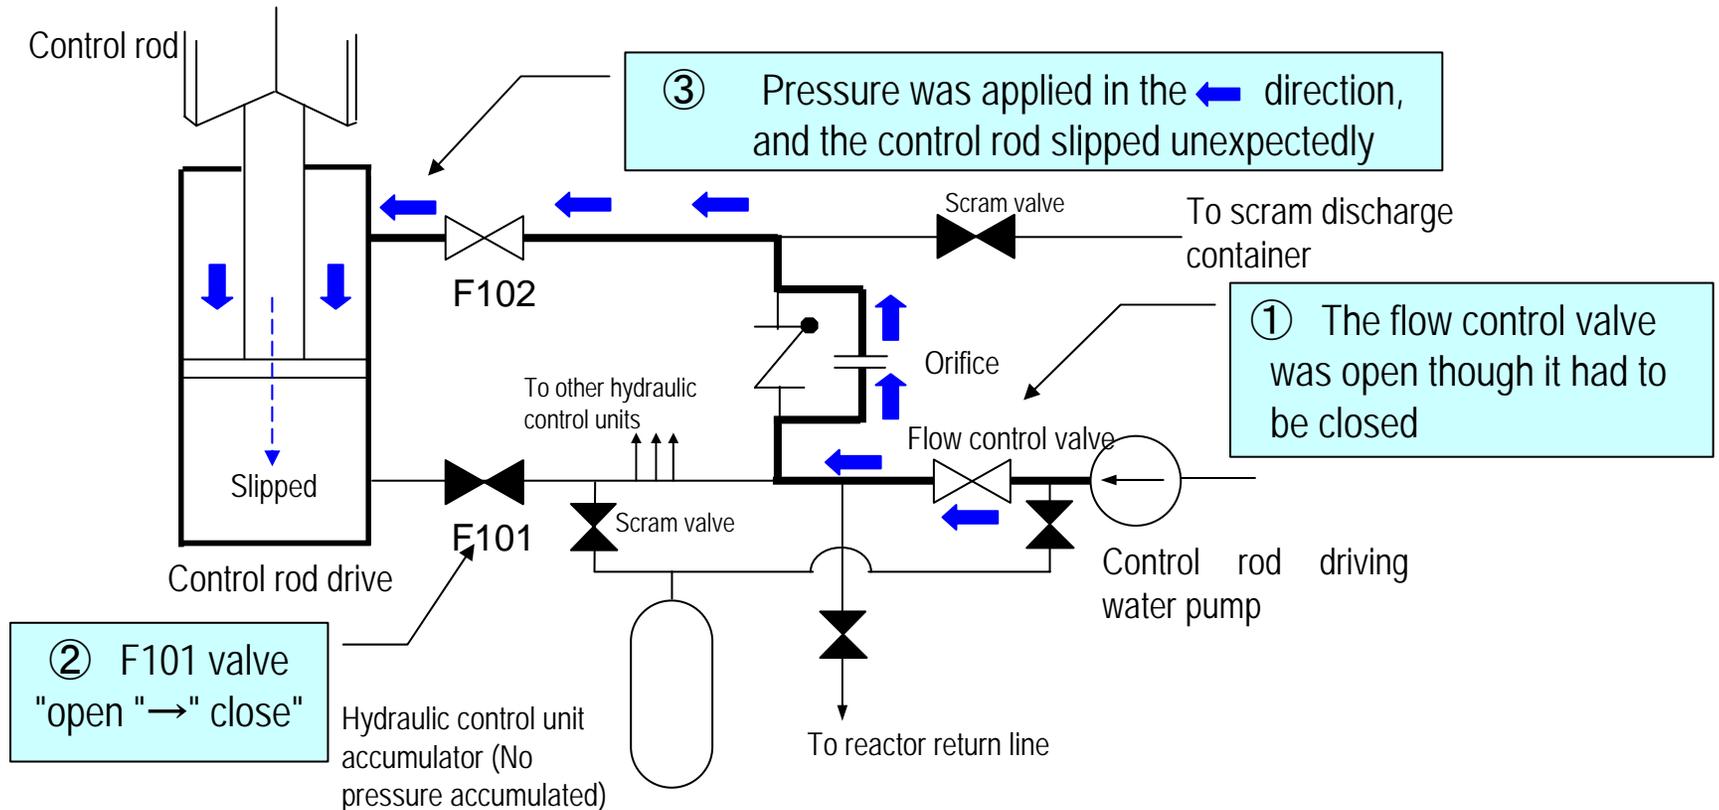
Situation where the control rods slipped

The CR slipped down since the water pressure stressed toward the side of withdrawing the CR, which was caused by neglecting the authorized procedure on manual.

As personnel started to close the 101, 102 valves of 88 HCUs while system flow was 1250/min, the system pressure increased enough to withdraw control rods from the core.

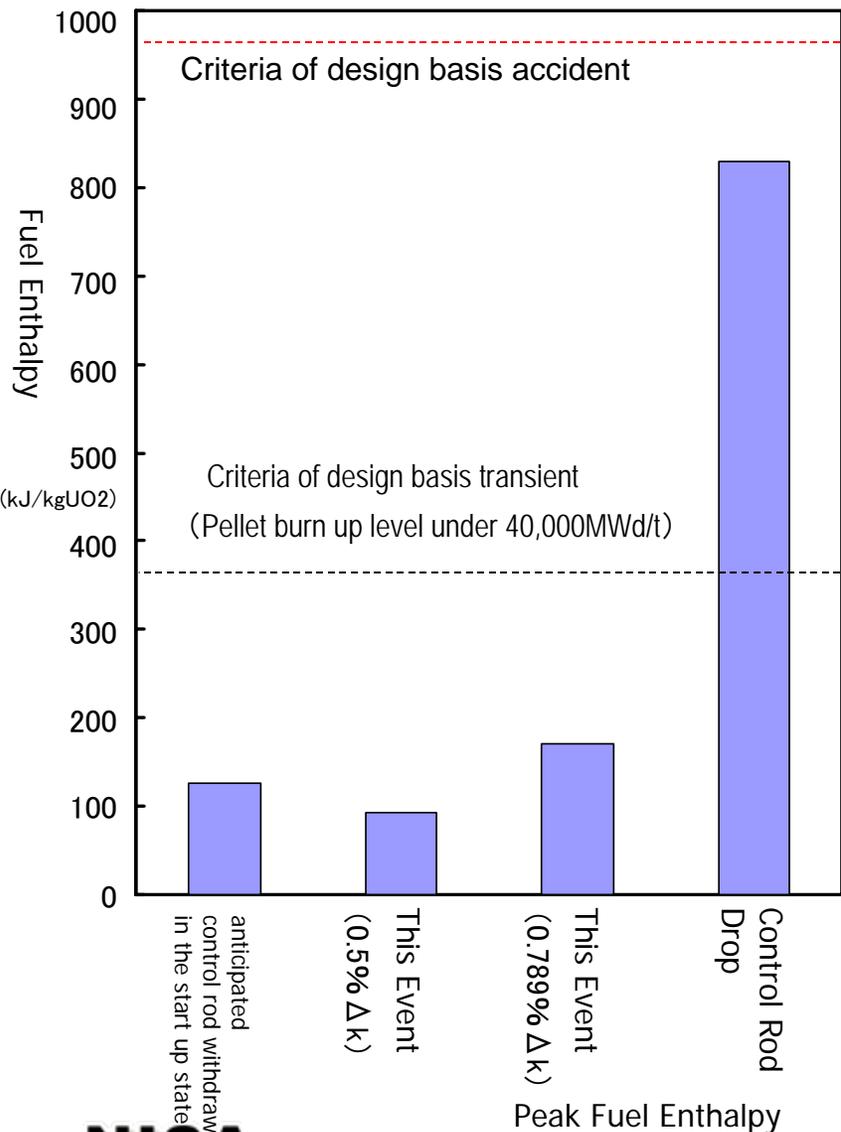
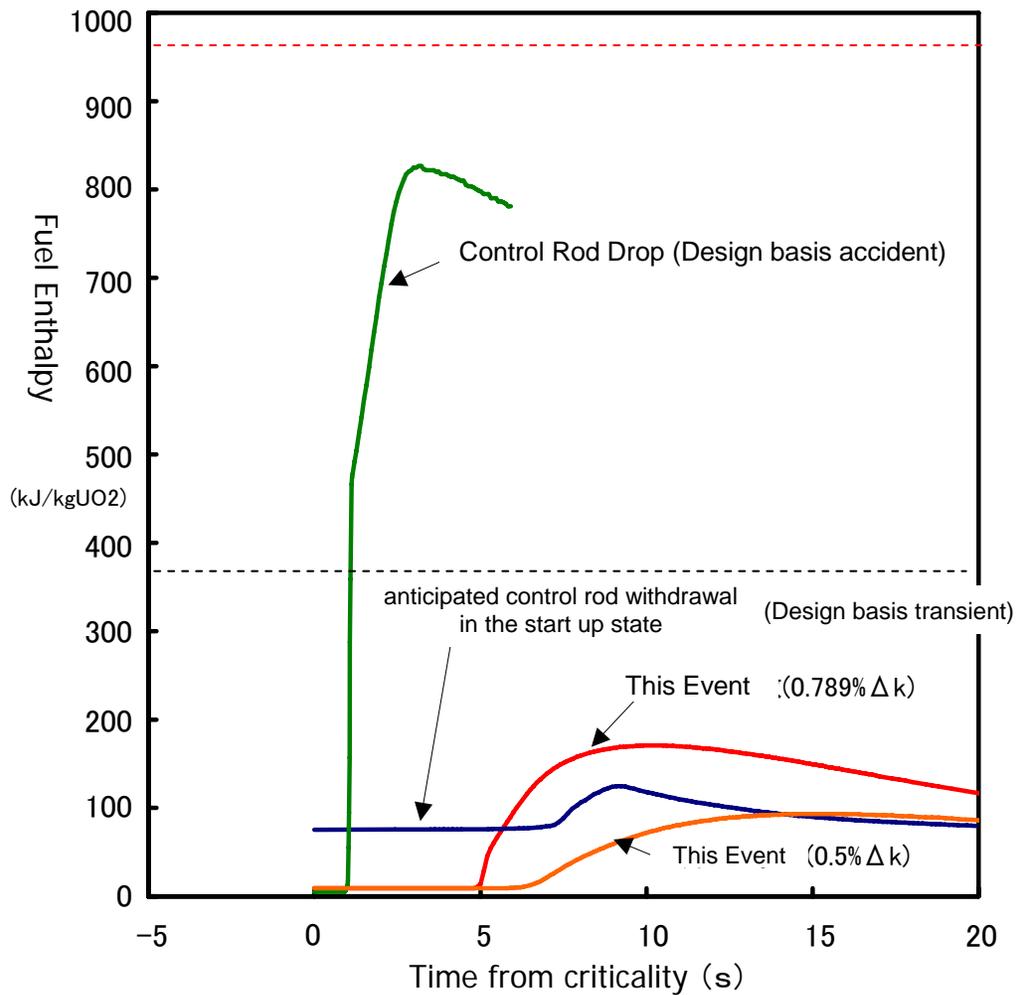
Result of Analysis

- (1) Hokuriku confirmed the integrity of the fuels in the core by the analytical method since neutronic data at the time of accident was not sufficiently recorded.
- (2) The analysis conducted by Hokuriku assumed the most limiting conditions considering the ordinary criticality and prompt criticality. NISA considers that the integrity of the fuel was not affected and there was no exposure to the workers or the public.
- (3) This accident was rated as Level 2 in accordance with the International Nuclear Event Scale (INES).

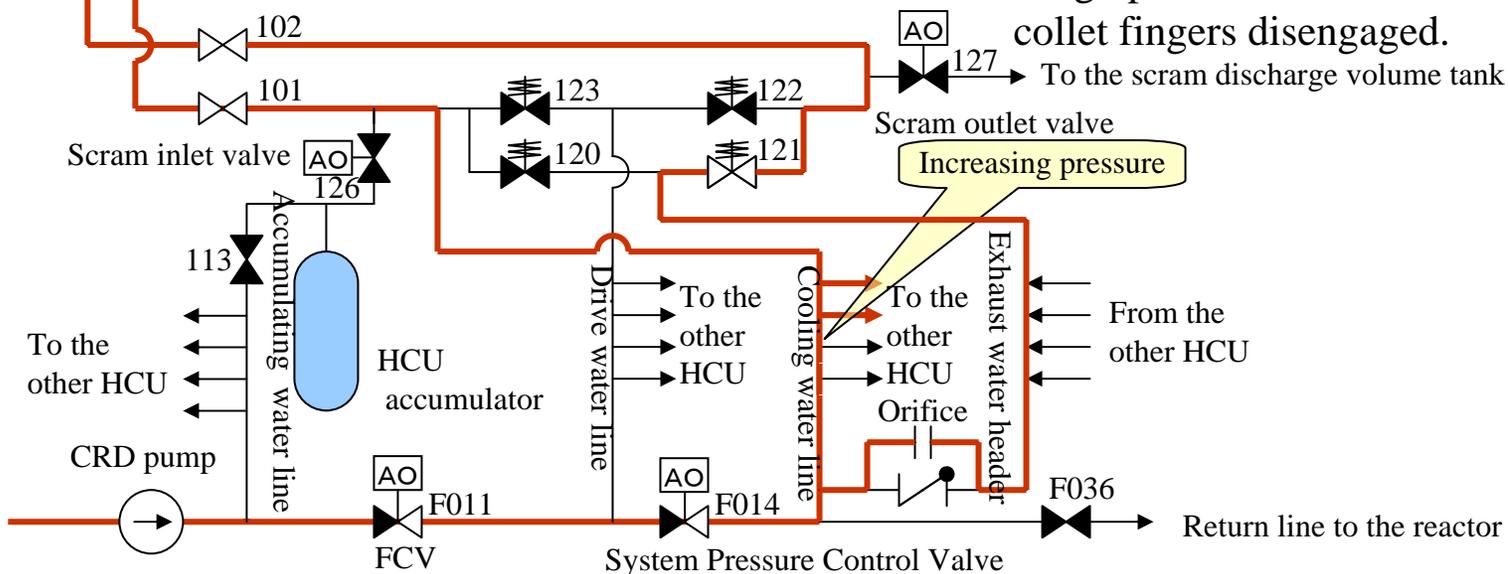
Mechanism of Control Rod Withdrawal (3)

- 88 HCU's were isolated by turns except for a HCU which was tested.

→ Pressure was gradually increased in cooling water header.

- Differential pressure (between cooling water header and reactor) > about 0.04MPa

→ As control valve (121) was open, cooling water running through the orifice pressurized withdrawal line.

- Differential pressure > about 0.7MPa

→ High Pressure in insert line keep CR overtraveled into the core.

- Differential pressure > about 1.0MPa

→ High pressure in withdrawal line keep the collet fingers disengaged.

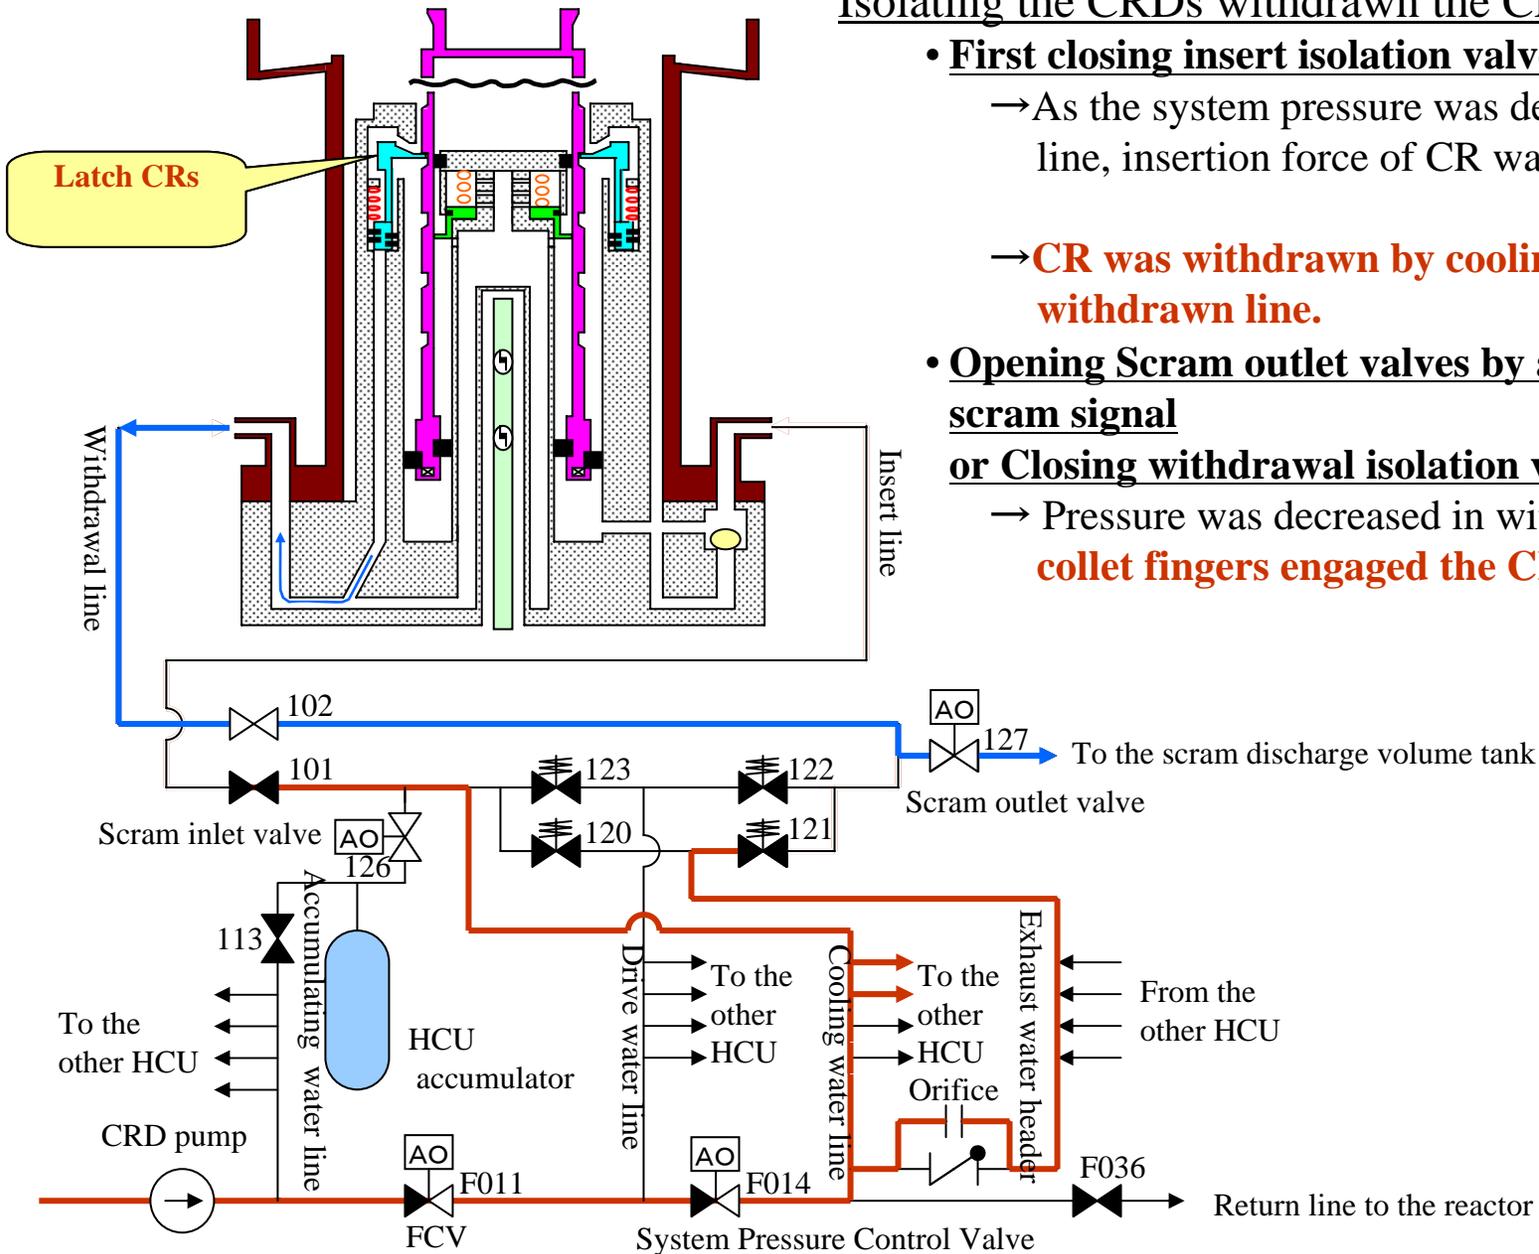
Mechanism of Control Rod Withdrawal (4)

- First closing insert isolation valve (101)

→ As the system pressure was decreased in insert line, insertion force of CR was decreased

→ **CR was withdrawn by cooling water in withdrawn line.**

- Opening Scram outlet valves by automatic reactor scram signal
or Closing withdrawal isolation valve (102)

→ Pressure was decreased in withdrawal line and **collet fingers engaged the CRs**

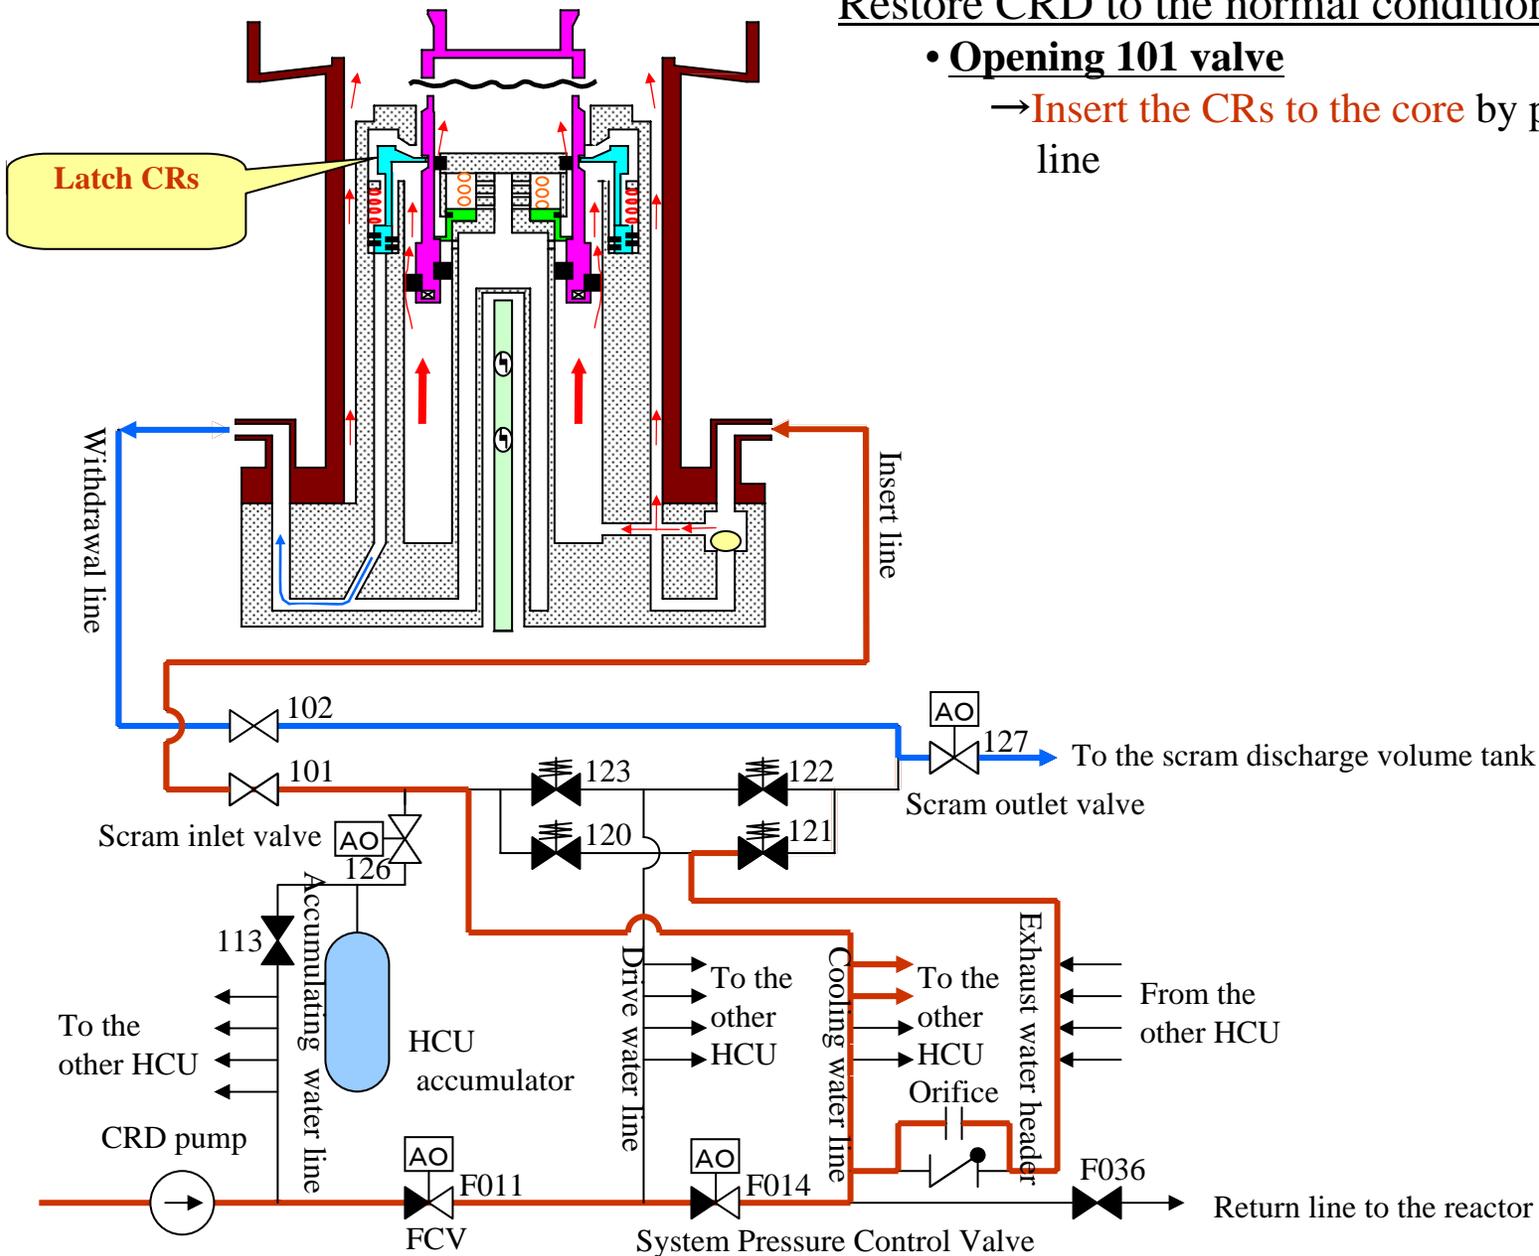
Mechanism of Control Rod Withdrawal (5)

- Opening 101 valve

→ Insert the CRs to the core by pressure in insert line
