MADAGASCAR EXPERIENCE IN MANAGEMENT OF CONSEQUENCES OF INCIDENT WITH CONTAMINATED SCRAP METAL

M.J. Ramanandraibe, Raoelina Andriambololona, H.F. Randriantseheno, J.L.R. Zafimanjato

Madagascar-Institut National des Sciences et Techniques Nucléaires (Madagascar-I.N.S.T.N)

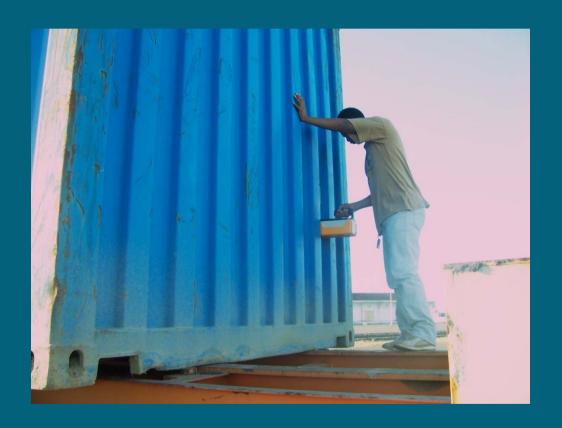
- Dose rate measurement around and at the surface container were carried by radiation protection and waste management team of Madagascar-I.NS.T.N.
- Maximum dose rate found near the bottom of the container.
- Confirmation that radiation level is widely higher than acceptable limit for transportation of excepted package.

Table 1: Radiation level at the container surface

Container identification	PCIU: 387 265/0	PCIU 379 046/5
Radioactive nuclide detected	Ra-226	Ra-226
Maximum dose rate at container surface (μSv/h)	23	40
Acceptable limit for transportation of excepted package (μSv/h)	5	5

Dose measurement at the container surface

• The contaminated scrap metal located at the container bottom should be removed before exporting the scrap metal.

After removing the radioactive material, contamination checking should be performed before shipment.

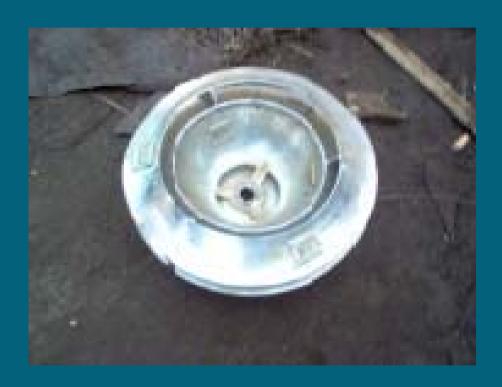
- June 2007: radioactive materials (lightning conductor with
 - Ra-226) isolated from the containers.
- The root causes of this incident were the lack of recognition of materials that may be radioactive by those involved in collecting, handling and exporting scrap metal.
- The origin of the scrap metal containing radio

Table 3: Radiation level around the isolated radioactive material

Dose rate	Surface (μSv/h)	At 1 meter (μSv/h)
Source 1	1036	10
Source 2	590	4

Figure 3: Isolated radioactive material (Lighting conductor with Ra-226 source)

- Radioactive waste should be stored in a safe place.
- According to the regulation in force in Madagascar, radioactive waste should not be removed unless authorization is given by the Regulatory Authority.
