Co-60 contaminated stainless steel in Gemany - experiences and first steps

Dr. Renate Sefzig / Dr. Bejoy Saha / Gisela Stoppa Germany

Supervision in the Field of Radiological Protection Federal Ministry for the Environment, Nature Conservation and Nuclear Safety

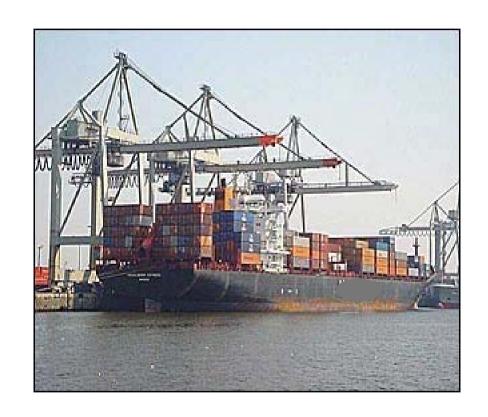
Hamburg Harbor
- Transit Area Container found with Co-60 contaminated steel. Final destination was Russia.
Material returned to sender.
Origin of material: India

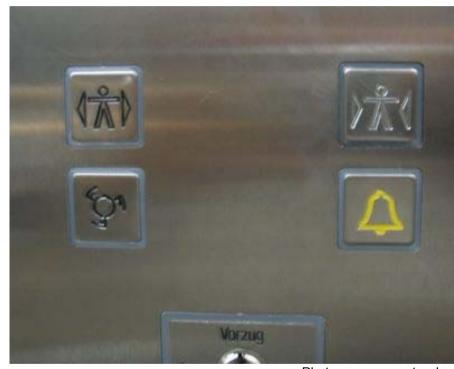
Co-60 contaminated elevator buttons supplied by a French company were found in France, Italy, Germany. Buttons were replaced.

Origin of material: India

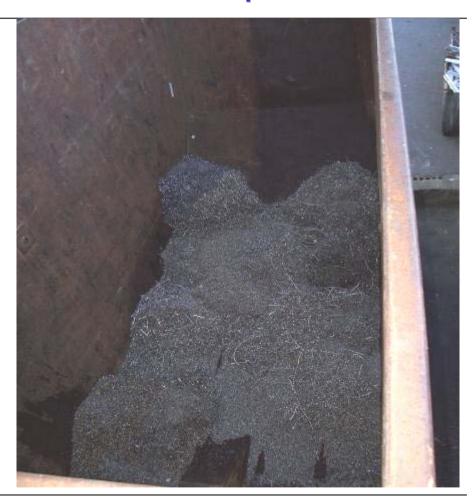
The detection of Co-60 contaminated stainless steel cuttings in a German scrap yard was the starting point for realizing the huge dimension of the issue.

Origin of material: India
