Overview of legacy/NORM sites in Belgium

S. Pepin (Belgium - FANC), EMRAS II WG 2 – 25-29 January 2010

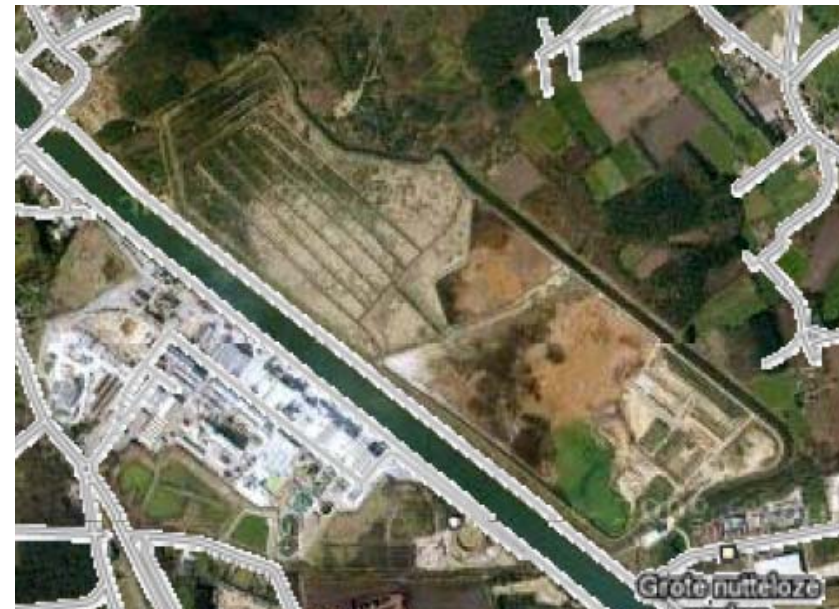
Phosphate industry: the Tessenderlo's sites

Tessenderlo: treatment of phosphate ores to produce cattle food

HCl process => CaF_2 sludges as residues

⇒ Disposal on landfills ("Veldhoven")

Area (ha)	Volume (tons)	Years of exploitation
S1	25	900,000	1963-1986
S2	4	50,000	(buffer dump) ~1980- today
S3	26	900,000	1987 - today
Dumpsite on factory premises	5.6	150,000	1935 - ~1970

+ two others disused dumpsites 1-2km SW

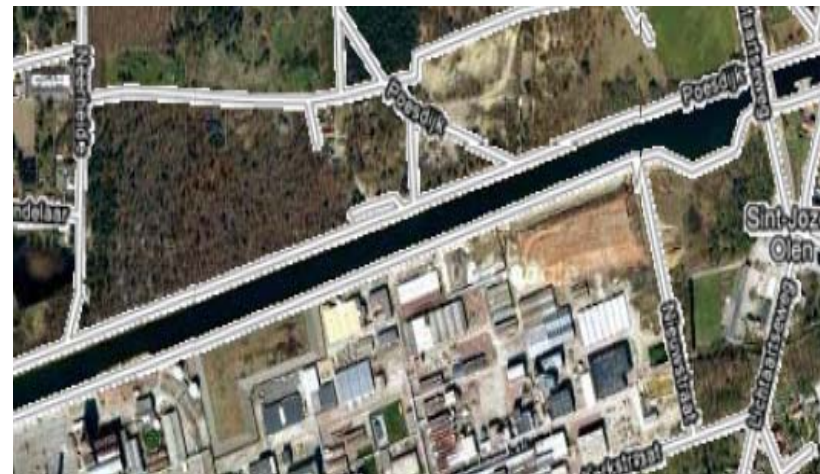
Olen site

Metallurgical company: radium extraction and production of radium sources from 1922 till 1969

⇒ Dumpsites D1 and S1 (to be remediated)

⇒ Contamination of banks of nearby river (« Bankloop ») (remediation project almost over => licensed disposal site for remediation waste)

Dump	Area (ha)	Volume (m ³)
D1	10	217,000
S1	2.4	207,000

D1 dump: iron hydroxide and CaSO₄ (non-ferrous activities) + residues from radium extraction + rubbles from dismantlement radium facility

S1 dump: residues from cobalt production + radium contaminated dredging sludges

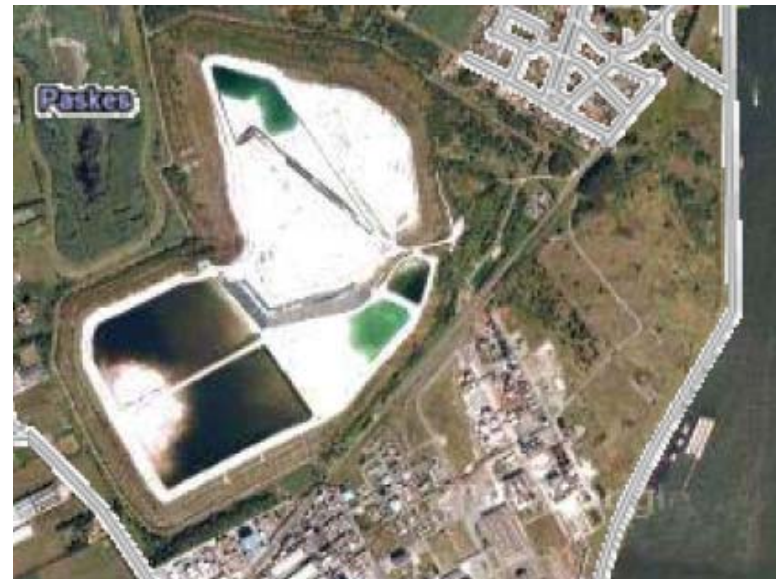
Ghent: PG stack (NB: ~ 10km to the North of FeNb site)

⇒ Ra-226 between 0.1 and 0.4 Bq/g

⇒ Th-232 between 0.05 and 0.4 Bq/g

⇒ Rn-222 + Rn-220 up to 130 Bq/m³

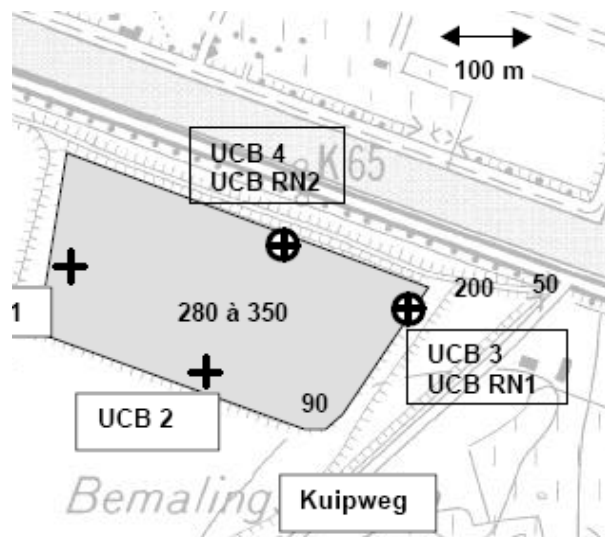
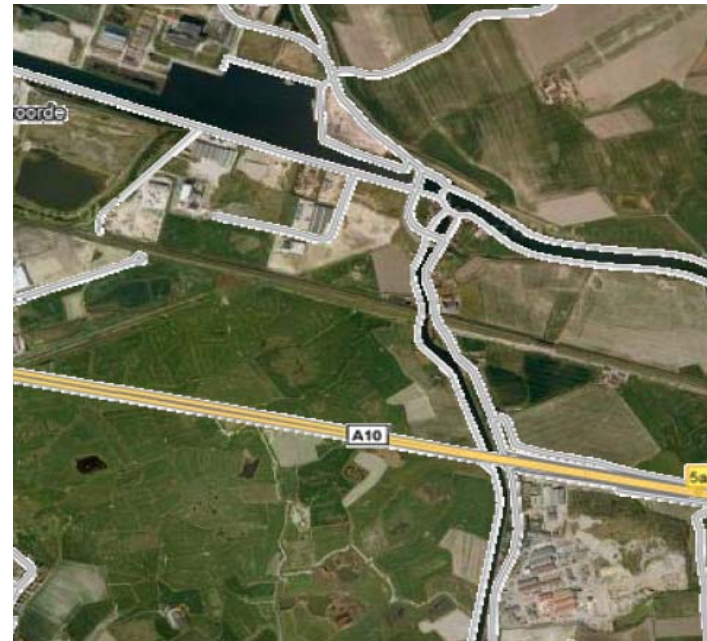
Oostende: 2 PG stacks (~ 3 km between each other) ~ 5km from the coast

- Ra-226 concentration up to 1 Bq/g
- Rn-222 up to 40 Bq/m³
