Overview of soil surveys and remediation

OVAM

5 octobre 2011

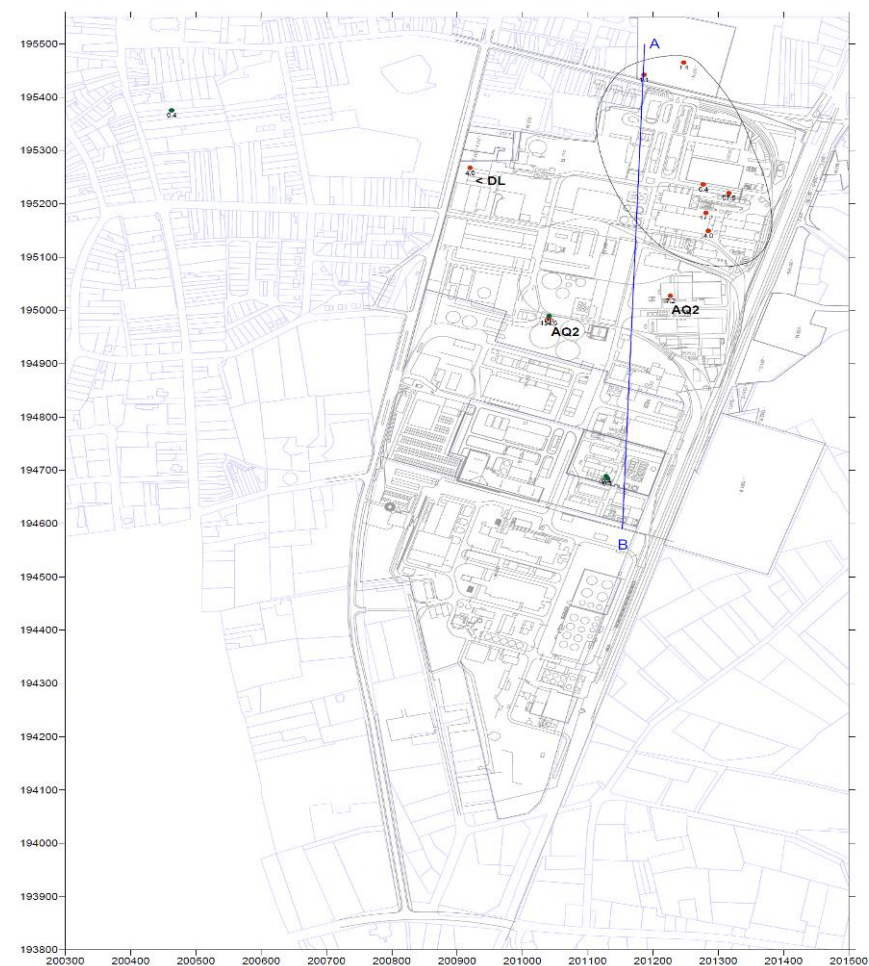
TCT: Descriptive soil survey: heavy metals

Zware metalen
 Grondwater (AQ2-AQ6)
 Max. overschrijdingsfactor BSN
 Recentste meting tot 24/04/2009
 Waarschijnlijkheidsniveau: 95%
 - S1
 - > 1
 - contour BSN
 A - B: profielijn

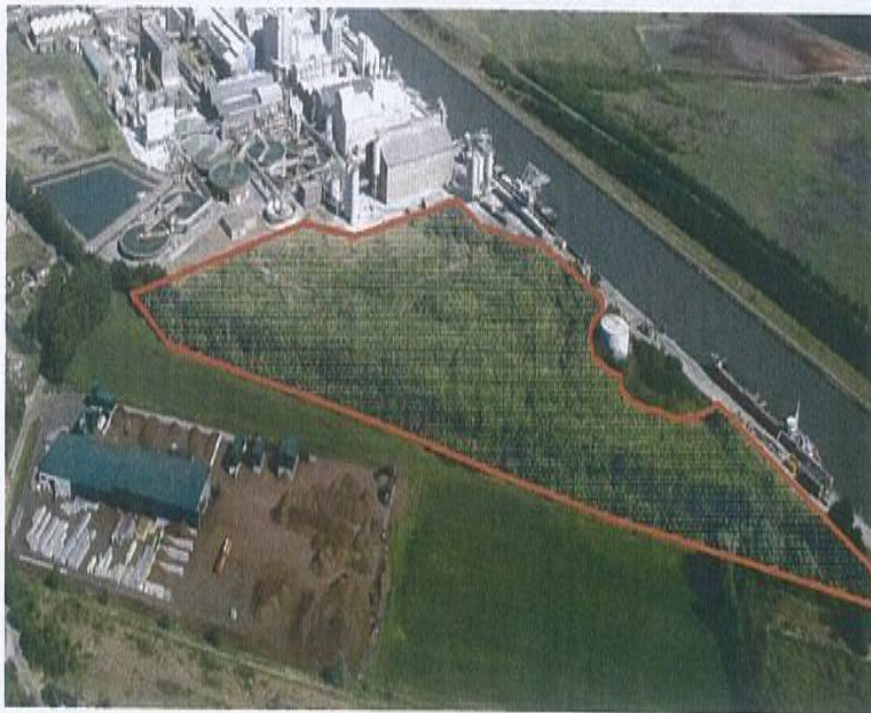
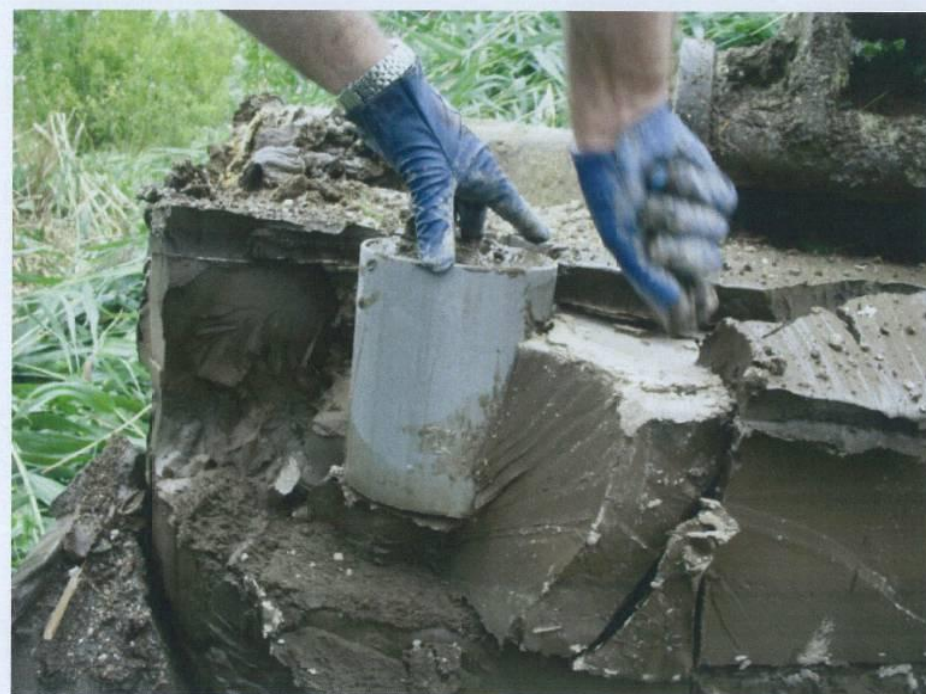
TCH: remediation of the sludge basin

Foto 12 OB 1-3 uitsteken PVC buis met slibmonster.

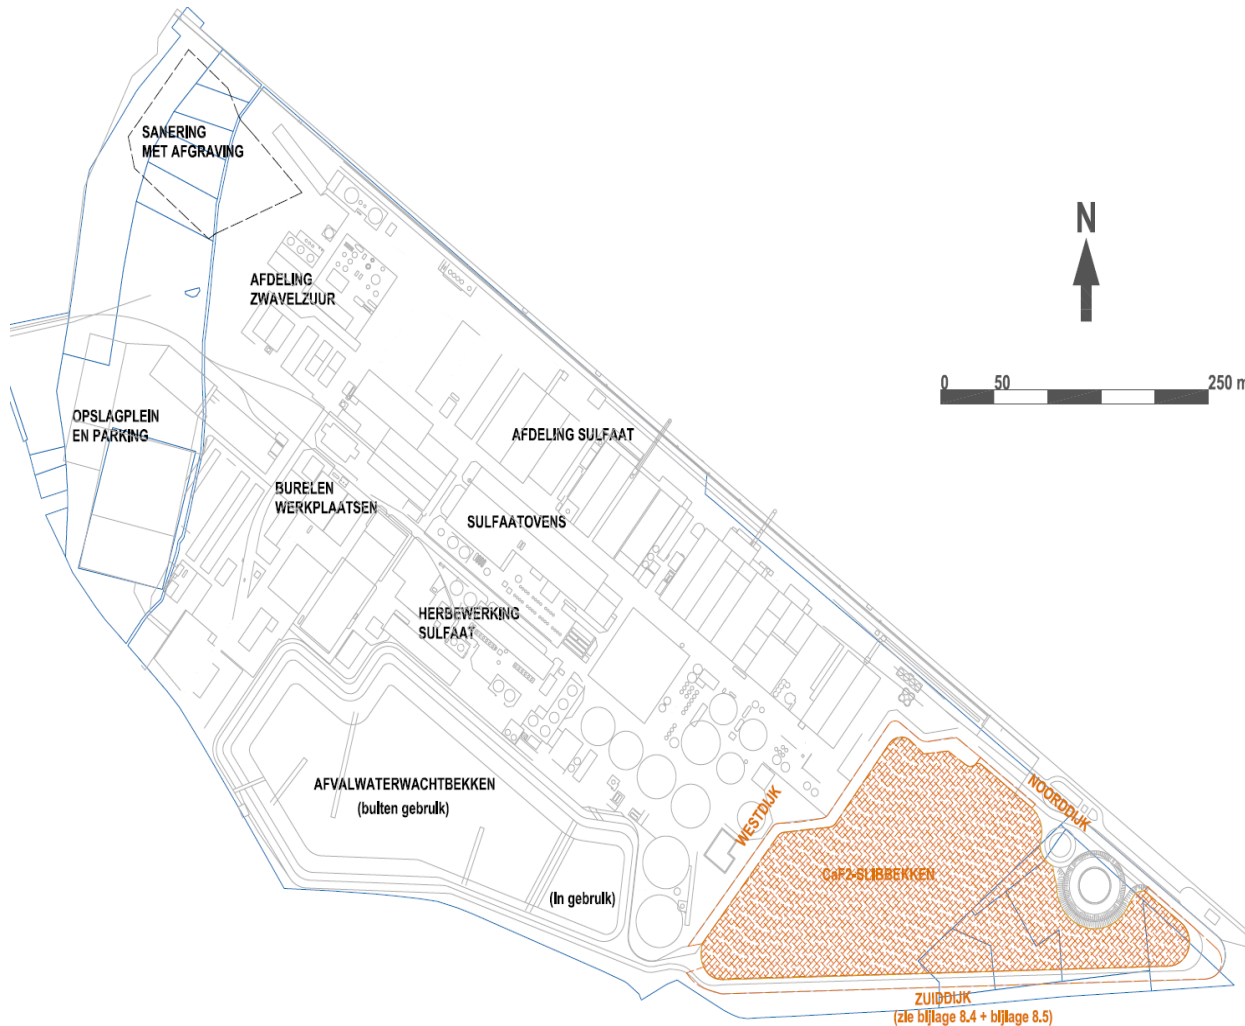
TCH: remediation of the sludge basin

Soil remediation plan: 2011

- Excavation of sludge and polluted 'natural' soil
- Transport to sludge basin Veldhoven
- Way of transport was still not decided
 - ▶ By boat
 - ▶ By trucks

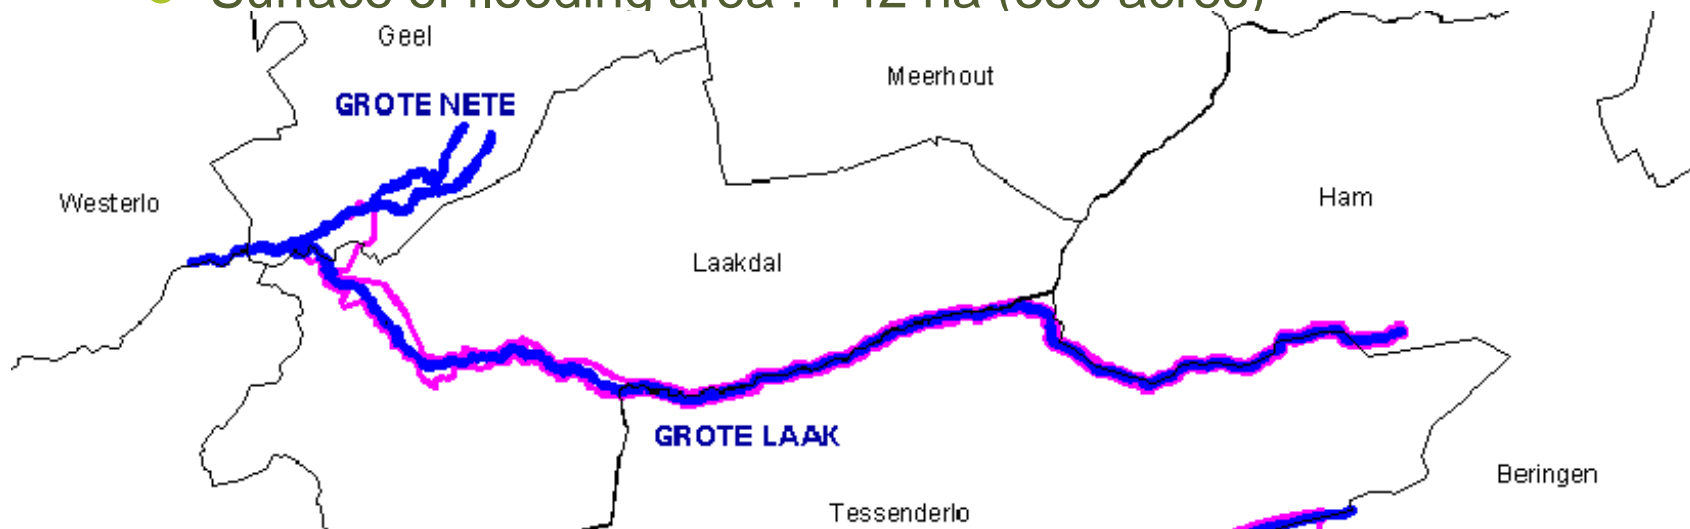
Contaminated Streams – Laak – Situation

- Stream of 20 km, through different municipalities and provinces
- Mainly rural area
- Geology : sand, at 100 m-mv heavy clay
- 2 discharge points
- Surface of flooding area : 142 ha (350 acres)
