Overview of the legacies of the former
radium production in Olen – summary of
radiological data

EMRAS II WG 2 – interim meeting October, 4-7

Olen: overview of legacies

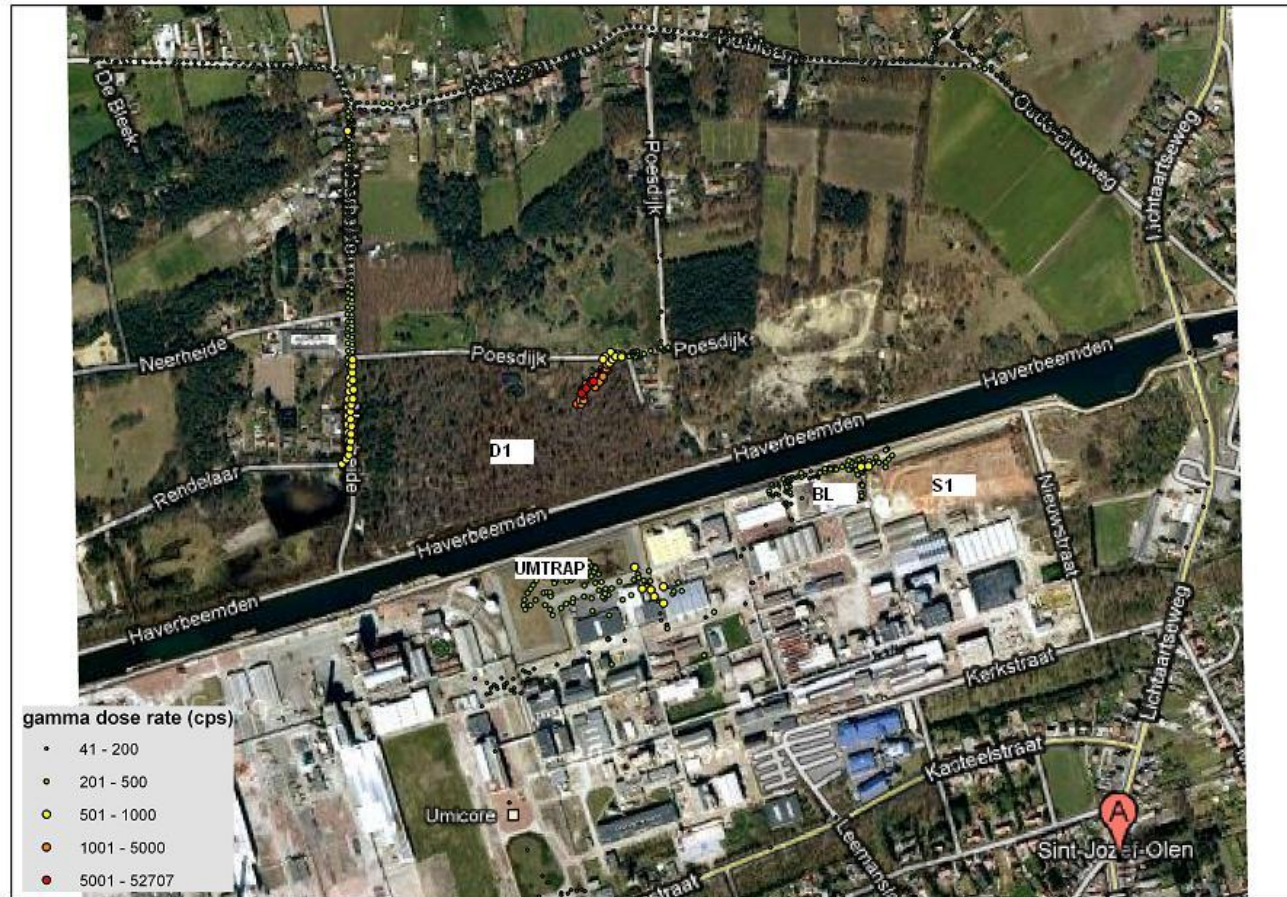
Olen site: overview

UMTRAP storage	Licensed facility	Built in the 80s for radioactive waste from former production
Bankloop storage	Licensed facility	Built in 2006 for waste from remediation of banks of Bankloop stream
D1 landfill	To be remediated	Residues non ferrous + radium extraction, rubbles from dismantlement Ra facility
S1 landfill	To be remediated	Residues non ferrous extraction + some sediments dredged from Bankloop
Contamination on plant site	To be remediated	Patchy contamination
Left-over Bankloop	To be remediated	Residual contamination after remediation

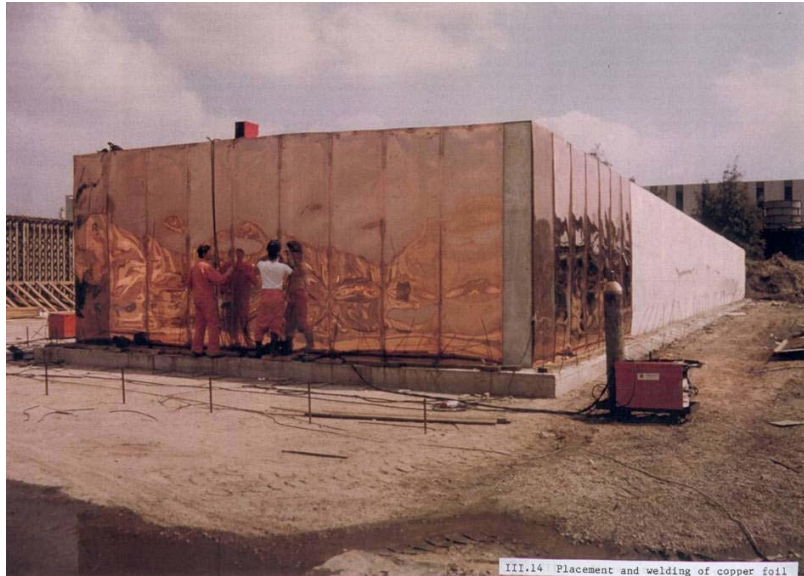
Welding of copper foil

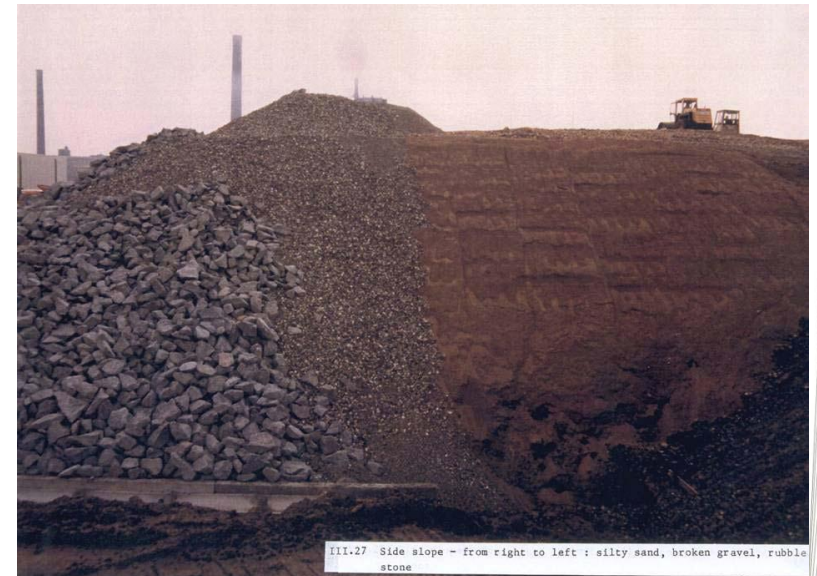
Side slope – silty sand, broken gravel, rubble stones

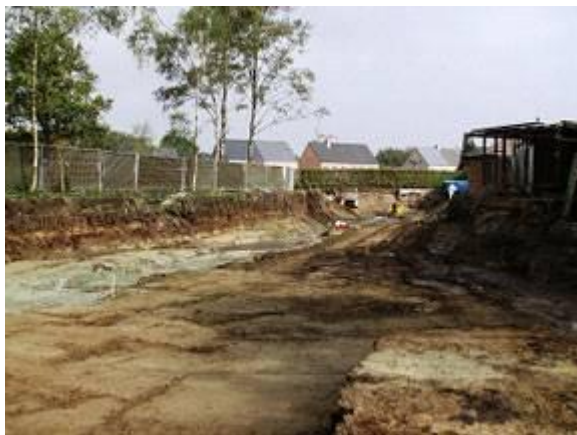
Discharge water to the nearby river => accumulation of radium in sediments

⇒ Dredging ⇒ sludges disposed on the banks.

Dose rate upto 5 $\mu\text{Sv/h}$. $\sim 7000 \text{ m}^2$ contaminated area

Remediation between 2006 – 2008

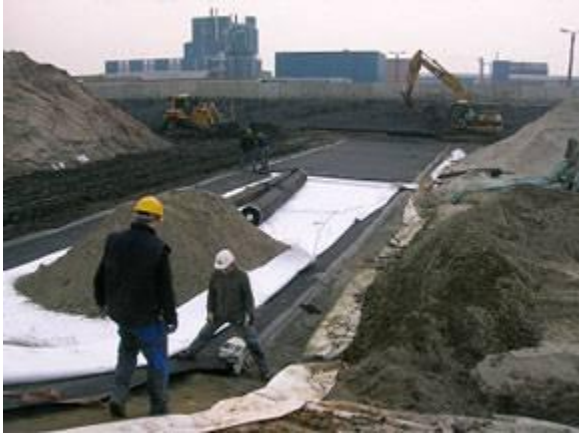
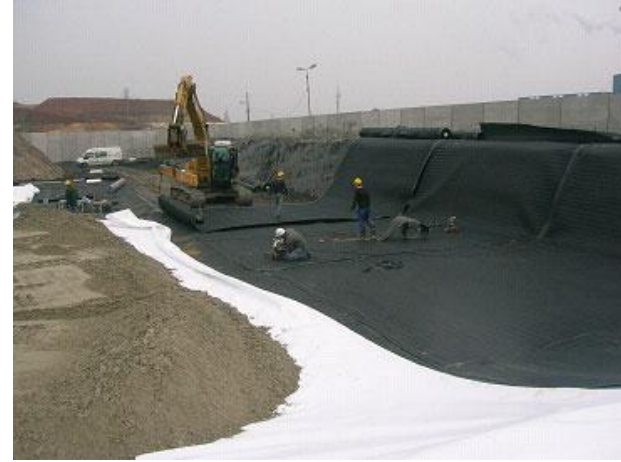
Design of “Bankloop” storage

Under the facility: from bottom up

- 50 cm clay layer ($k < 10^{-10}$ m/s)
- HDPE foil
- Geotextile
- 40 cm draining layer with drainage system for leachate
- Geotextile

Capping:

- 50 cm clay layer ($k < 10^{-10}$ m/s)
- 30 cm drainage layer with drainage system
- 50 cm rooting layer

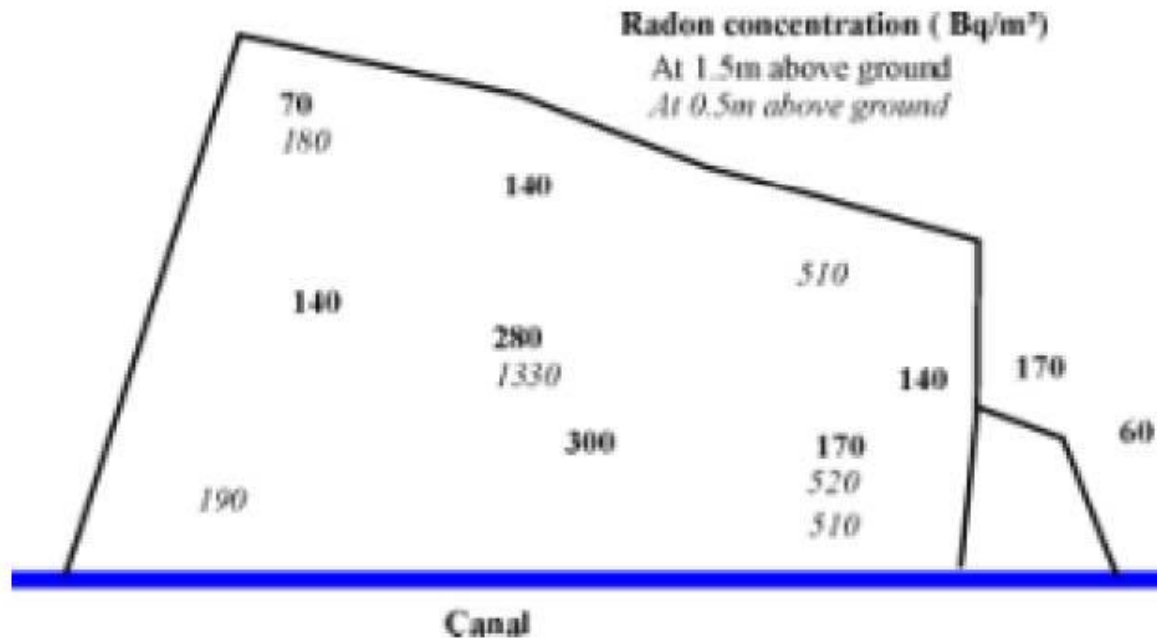
D1: radon measurements

Rn-222 up to $\sim 1300 \text{ Bq/m}^3$ (0.5 m high) – 300 Bq/m^3 (1.5 m high)
