**PRESENTATION ON DECOMMISSIONING PROGRAMME
IN IRAQ FOR WORKSHOP ON REVIEW OF A
DECOMMISSIONING PLAN/ BUCHAREST**

HADI I. JASSIM

DECOMMISSIONING OF LAMA FACILITY

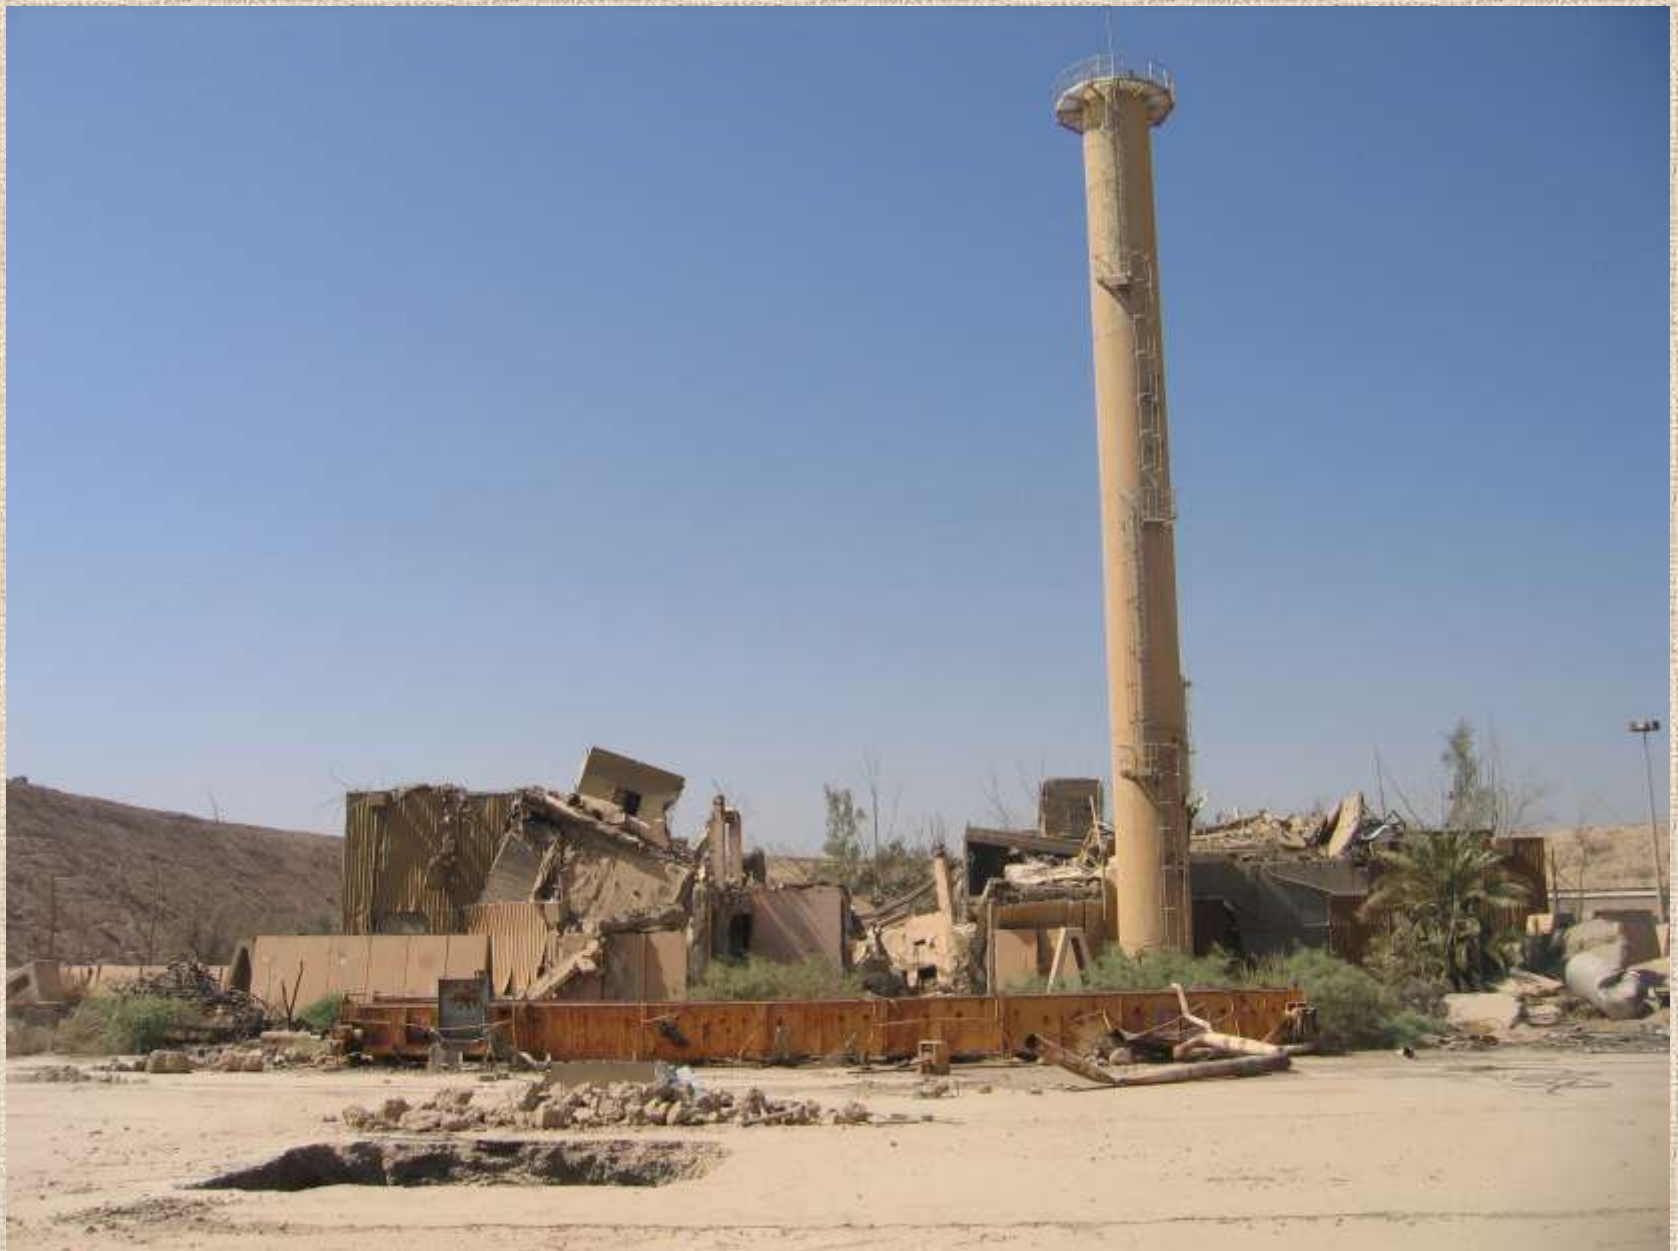
Lama building before 2008

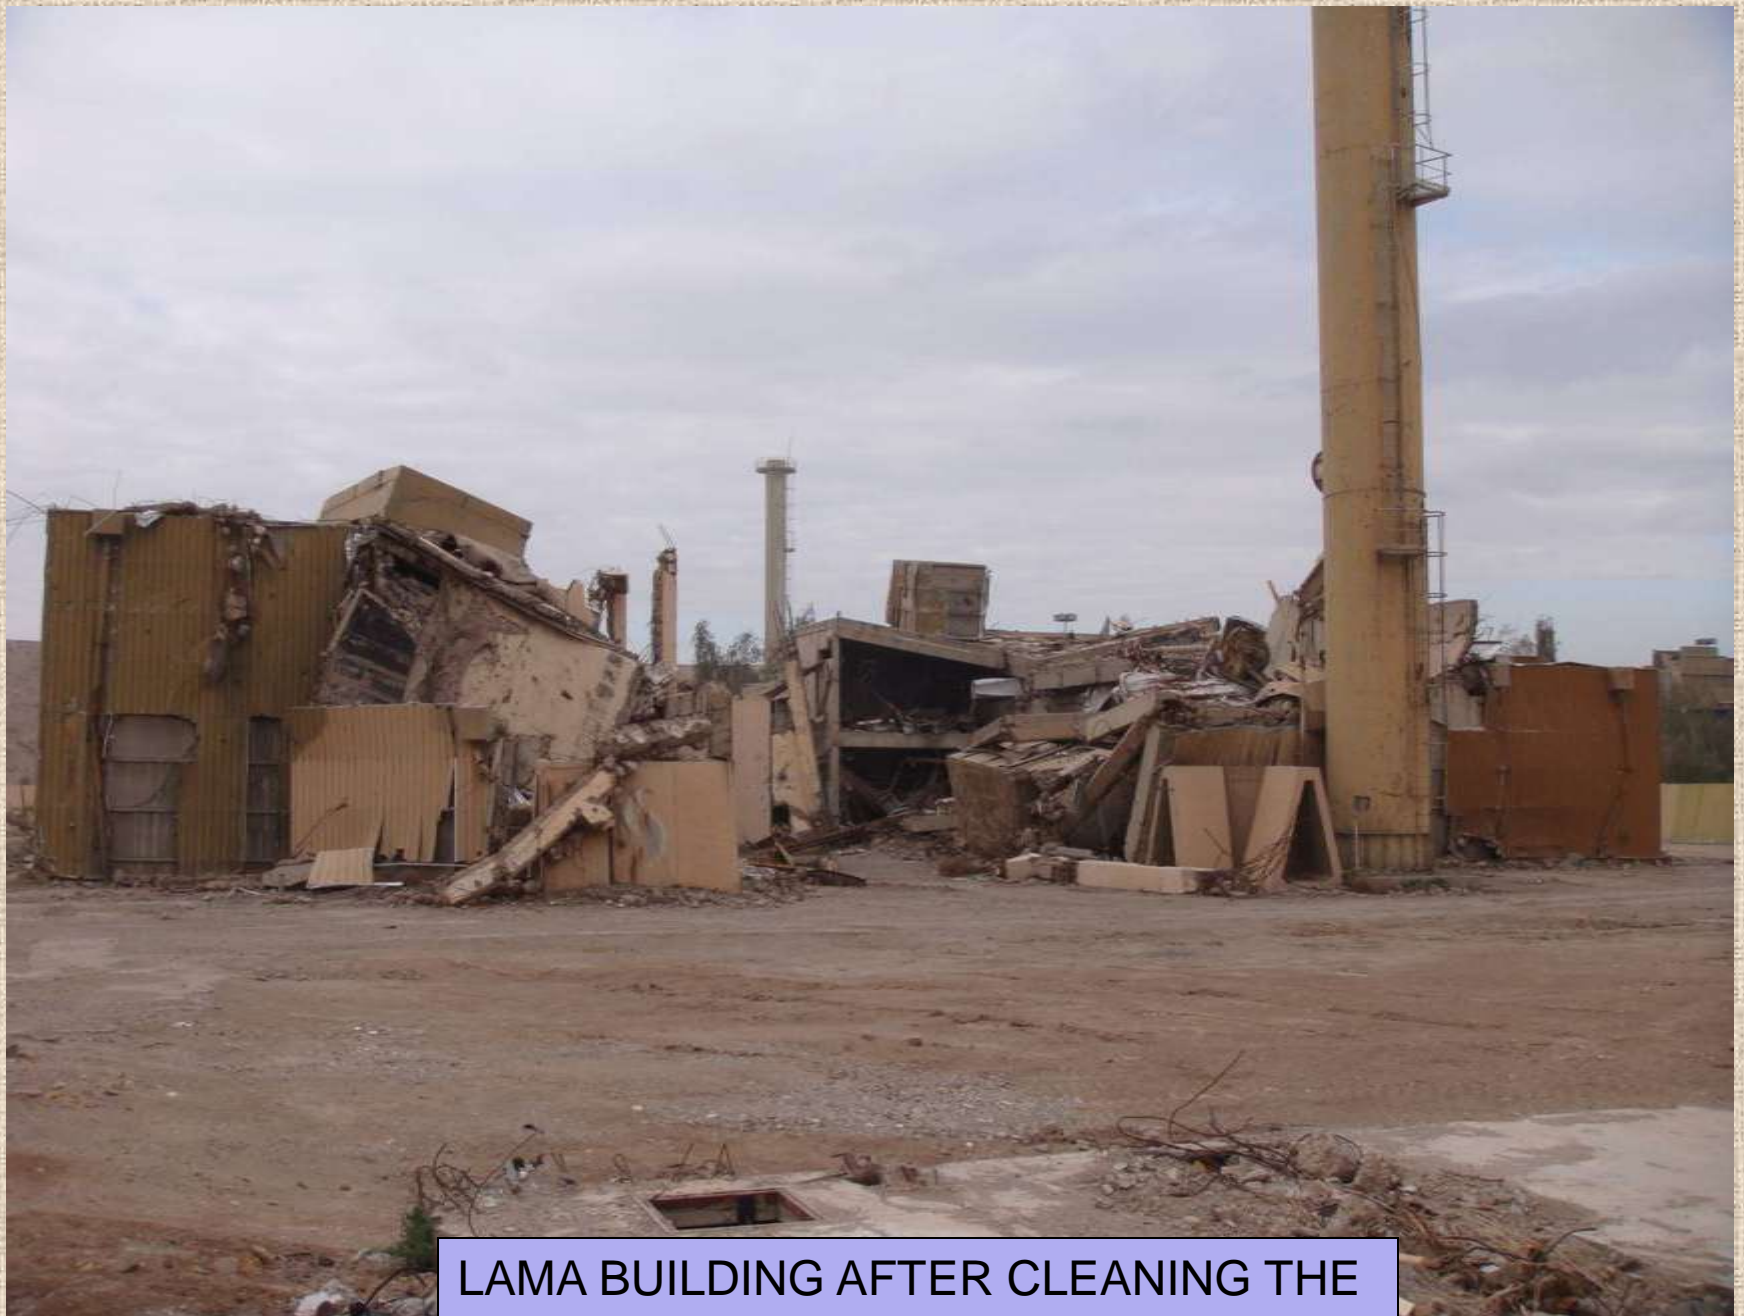
LAMA BUILDING AFTER CLEANING THE SURROUNDING AREA

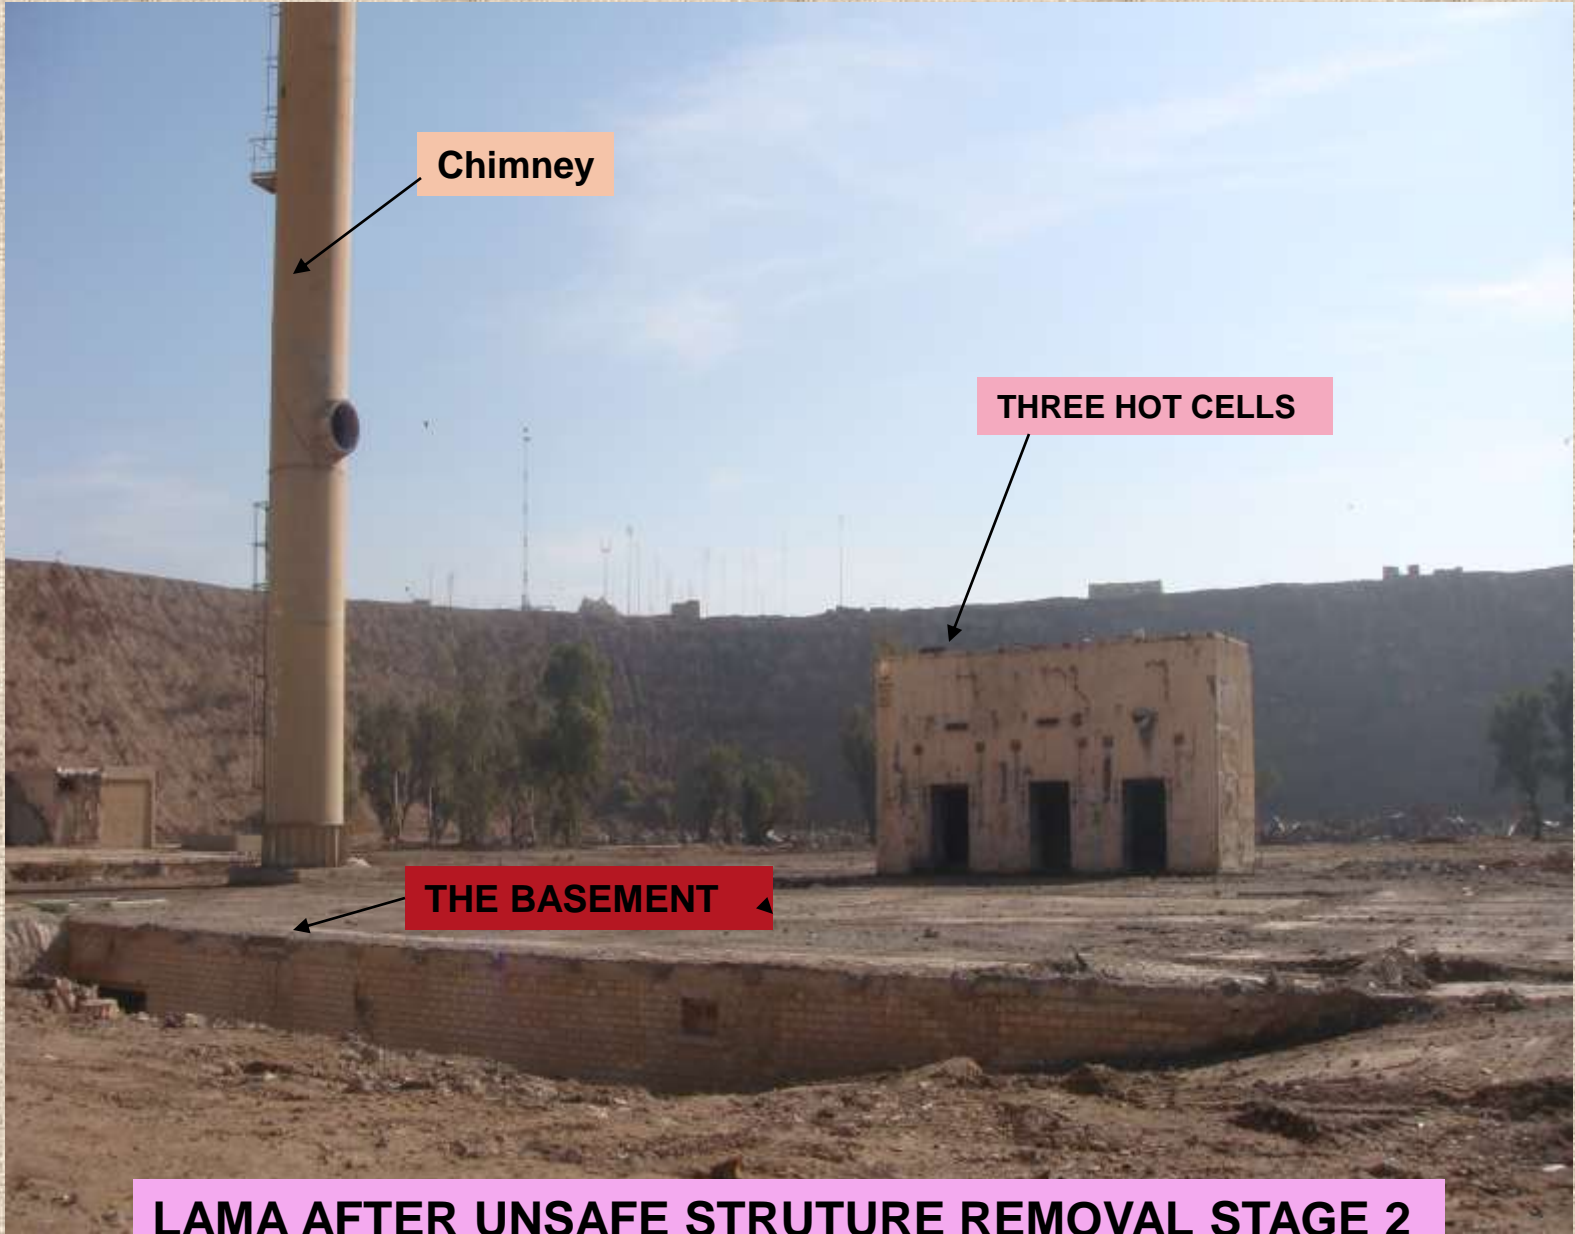
Chimney

THREE HOT CELLS

THE BASEMENT

LAMA AFTER UNSAFE STRUTURE REMOVAL STAGE 2

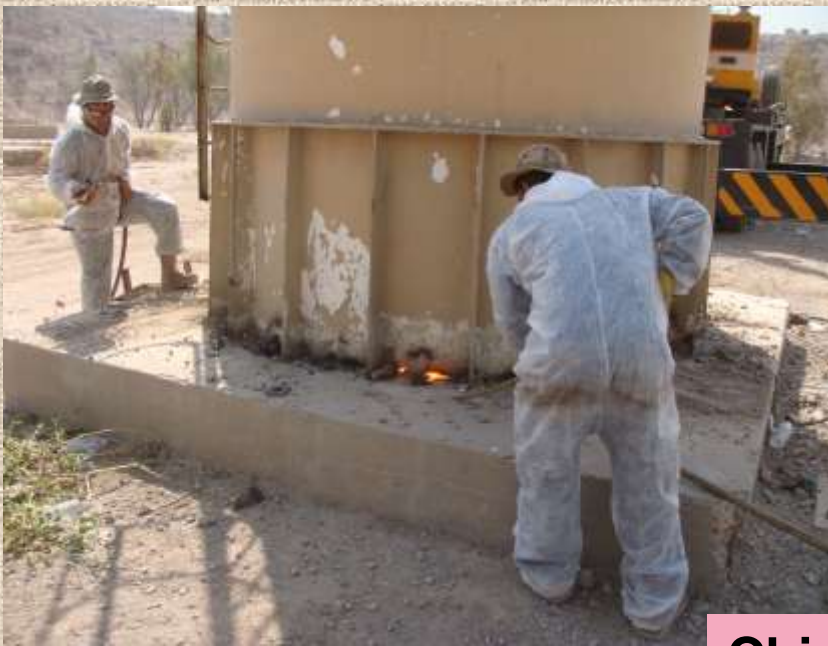
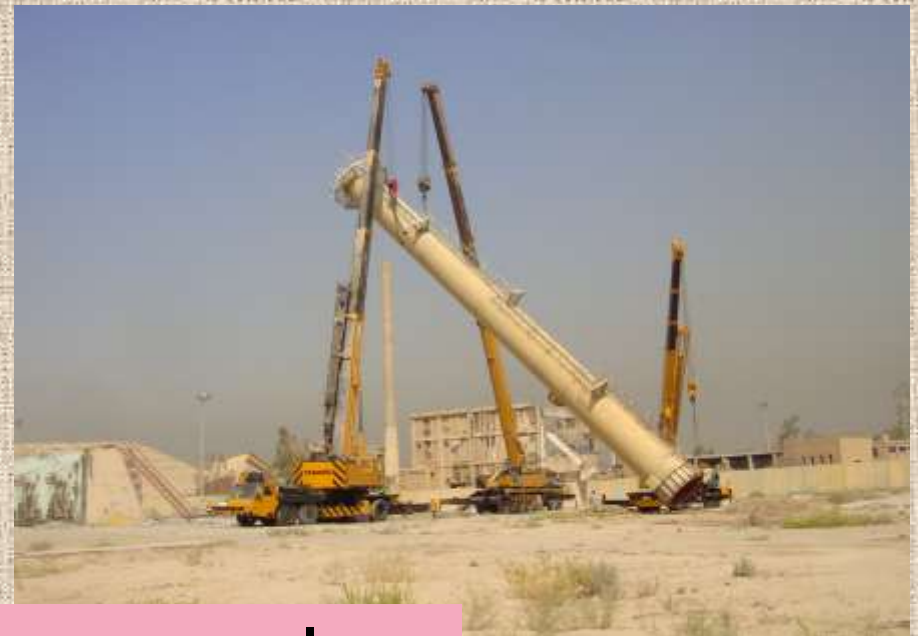
Chimney removal

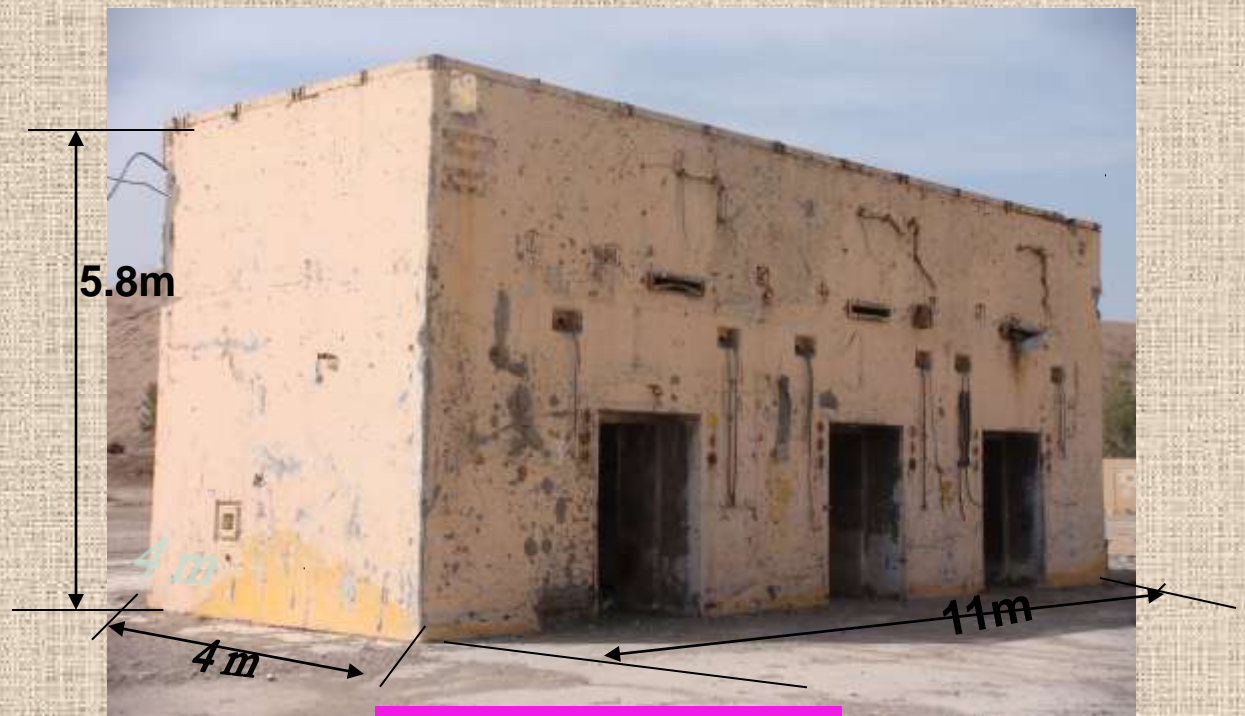
Three concrete hot cells

There are three concrete hot cells as shown in figs. below
Their walls thickness about 100 cm of reinforced concrete with
Iron bar diameter 2.5 cm . the inner lining made of stainless steel
Sheet (5mm) thickness. Each cell contains ; Lead glass window
,manipulator, over head crane and basket. After 1991 some equipments
were removed from the hot cells.

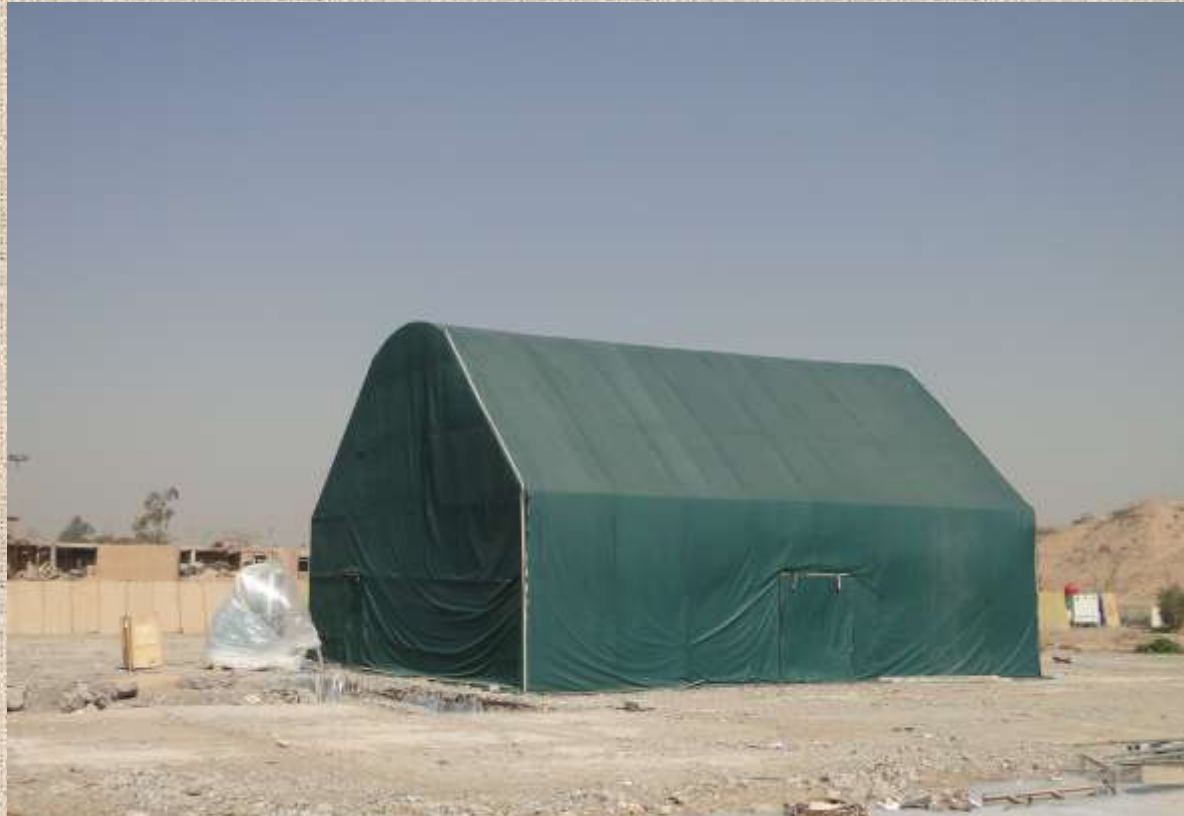
Tent to isolate hot cells during decontamination

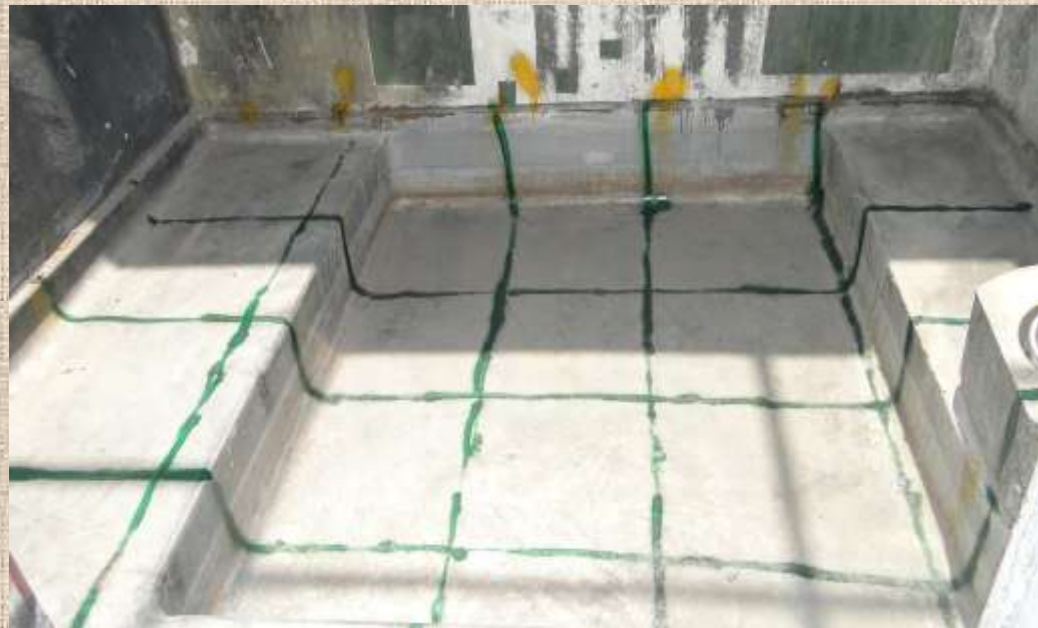
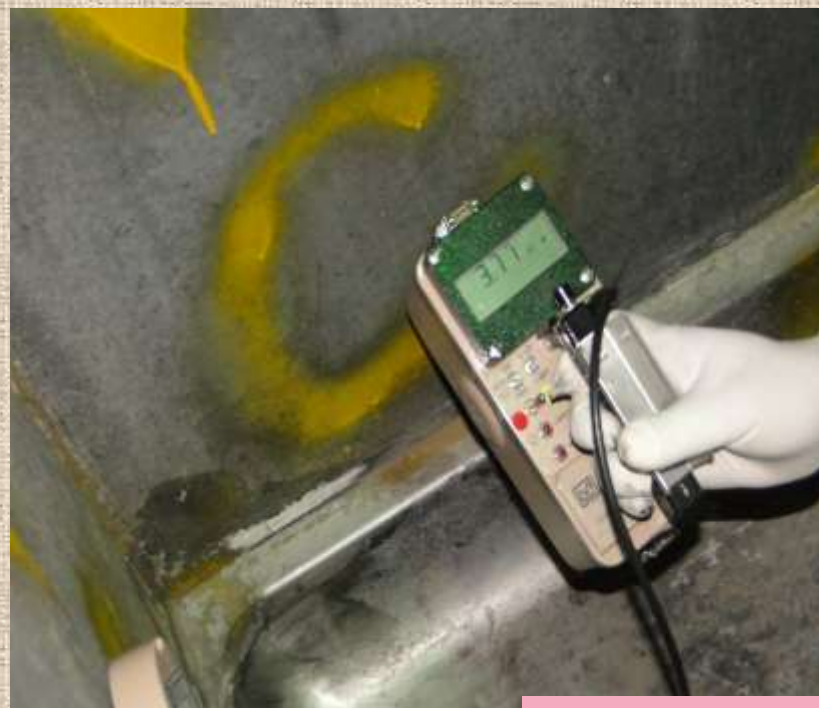
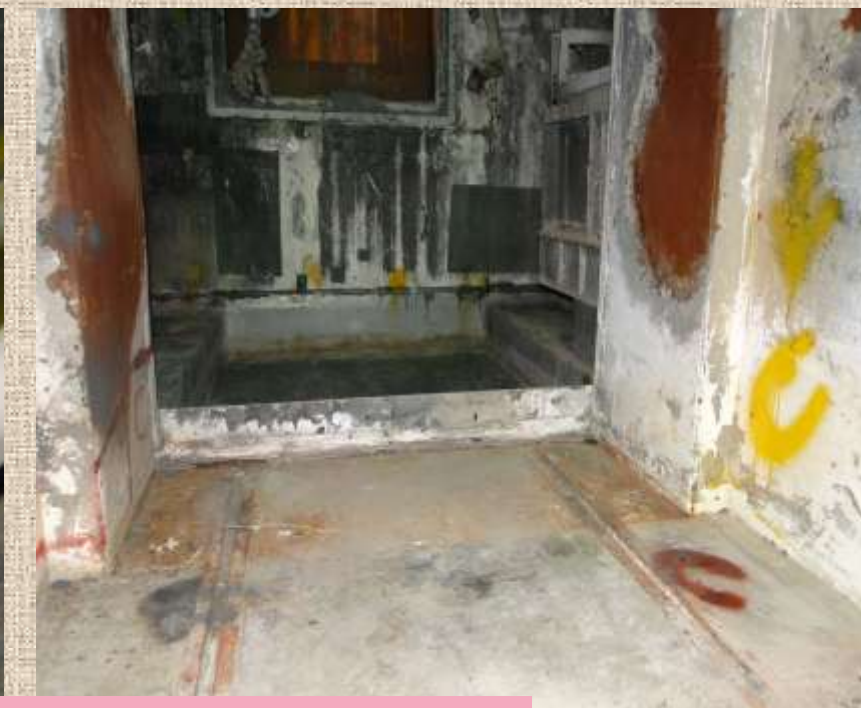
characterization of Hot cell A

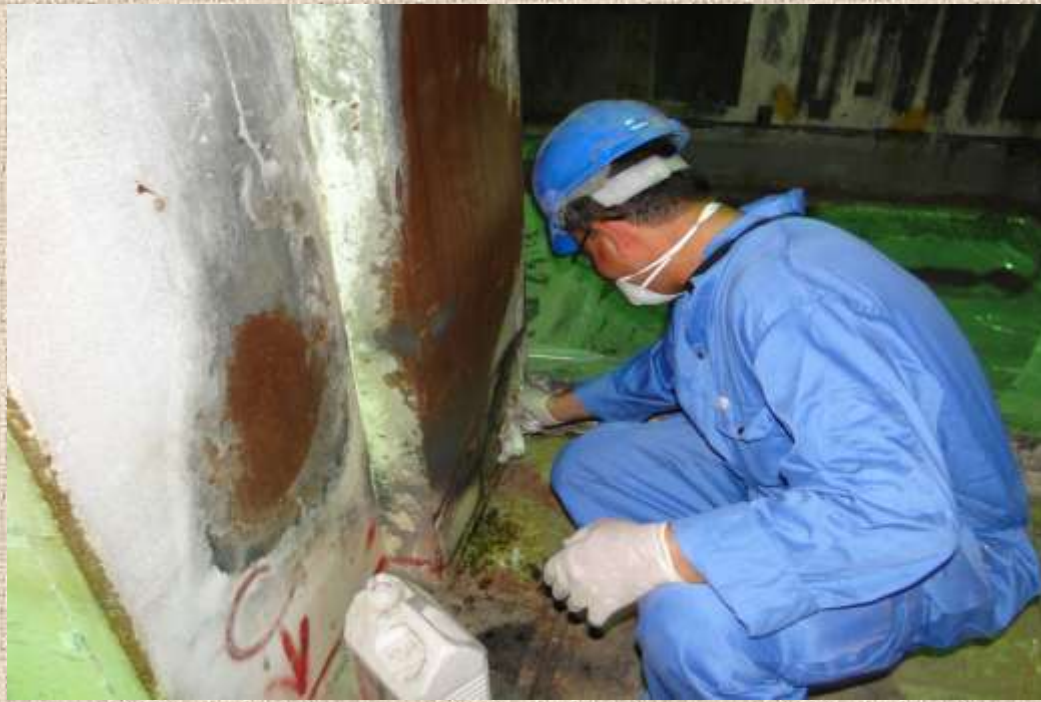
Decontamination of hot cell A

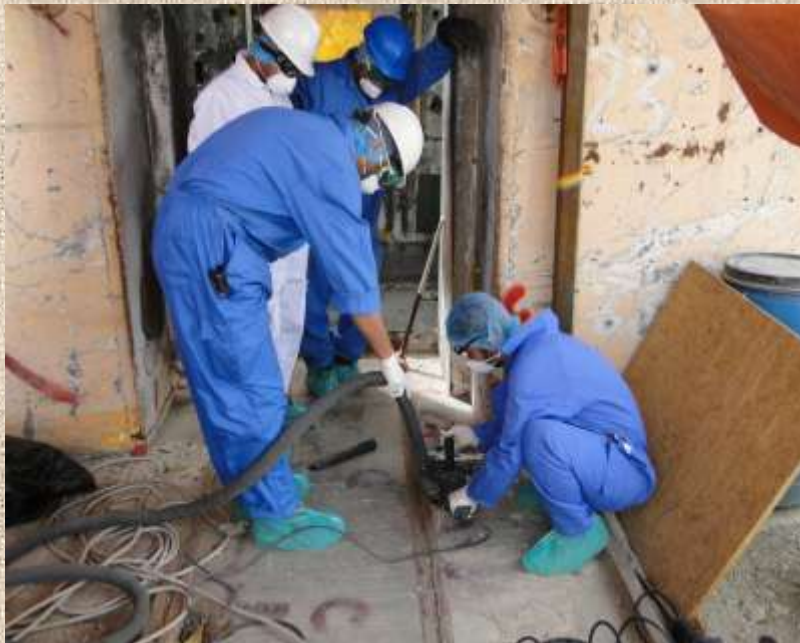
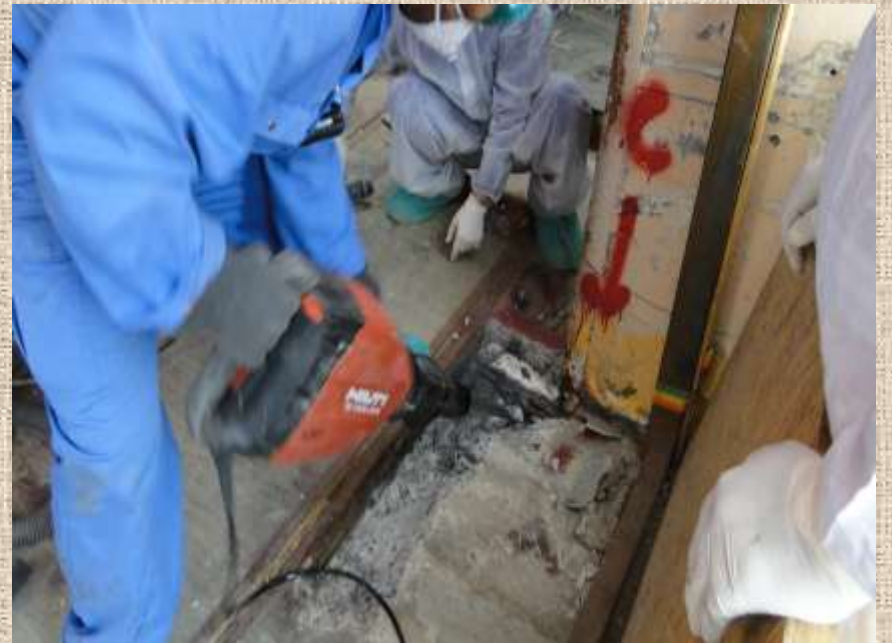
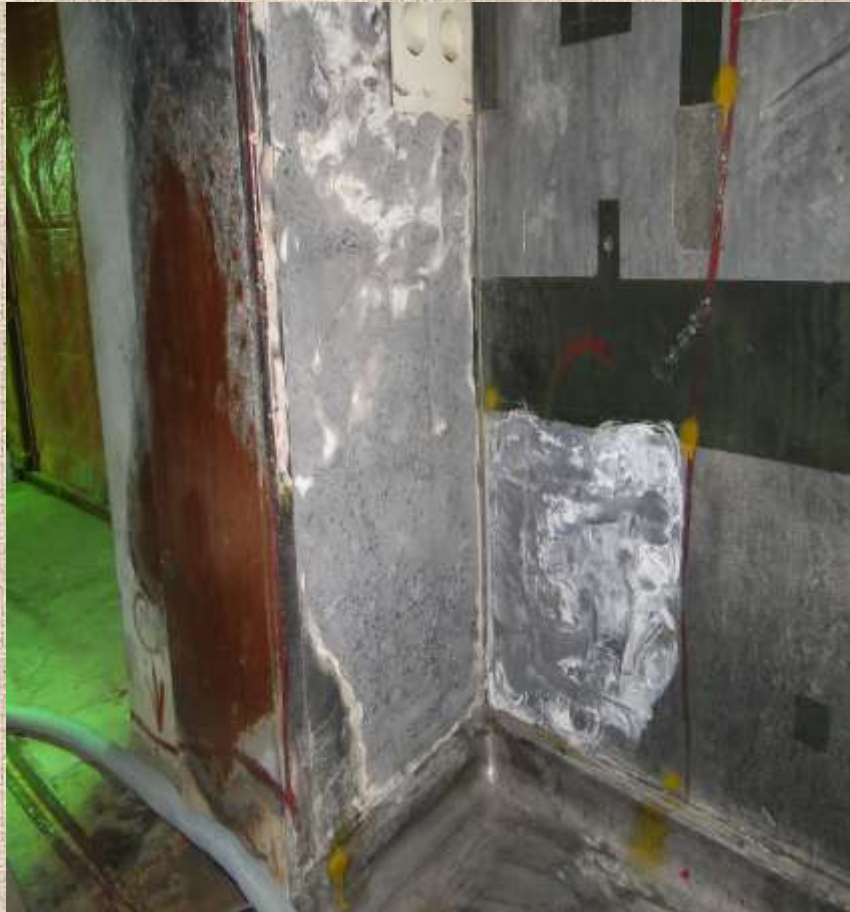
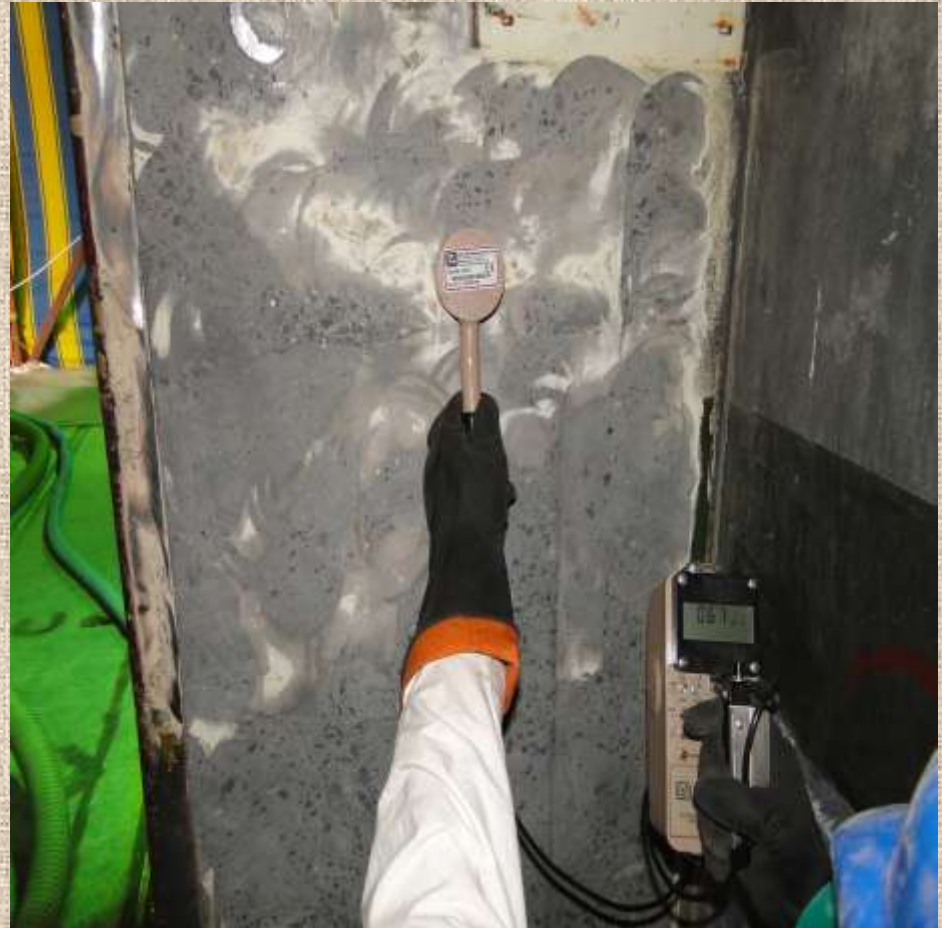
Hot spots after decontamination

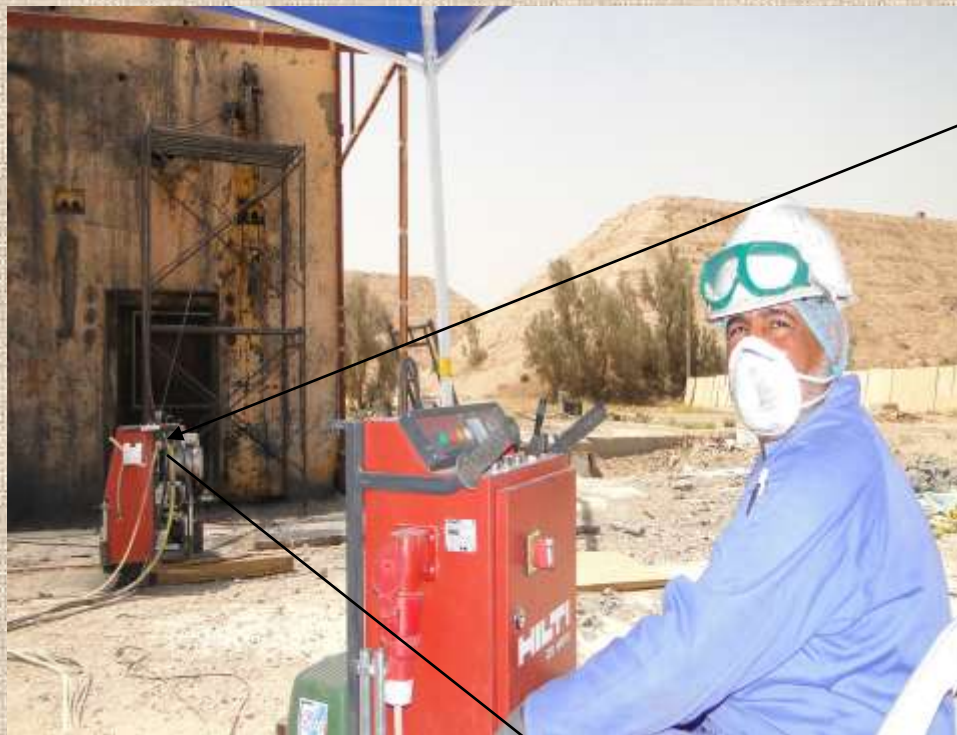
DIAMOND WIRE CUTTING MACHINE USED TO DEMOLISH THE HOT CELL WALLS

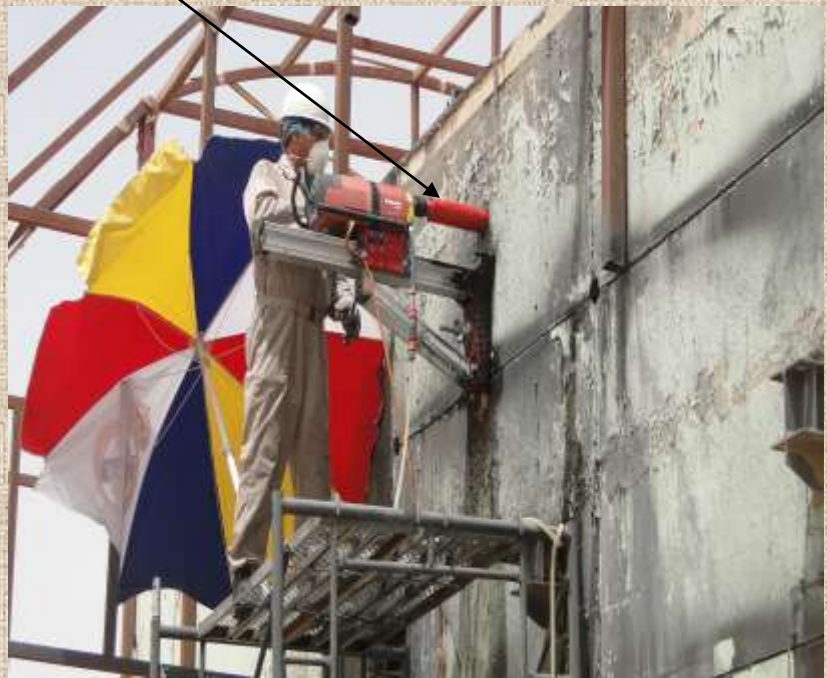
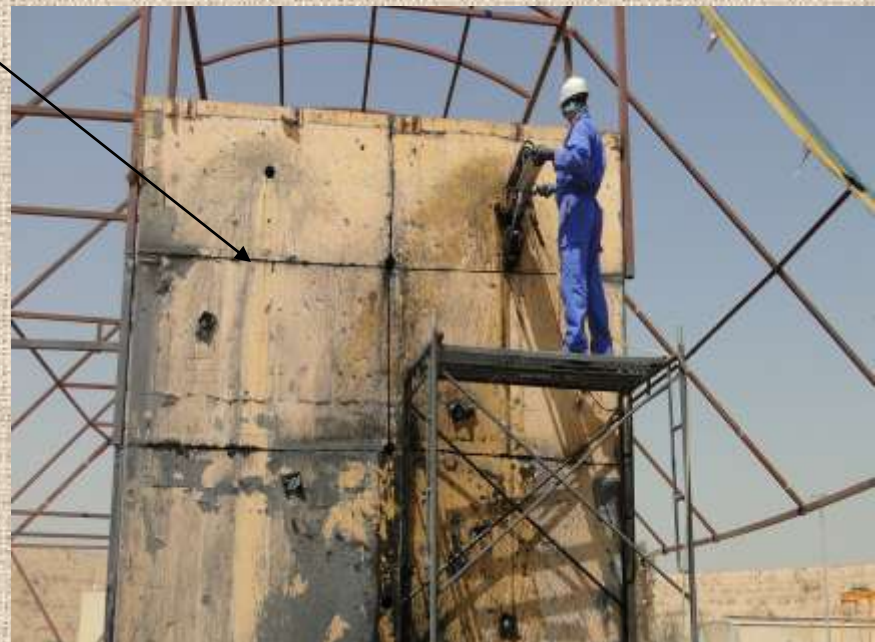
DIAMONDCORING BY DD 500

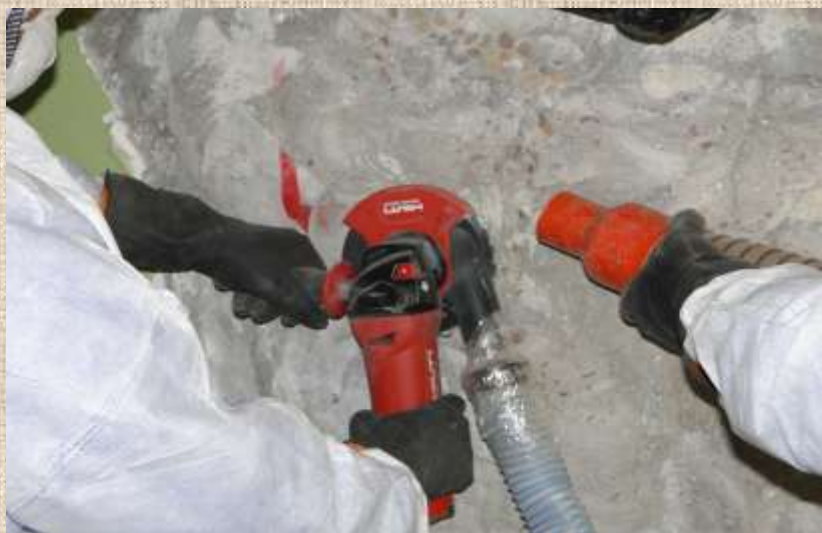
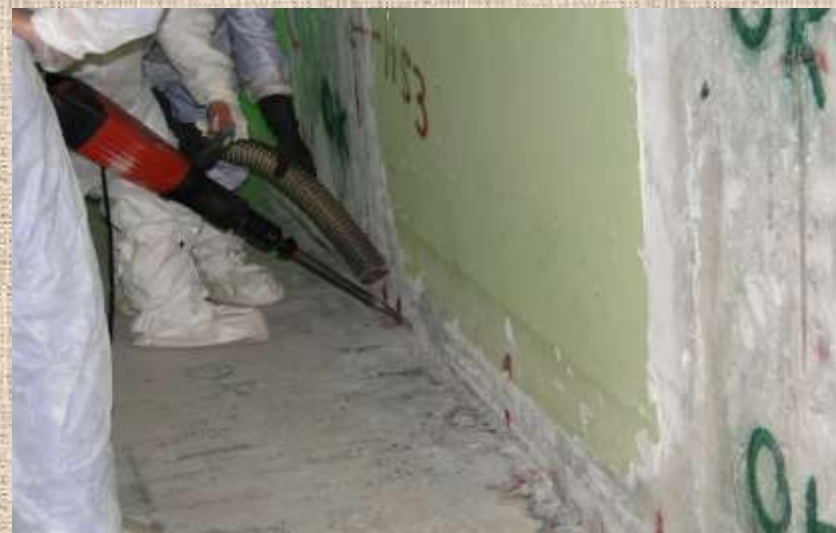
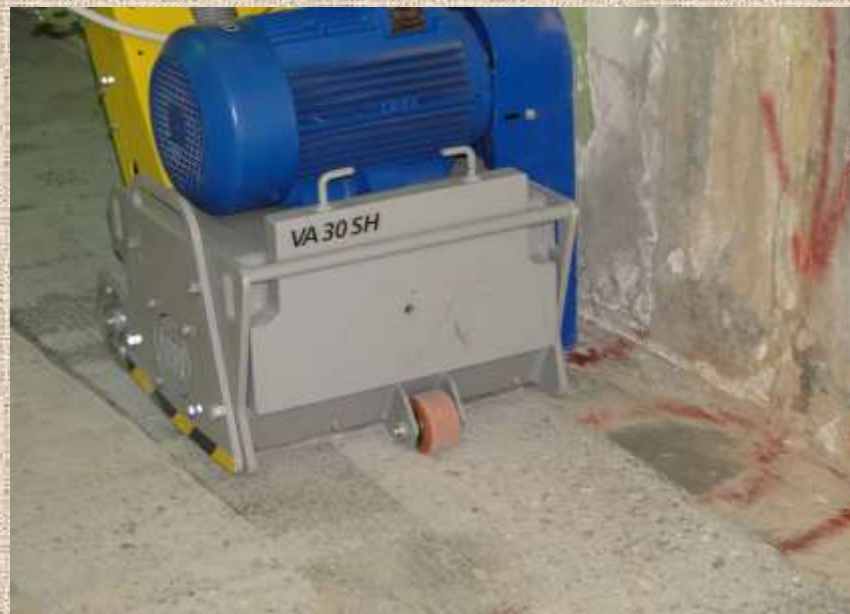
DECONTAMINATION OF WASTE TANK

Th-234=1708Bq/kg, Pa-234m=2769Bq/kg, Co-60=6.2Bq/kg, U-235=66, Th-231=29 Bq/kg, Cs-137=2.3Bq/kg
