IAEA Workshop „Decommissioning Technologies“ 06-10 July 2009 Karlsruhe, Germany

Decommissioning of Hot Cells at the Karlsruhe Reprocessing Plant (WAK)

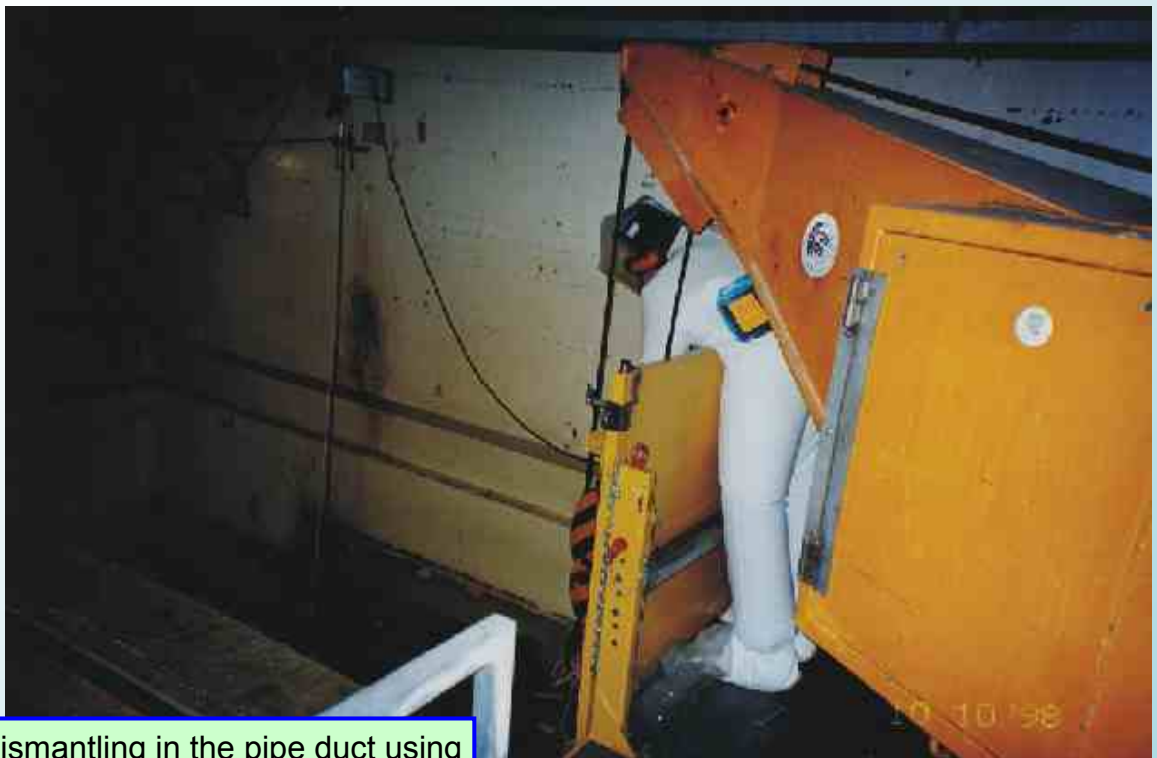
Semi-remote dismantling in the pipe duct using a hydraulic shear on a crane hook. The shear is operated from a shielded working platform.

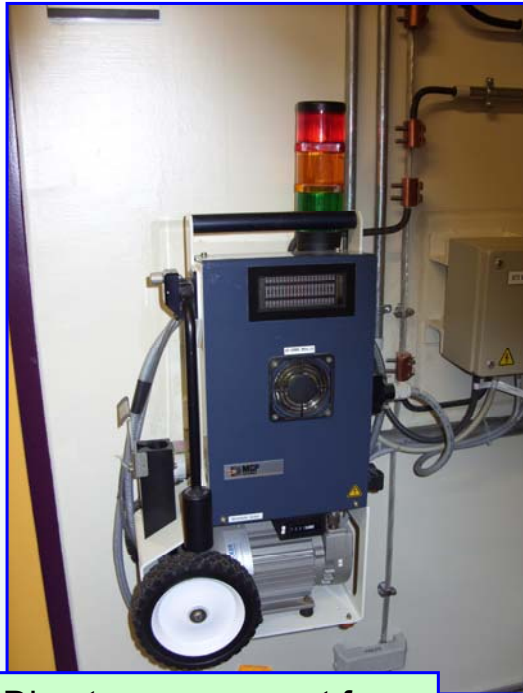
Direct measurement for room air monitoring BA33

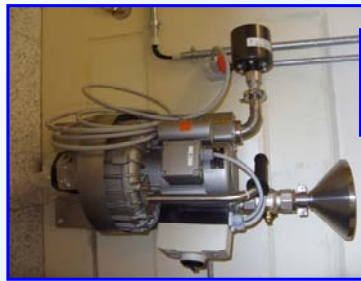
Sampler for room air monitoring

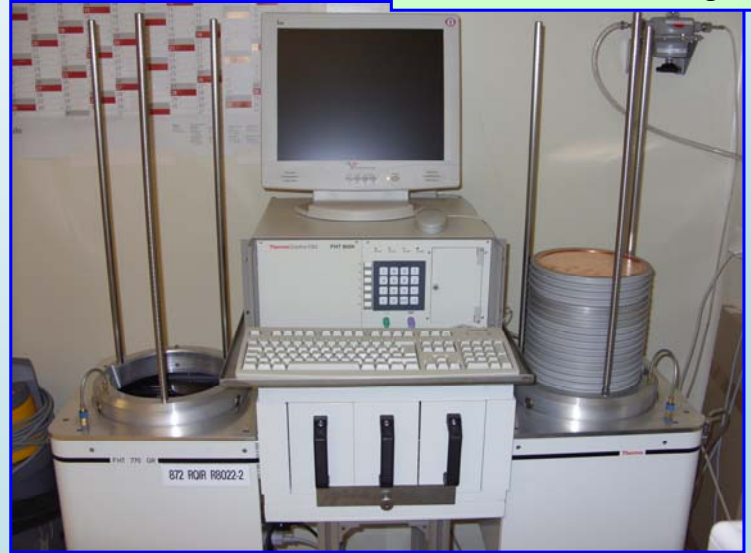
Analysis of filters for room air monitoring

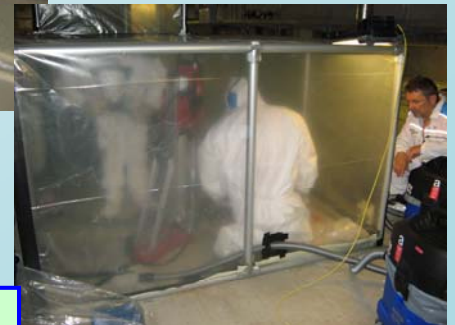
Cutting of fuel element racks by means of band saws

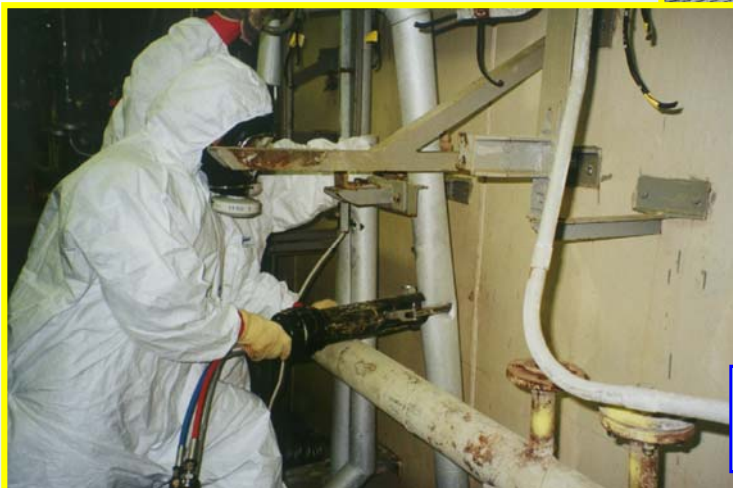
Cutting of pipelines by means of hydraulic shear

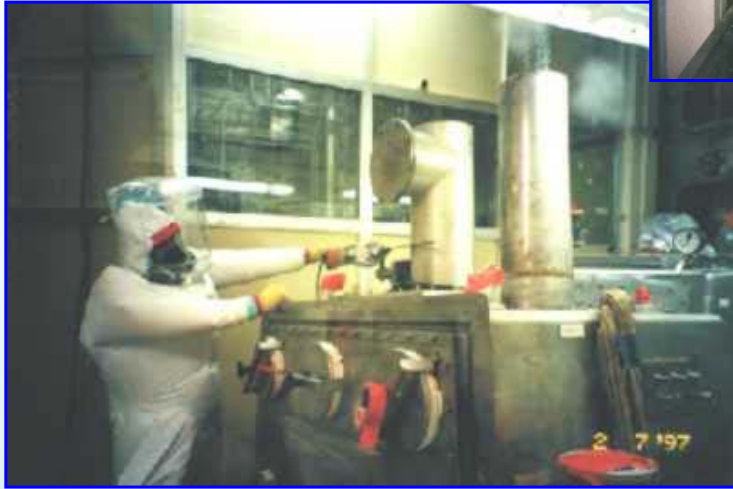
Dismantling of the Pu evaporator box in cell VIII using a compass saw

Cutting of floor liner in room 253 using angle grinders

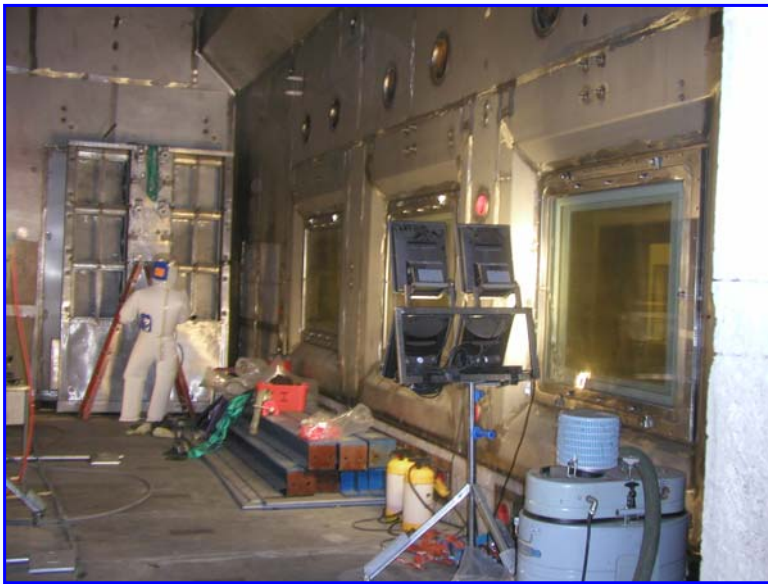
Mechanical dismantling cell: Prior to and after removal of the stainless steel liner

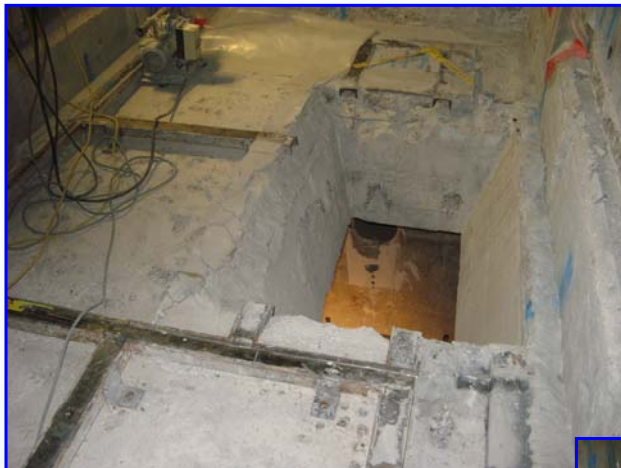
Mortising of concrete screed below the floor liner

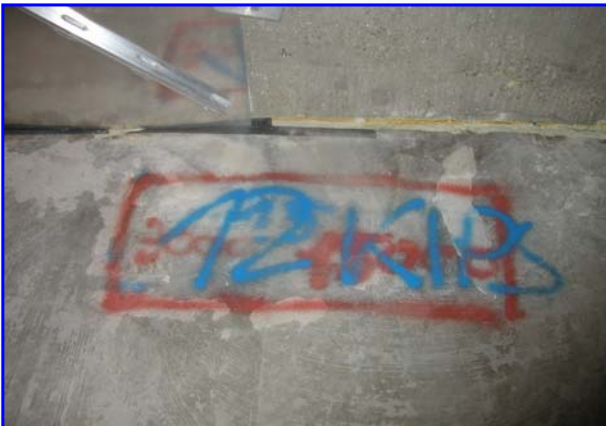
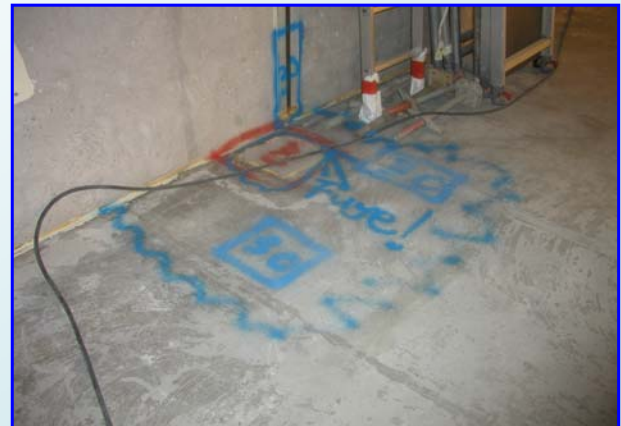
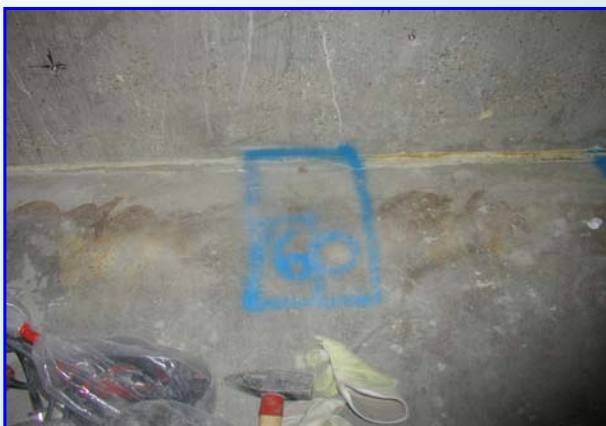
Measurements revealed sharply confined hot spots on the floor, with the values measured reaching up to > 100,000 ips.

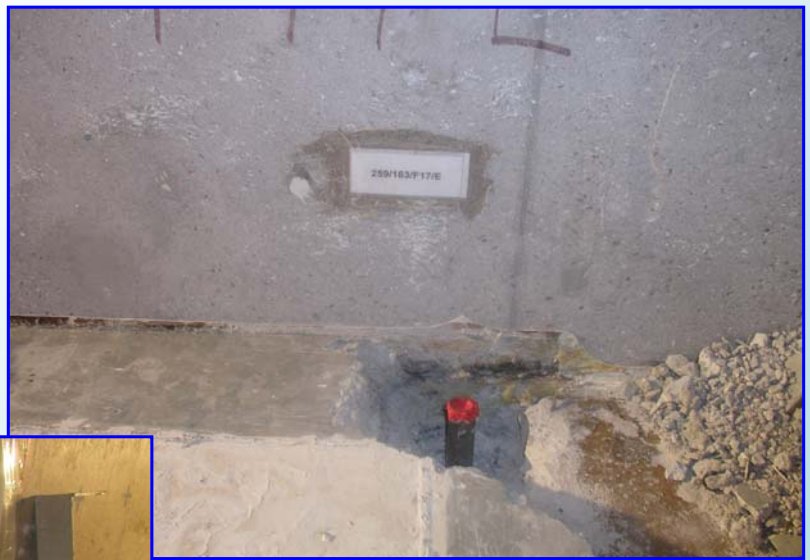
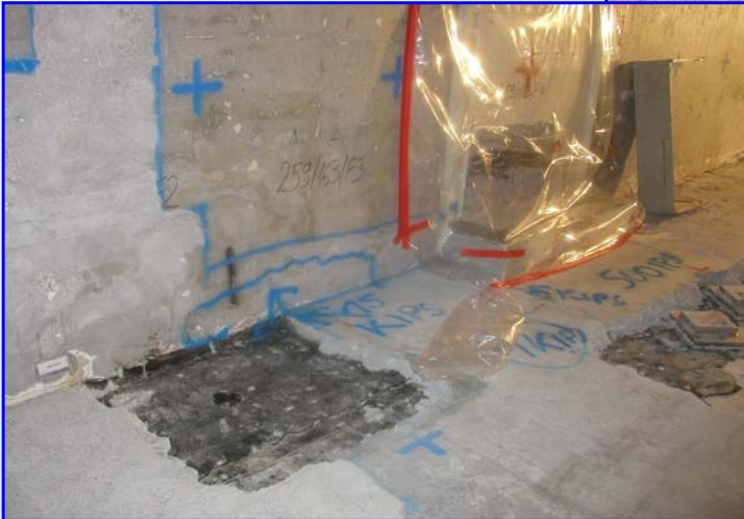
To eliminate these hot spots, the screed in these areas was mortised by a paving breaker. The surfaces treated were cleaned by sucking off the rubble.

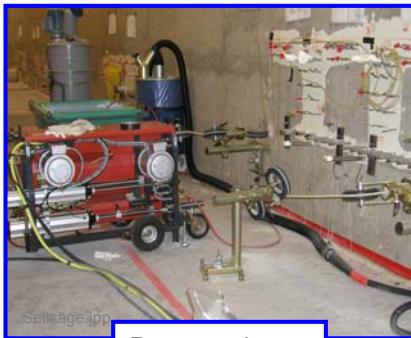
Rope saw in use

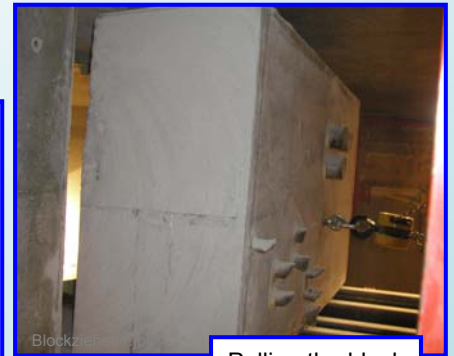
Pulling the block

Lowering the block

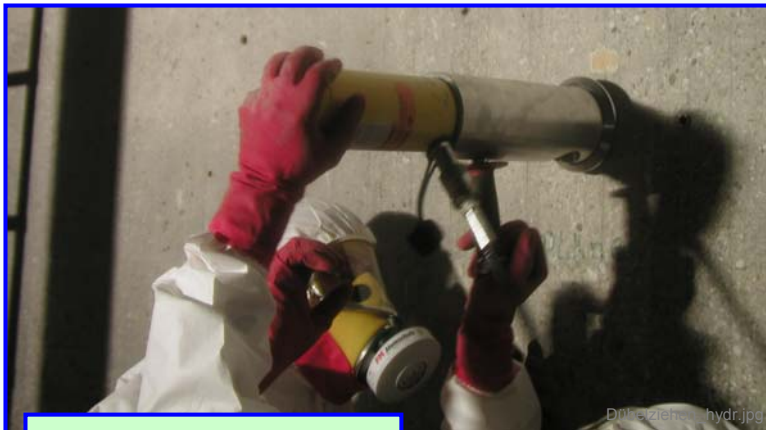
Pulling out dowels using hydraulic pulling device

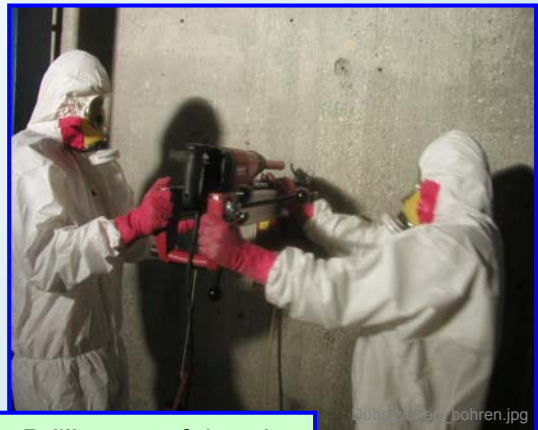
Drilling out of dowels

- Cell VII about 800 dowels
- so far, about, 4,500 dowels have been removed

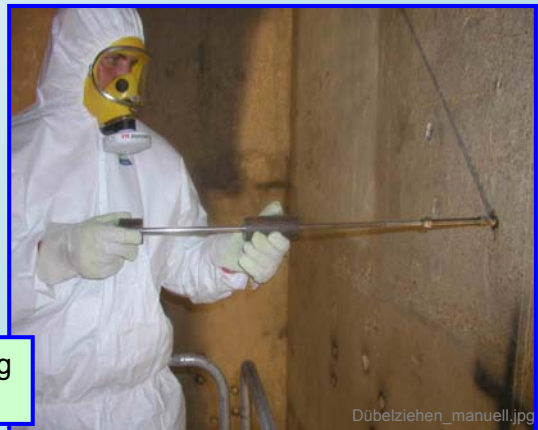
Manual pulling using a striking weight

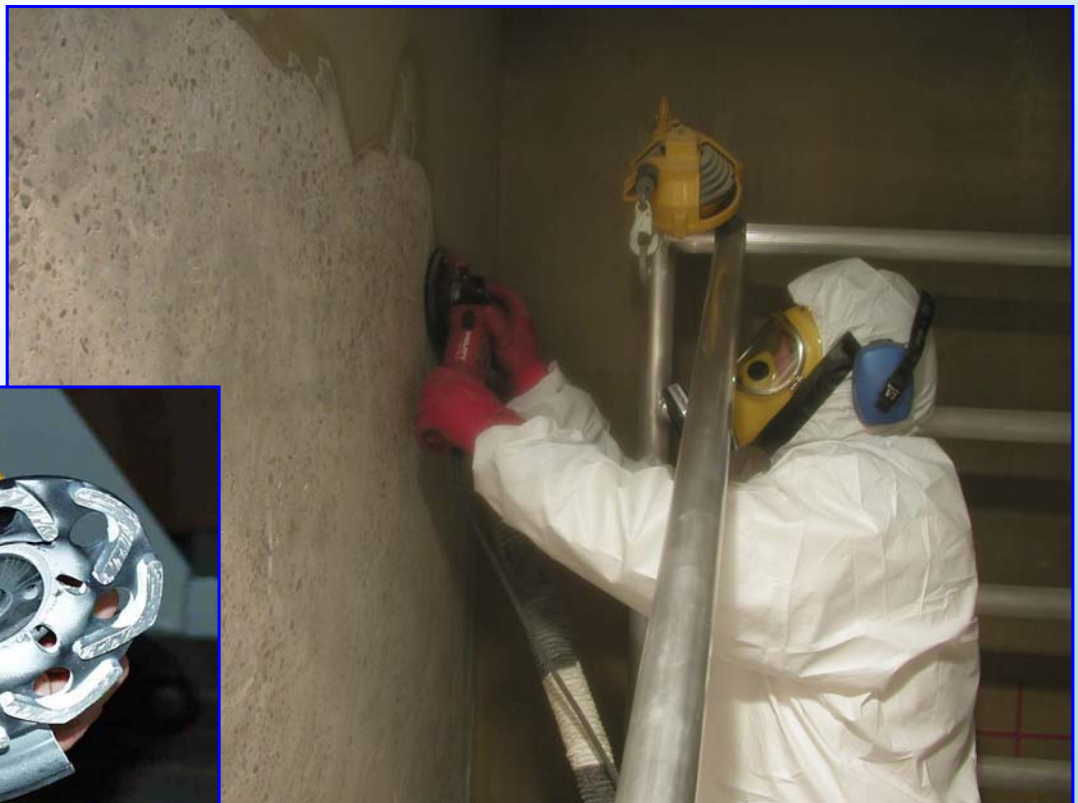
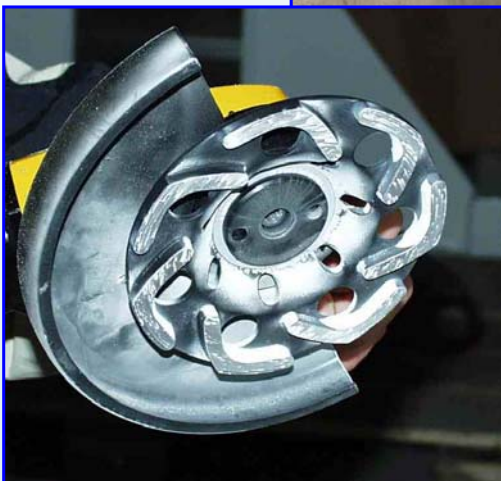
Manual grinding

Manual grinding performance:
About 2 m²/d

Layer thickness 2-3 mm

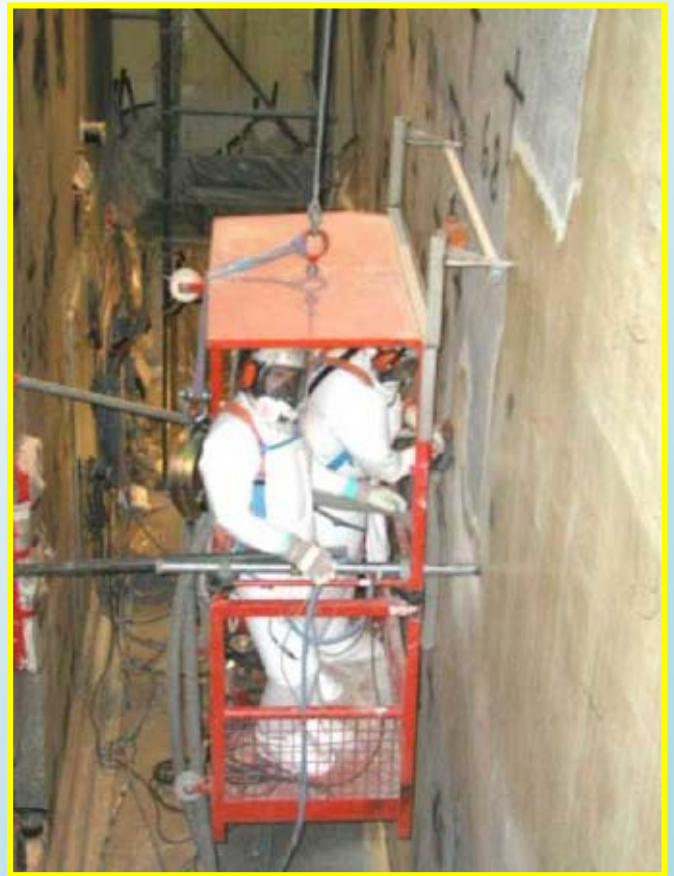
Concrete grinder for floor removal

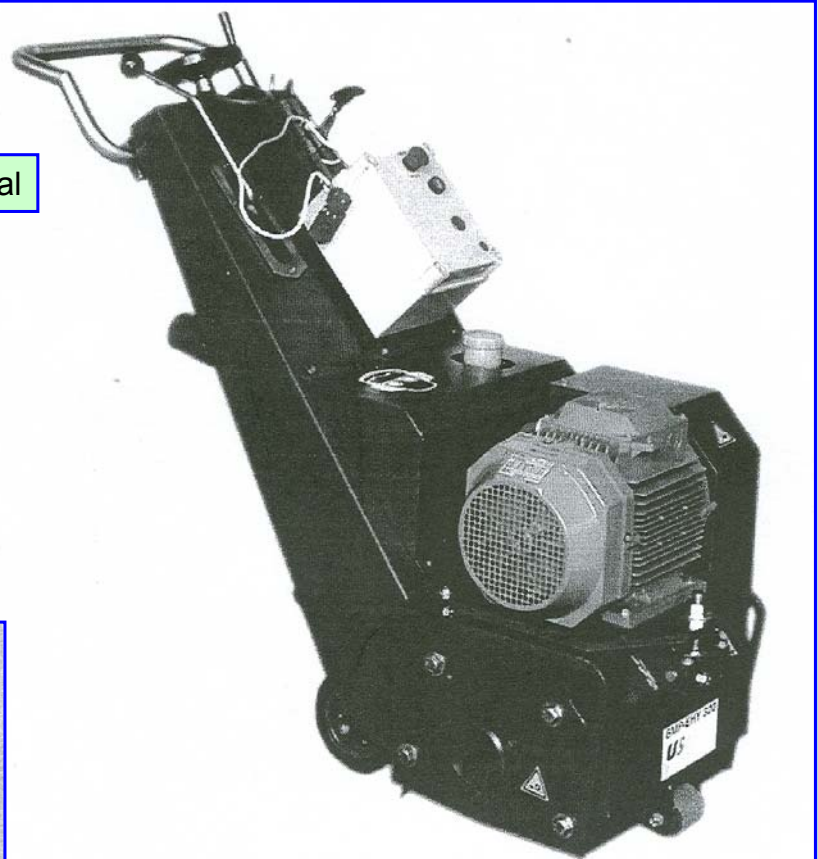
Manual grinder for surface removal

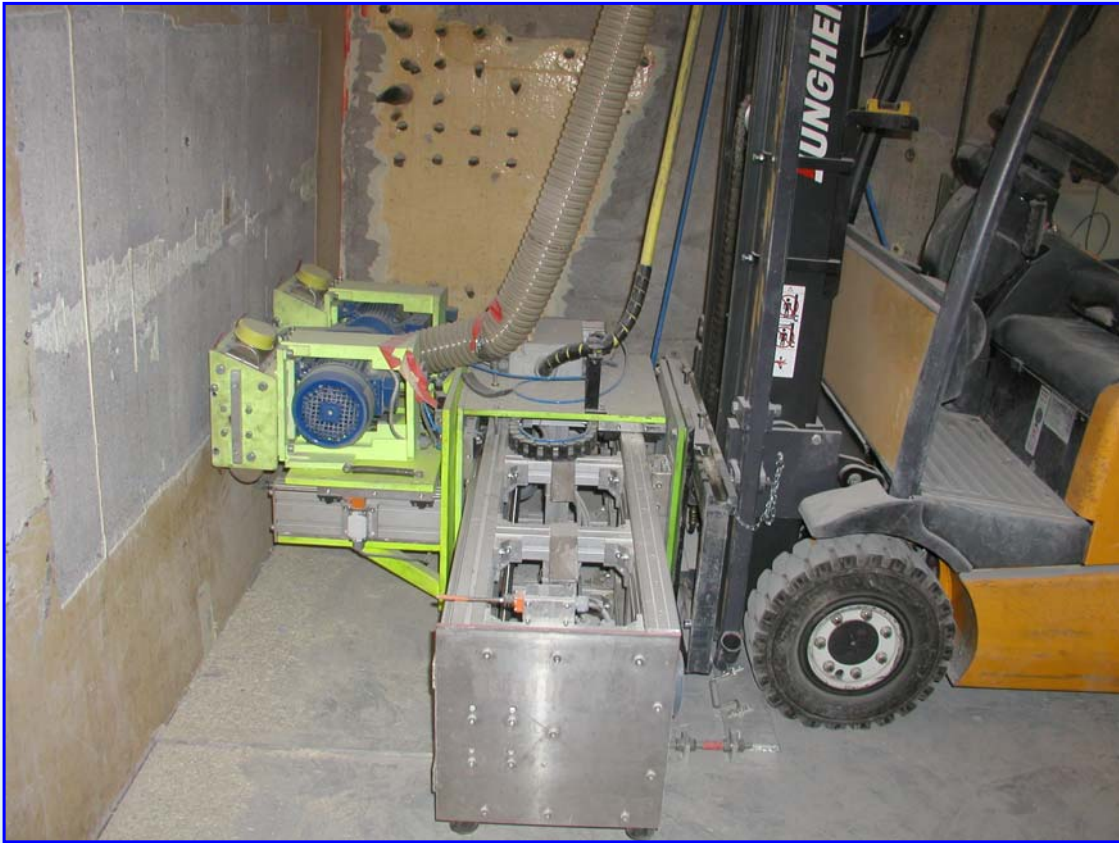
Forklift with attached shaver

Removal width	2 x 0.185 m = 0.37 m
Removal rate	1.4 – 1.8 m/min
Removal depth	3 mm
Roughness depth	< 1 mm
Rotating speed of shaver	1,800 rpm
Theoretical removal rate	40 m ² /h
Range of shaver on a forklift (without change of position)	5 m height, 2 m width
Range of shaver on a rack (without change of position)	9.7 m height, 2.6 m width
Removed surface area (without change of position)	Shaver on forklift 10 m ²
	Shaver on rack 25 m ² wall 5.5 m ² ceiling
Daily performance, including fitting times	15 m ² /d

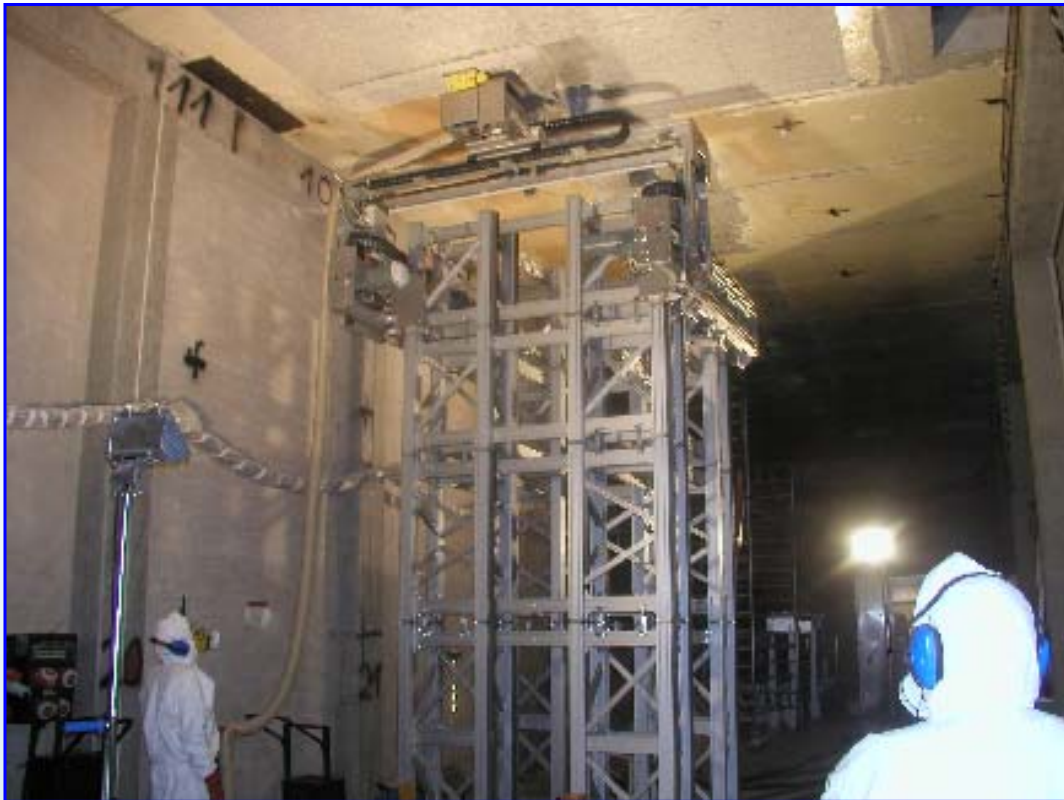
Shaver fixed to a modular rack

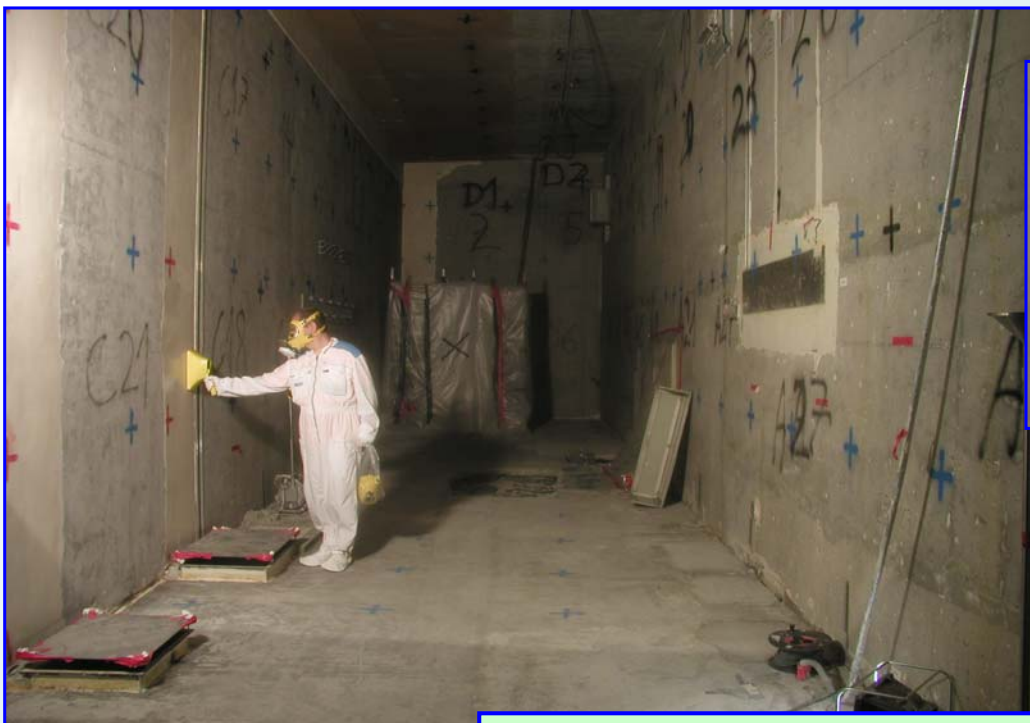
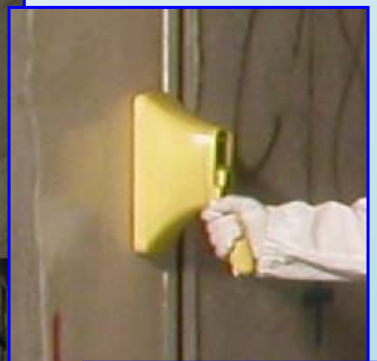
COMO measurement instrument

A COMO instrument was used for the radiological measurement of the room surfaces

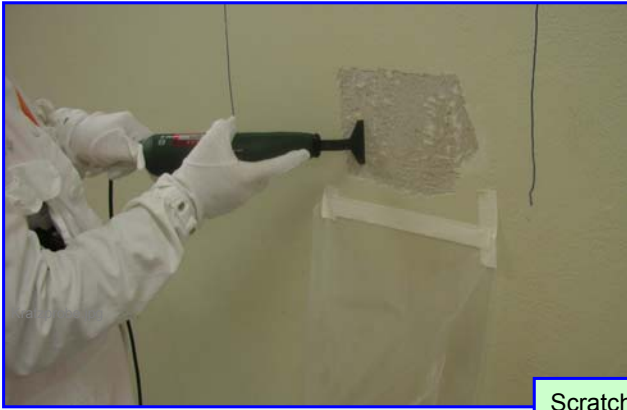
Scratch sample

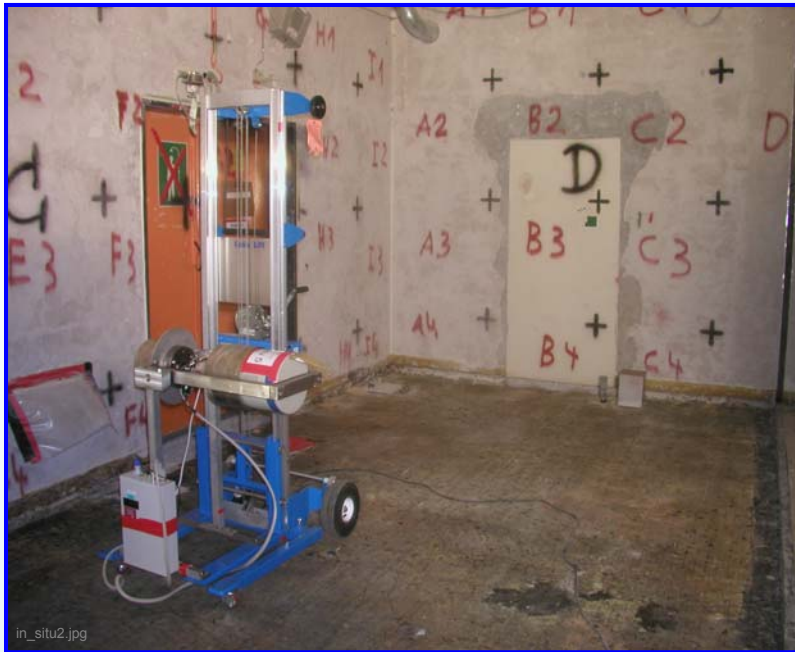
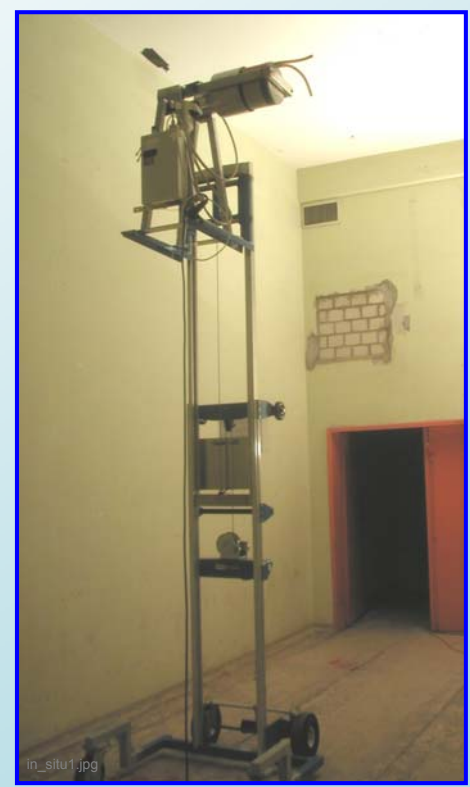
In-situ Measurement Setup
