The internal and external dosimetry challenges from past experience : Fukushima Daiichi accident

Toshikazu Suzuki

Chiyoda Technol Corporation

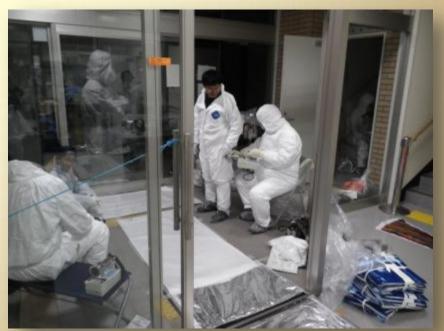
Immediately after that, surface contamination check by a pancake GM survey meter was started for the workers returning from FDNPS at the entrance

The screening level was decided temporary as 13000cpm which meant approx. 40Bq/cm²

At this point, the contamination of the tire or the shoe sole was already difficult to decontaminate

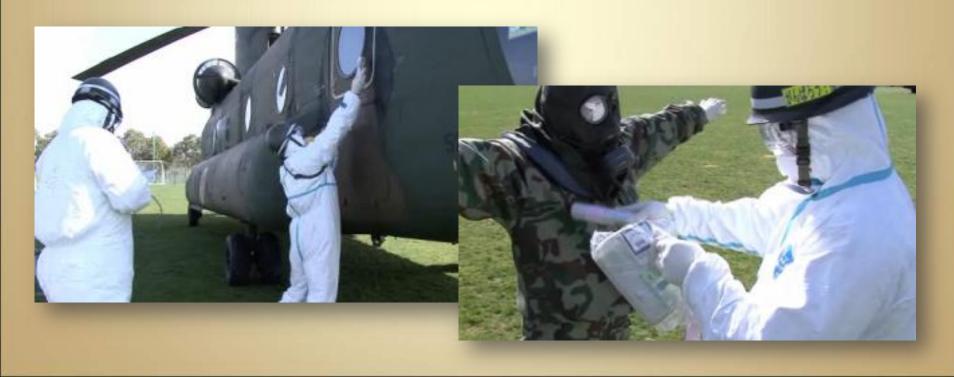
Self – Defense Force personnel -dose evaluated-

Through four times of flight in this mission external exposure of all personnel was below 1mSv

Internal contamination of them all was below the detection limit, which was measured by chair-type WBC installed in central military hospital

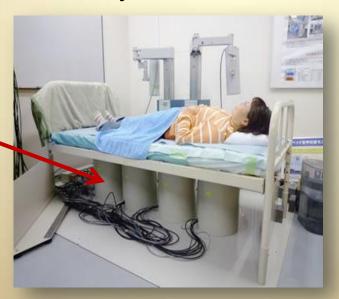
8"φx4" shielded NaI(TI) scintillator

For the emergency screening, four channel open air WBC was adopted, which was always energized to keep the stability

The calibration was carried out by using ANSI 13.35 BOMAB phantoms

In order to compensate the contribution of ambient background and shielding effect of human body, K-40 water BOMAB phantom was applied

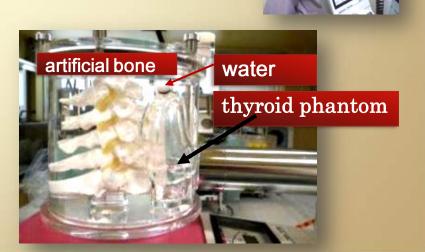
- 1. Only one thyroid monitor was left in high contaminated area
- 2. Nal(TI) scintillation survey meter was applied as the substitution
- 3. Conversion coefficient between µSv/h and Bq was decided by neck phantom which included thyroid phantom filled with standard Ba-133
- 4. The value is 1µSv/h=22kBq

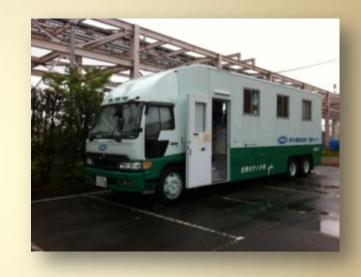
From the end of March 2011, the JAEA sent mobile WBC in which Canberra FASTSCAN was installed

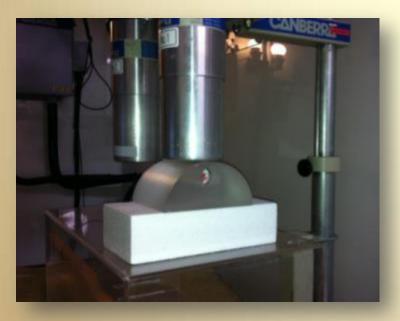
Peak efficiency values and fitted curves

The HPGe detector was calibrated with the neck part of a Transfer phantom (Canberra) based on the specifications of ANSI
