Lessons Learned: Radiation Protection for Emergency Response and Remediation / Decontamination Work Involved in TEPCO Fukushima Daiichi NPP Accident

Office for Radiation Protection of Workers
Ministry of Health, Labour and Welfare

1. Introduction

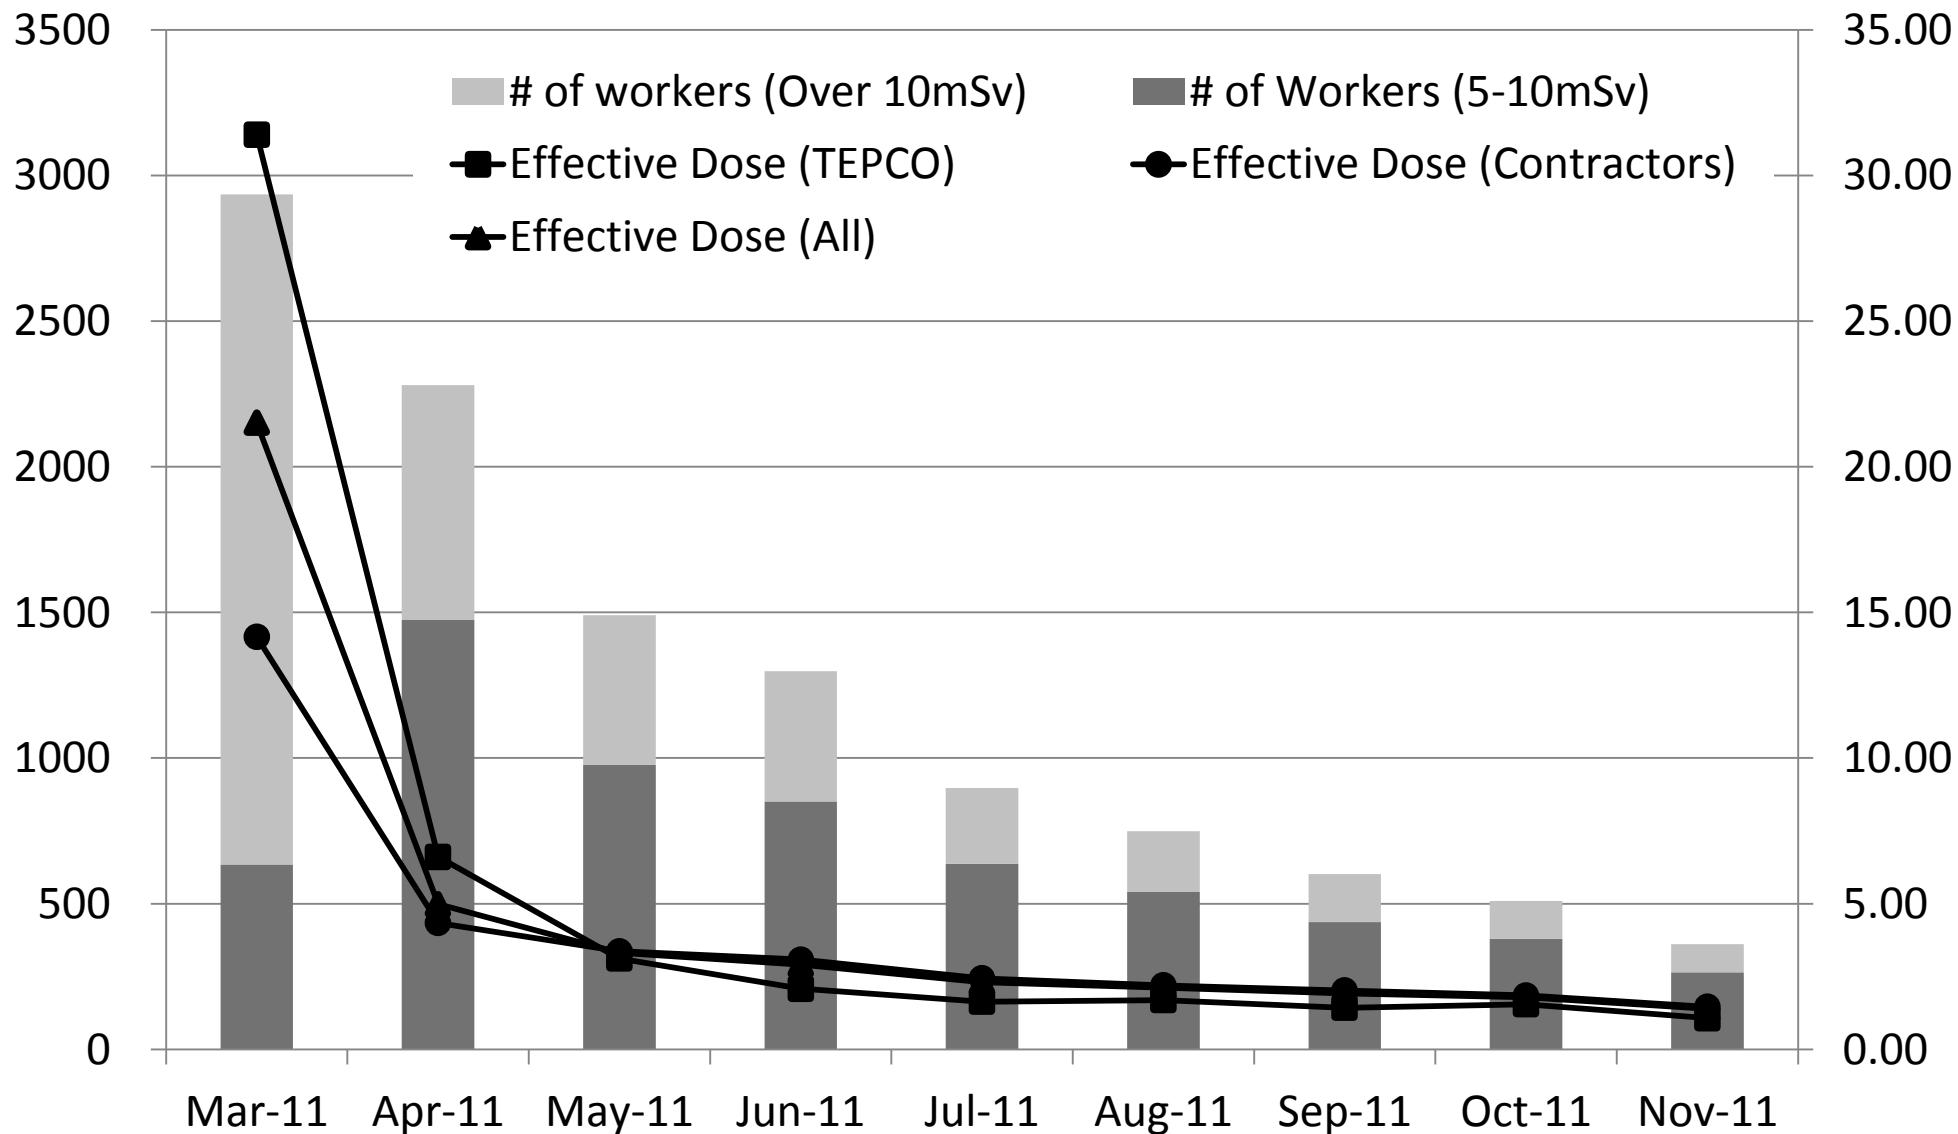
Trend of Monthly Effective Dose of Fukushima Daiichi NPP Workers (Emergency Situation: 2011.3-2011.11)

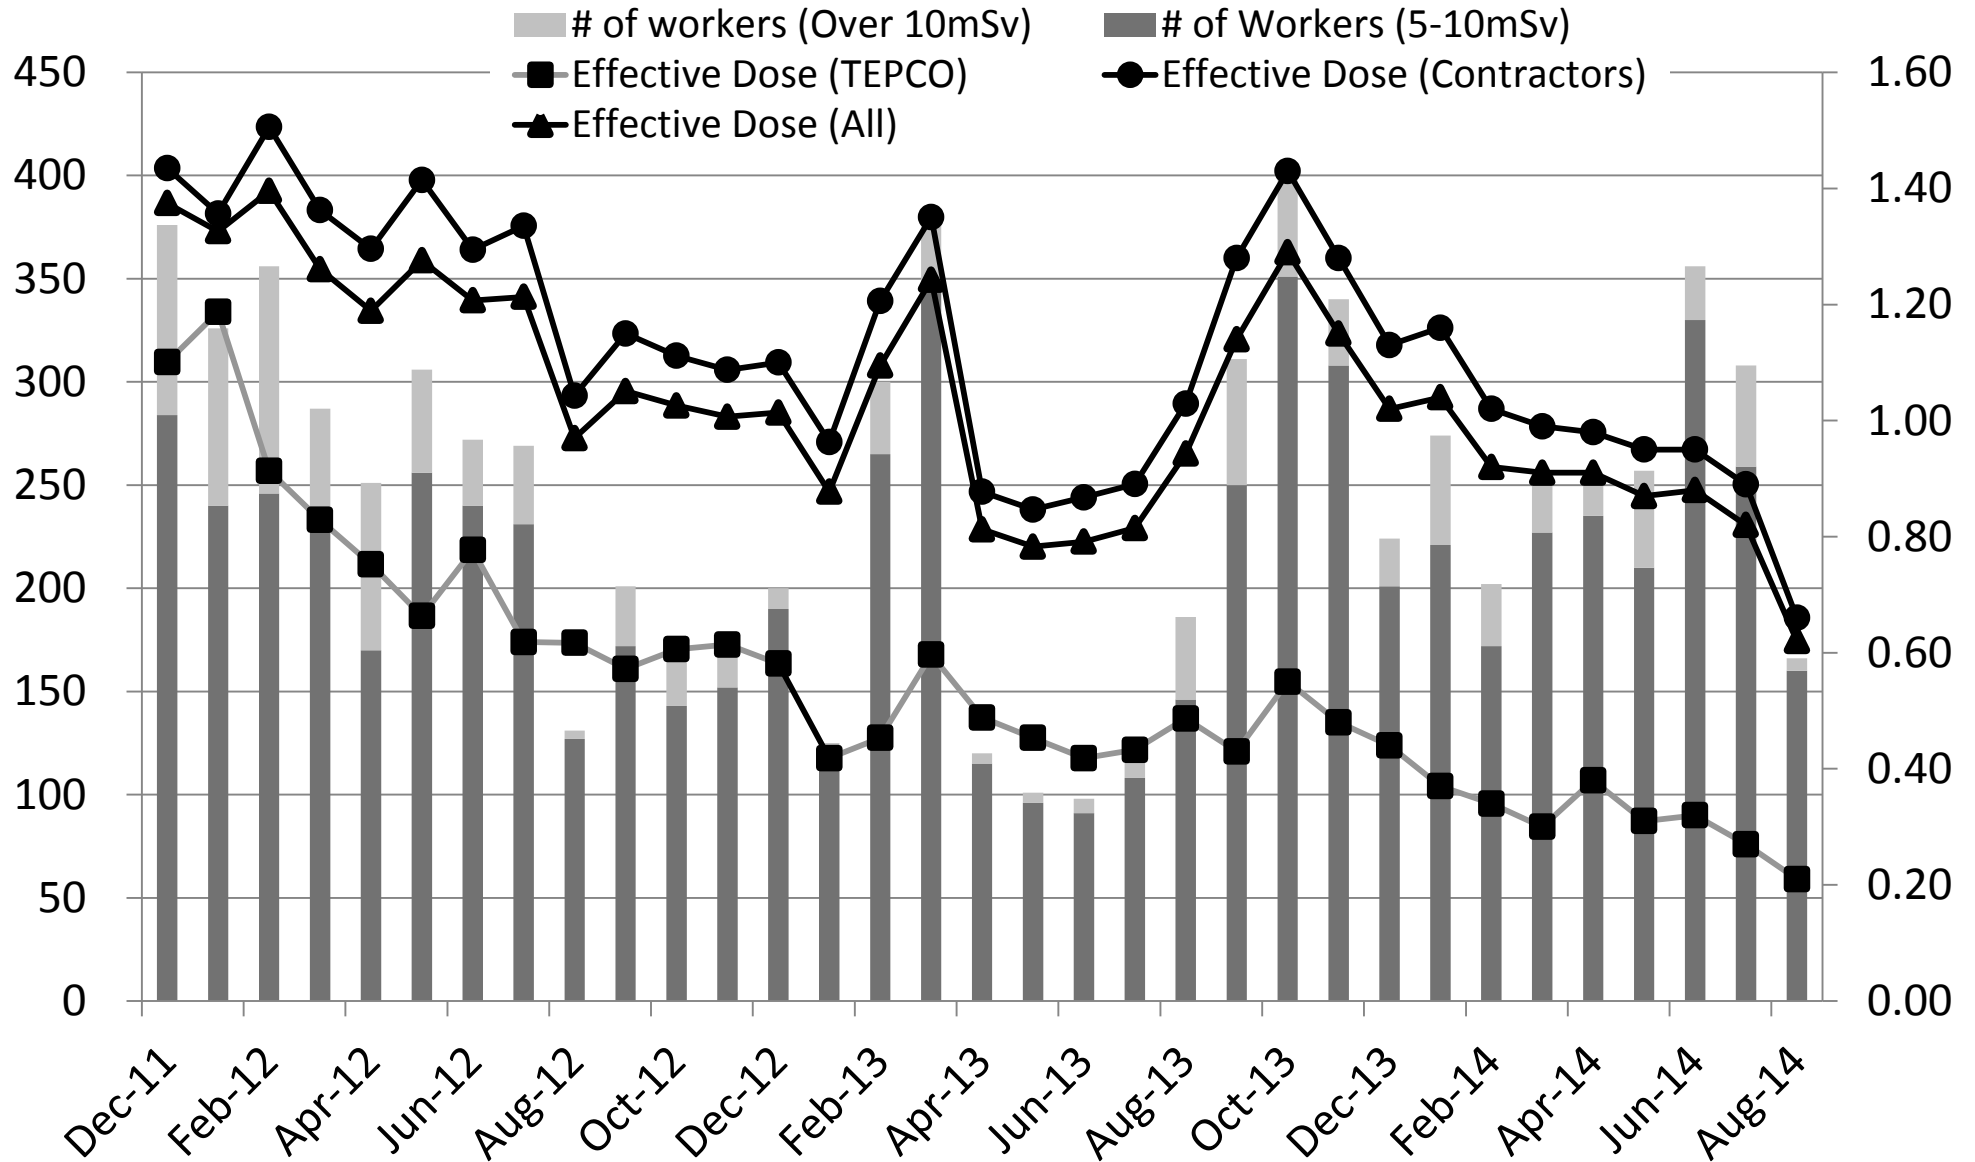
Trend of Monthly Effective Dose of Fukushima Daiichi NPP (Post Emergency: 2011.12-2014.08)

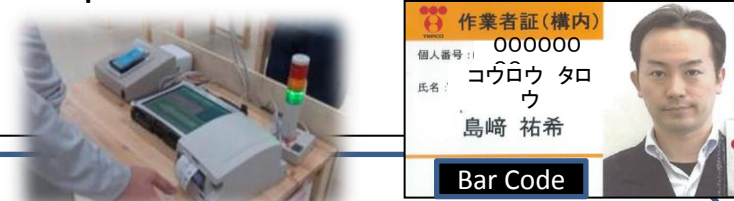
- Due to **loss of the electronic system**, TEPCO implemented **paper-based dosimeter circulation management** until April 4 (June 8 in J-village).
 - Many cases of improper procedure, i.e. **wrote down only family names or illegible writing**, resulted in difficulty conducting a **name-based aggregation of doses**.
 - **Manual entry of data and calculation** by PCs, although manpower was limited.
- Temporal system was **unable to print out dose records**,
- making it difficult for workers to know their dose.

- MHLW required TEPCO to comply with the following guidance since May 23, 2011:
 - Implement **data entry and the name-based aggregation** of dose by **corporate office**.
 - **Collect personal identification information** and issue admission passes with **PINs**.
 - Required providing a **printed dose record** when workers returned their dosimeters.
- TEPCO:
 - Transferred tasks to the corporate office and dispatched personnel to the plant.
 - Started **issuing worker ID cards** on April 4, 2011 (on June 8, 2011, in J-Village).
 - On July 29, 2011, started **issuing admission cards with photographs**.
 - On August 8, 2011, initiated the combined use of admission cards and ID.
 - Since August 16, 2011, a system has been modified to **print records of exposure dose**.
 - On August 2011, started **providing weekly exposure dose records** to the primary contractors.

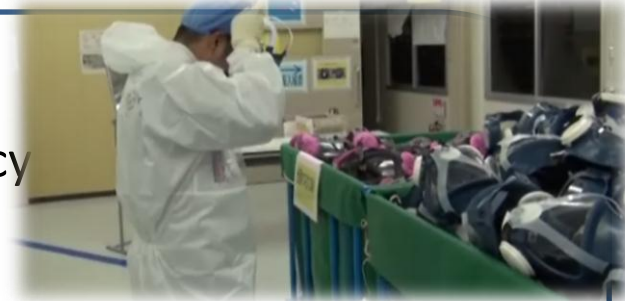
- MHLW:
 - **Measured filtration rate of masks** worn by 6 emergency workers with JNIOOSH experts on September 26, 2011.
- Experts revealed:
 - Leak rate ranged between **1.1% and 56.0% with an average leak rate of 17.4%**.
 - The leak rate of workers who wore **eyeglasses was higher than other** workers.
 - 2 main factors affected leakage:
 - **Interference between respirator face seal** and faces created by eyeglasses, cotton caps and hair.
 - **Poor match between the shapes** of workers' faces and the respirator.
- TEPCO implemented the following improvements:
 - After September 27, 2011, respirators were **sorted by size and manufacturer** so that workers could choose better-fitting masks.
 - After November 17, 2011, **a fit tester was used in the training** of new workers.
 - As a result, **no significant internal exposure was observed** after October 2011.

- **Internal exposures were repeatedly found** in September, 6 months after the accident.
- Internal exposure should not happen **if respirators were properly fitted**.

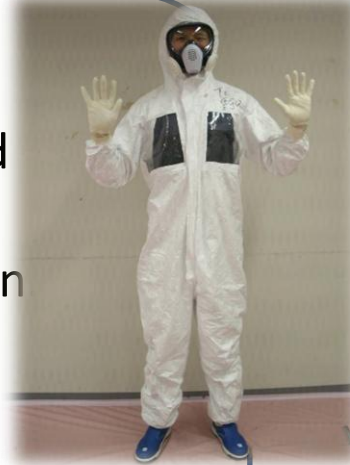
- On March 24, 2011, when workers received **beta-rays on their feet** after stepping into 30 cm deep contaminated water.
 - Workers **did not monitor the ambient dose rate** prior to work, nor wear **long protective boots**, and continued to work after PAD alarm sounded.
- In August 2011, the contaminated-water processing plant, which **filters radioactive Cs**, began operation, and some workers were accidentally exposed to **Sr-rich contaminated water**.
 - Monitored 70 μm dose was **17.1 mSv and 23.4 mSv**, whereas 1 cm dose was **0.28 mSv and 0.22 mSv**.

- MHLW issued a recommendation that instructed TEPCO to:
 - **Monitor the ambient dose rate** of the work area prior to the work and develop a work plan in consideration of the work area contamination.
 - **Use proper protective garments and shoes** according to contamination
 - Monitor equivalent dose of extremities by **ring badges** and **convert to effective dose** using tissue weighting factors (0.01 for skin exposure).
- TEPCO:
 - Fully enforced use of **rubber boots** at all times and wearing **liquid-proof coveralls** when workers handled contaminated water.
 - Introduced a temporary measure **attaching glass badges to the wrists** of workers because TEPCO did not have a sufficient stock of badges at that time.

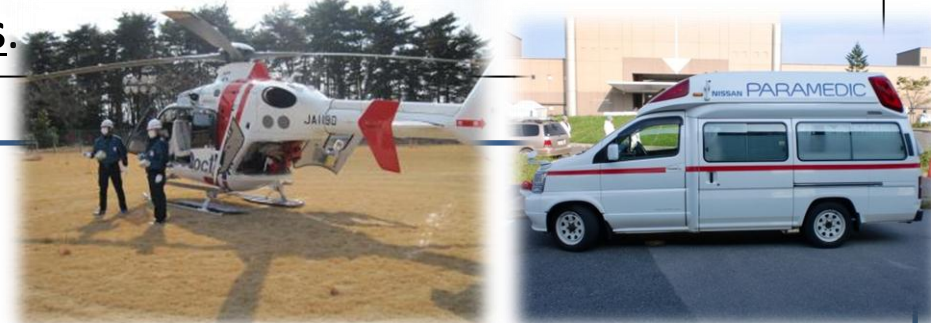
- On April 2, 2011, **Off-site Response Center (OFC)** established the **2-stage transportation**.
 - a) Contaminated patients should be **triaged and decontaminated in the plant**, transport to **J-Village** by **TEPCO's car**; and
 - b) Patients should be triaged and decontaminated in the **medical clinic of J-village** and transported to **hospitals in Iwaki city** by **local ambulances**.
- MHLW consulted with and agreed that hospitals accept the condition that surface contamination level of patients was **less than 400Bq/cm²** on August 14, 2011.

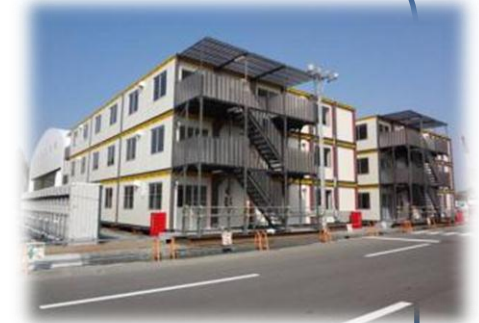
- MHLW provided administrative guidance to TEPCO on April 20, 2011 as follows:
 - a) Ensuring **sleeping facilities**, including **beds or mattresses**;
 - b) Taking preventative measures to stop the **spread of communicative diseases**;
 - c) Supplying **nutritious foods**.
- TEPCO
 - Set up **120 double-deck beds** with bedclothes and **30 sets of showers** in the gymnasium of Fukushima Daini NPP and **42 double-deck beds** in the plant.
 - Established a **makeshift dormitory** that could accommodate **1,600 workers**.
 - Began to provide **lunch boxes** instead of vacuum-packed foods and reopened a **restaurant in J-Village and Fukushima Daini NPP** on June 18, 2012.
