Report on the earthquake impact to Kashiwazaki-Kariwa NPP

Senior Regulators' Meeting
September 20, 2007

Akira Fukushima
Deputy Director-General for Safety Examination
Nuclear and Industrial Safety Agency

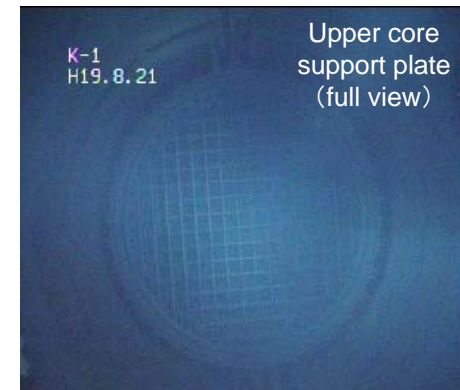
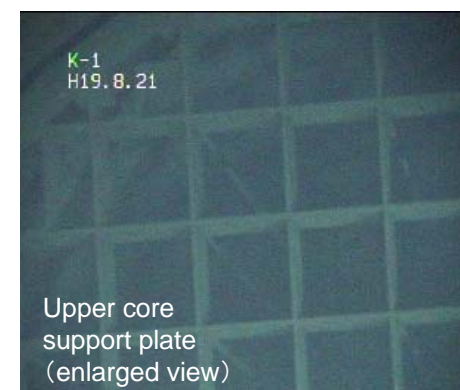
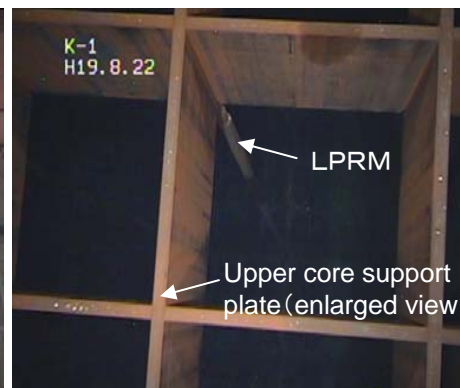
Upper reactor pressure vessel at Unit 1

No anomaly such as damage, deformation and dropout has been identified from the inspection by under water camera.

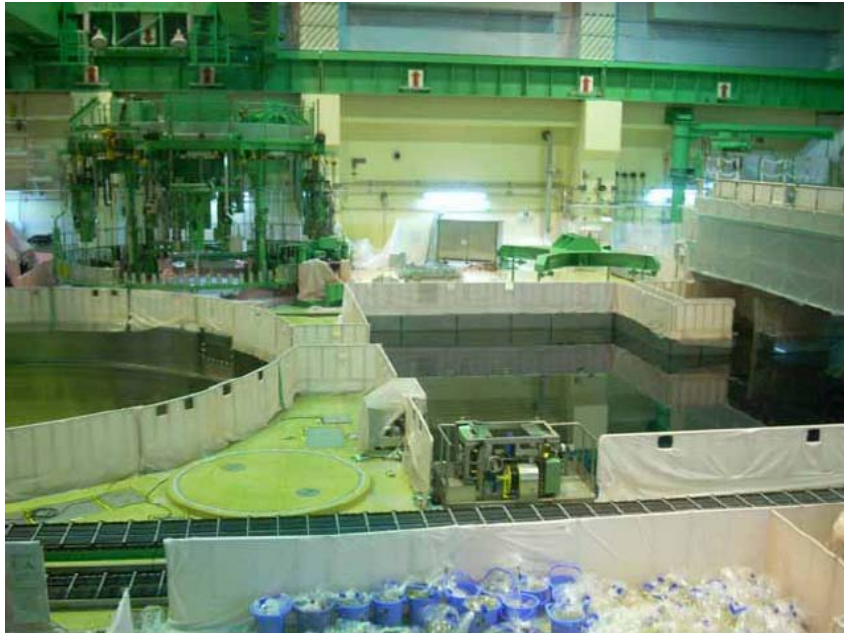
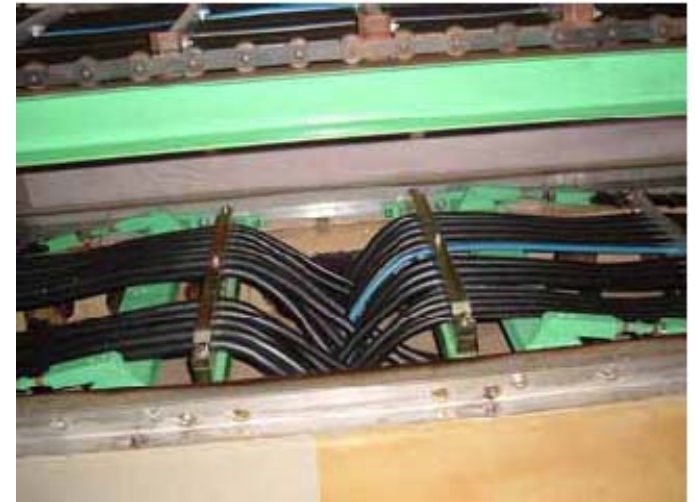
Leakage path at unit 6

- Water leakage and subsequent release of radioactive substances into the sea

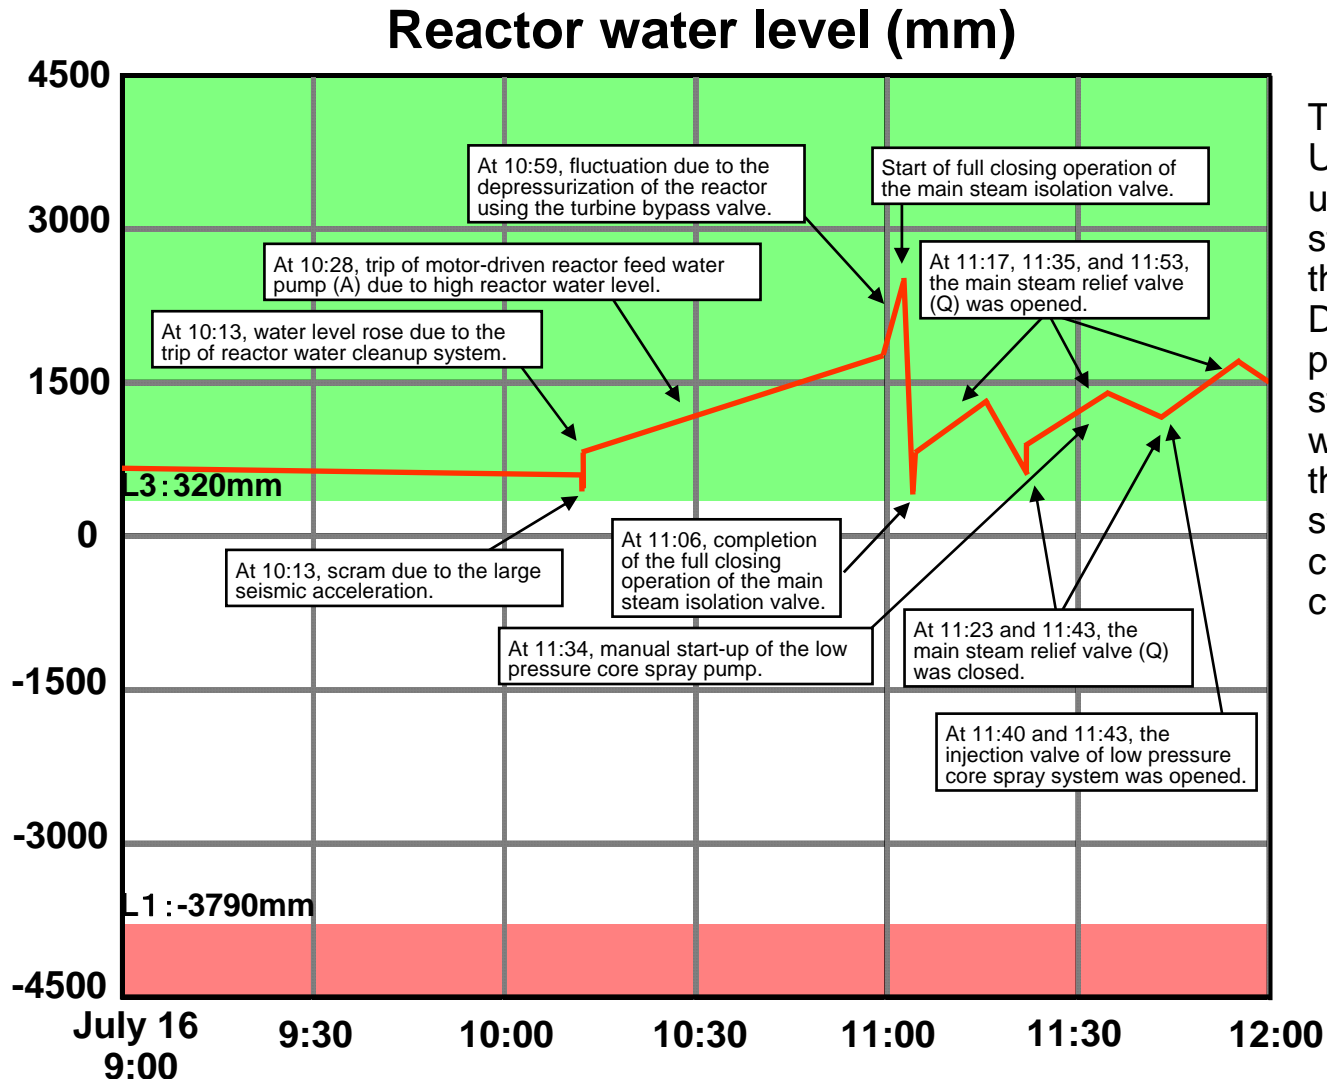
Behaviors of water level at Unit 2

The reactor water level of Unit 2, which was in start-up operation (subcritical status), was maintained by the condensate pump. During the depressurization process using the main steam relief valve, cooling water was supplied using the low pressure core spray system in addition to the condensate pump and control rod drive pump.
