Enhancing Operational Experience Feedback: Regulatory control during outages and refueling

Senior Regulators' Meeting
September 20, 2007

Akira Fukushima
Deputy Director-General for Safety Examination
Nuclear and Industrial Safety Agency

Outline of the Shika NPP Unit 1 accident

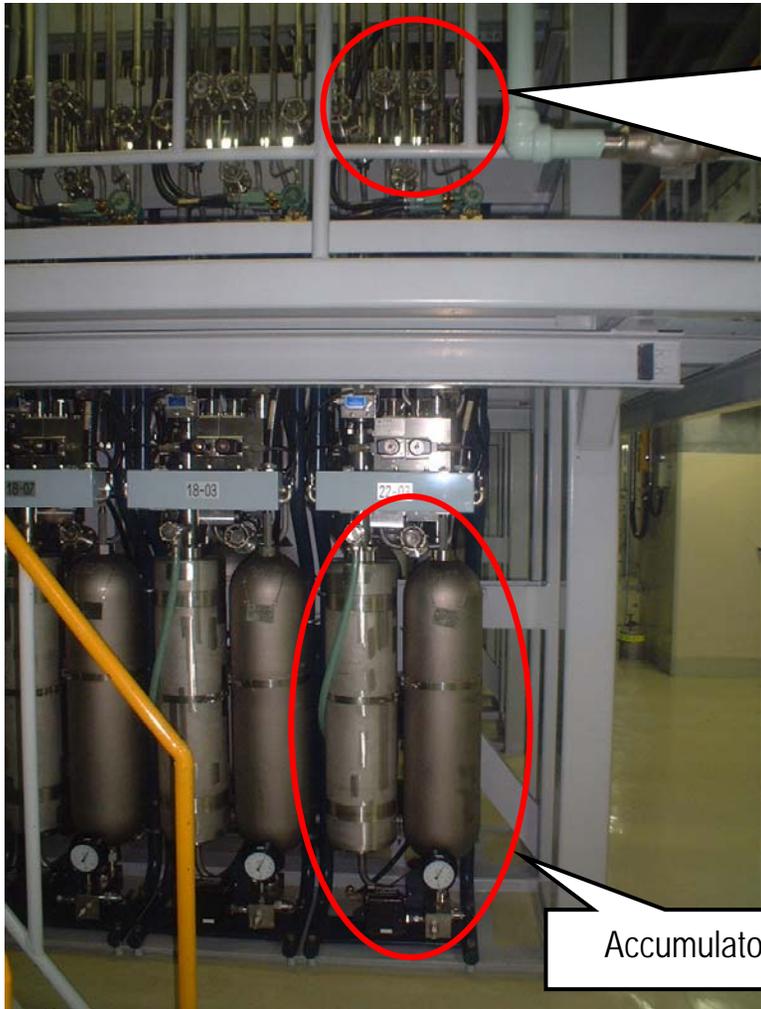
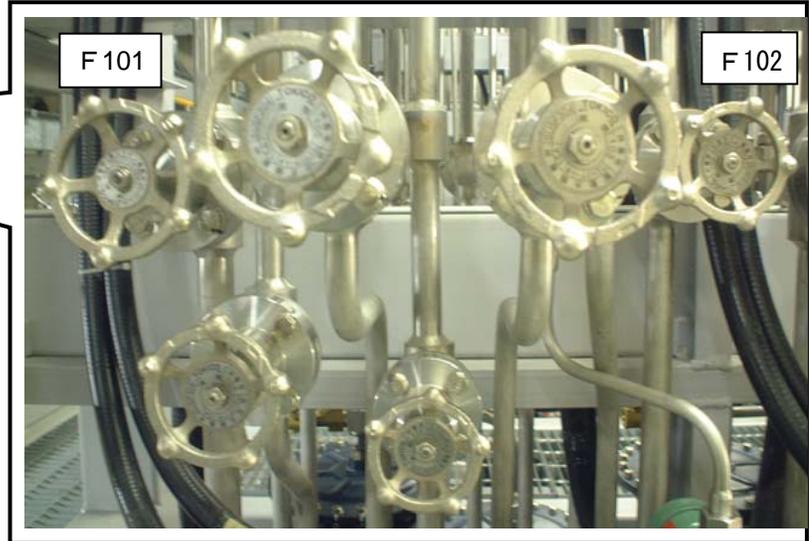
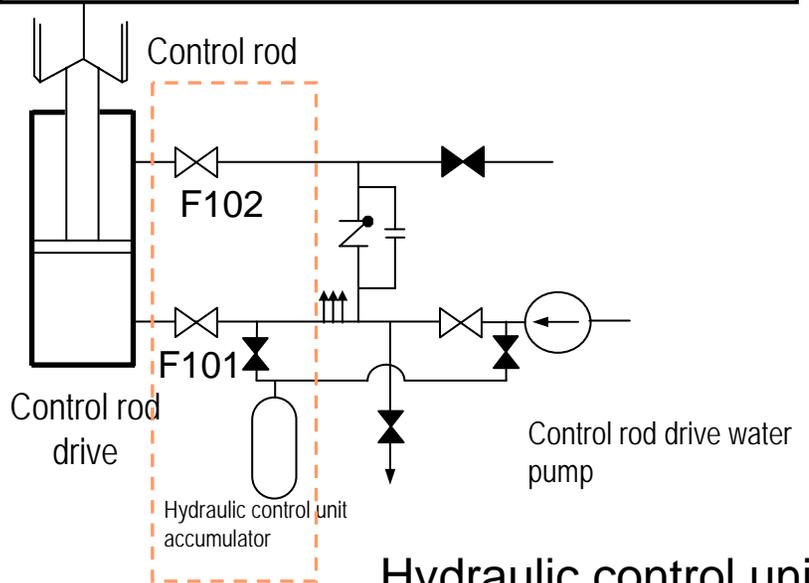
Hydraulic control unit

As personnel started to close the 101, 102 valves of 88 HCUs while system flow was 1250/min, the system pressure increased enough to withdraw control rods from the core.

- Before the ARI test, the reactor / CRD water pressure differential annunciation was disabled to do a single rod scram test. This is because frequent announces were annoying.
- As high pressure alarm and low pressure alarm are in common, high system pressure annunciation did not work to alert operators abnormal high system pressure.

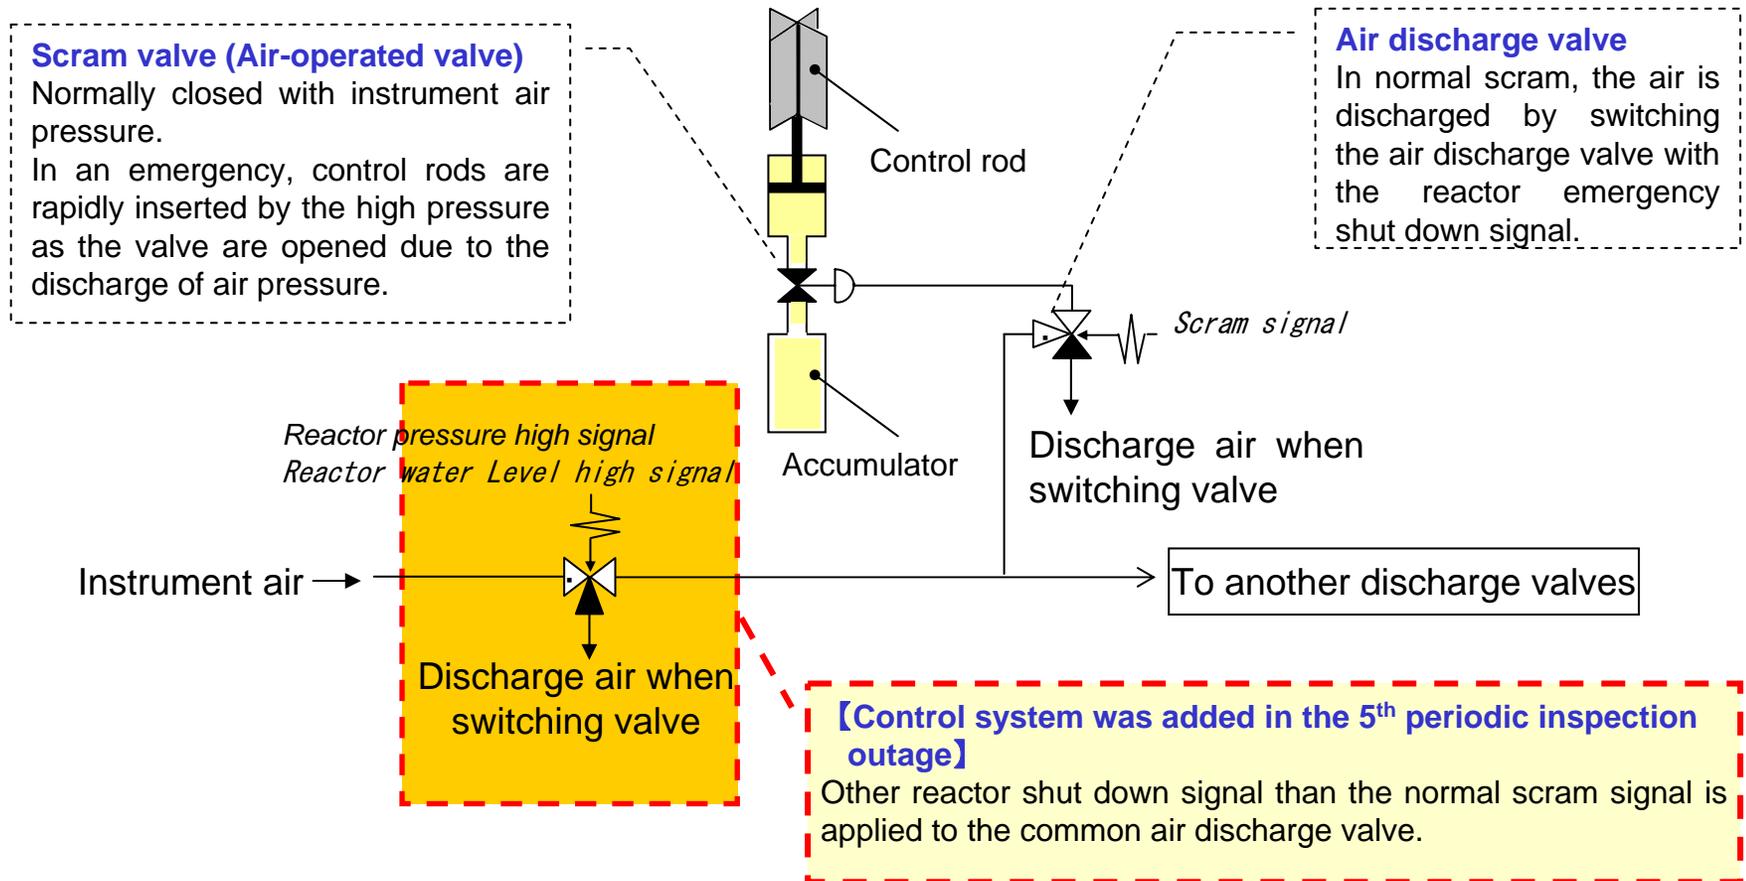
Test which caused Criticality Event(1)

- The test was conducted to verify the added function of ARI (Alternative Rod Insertion) which was installed to enhance the function of reactor shutdown, as part of countermeasure for accident management.

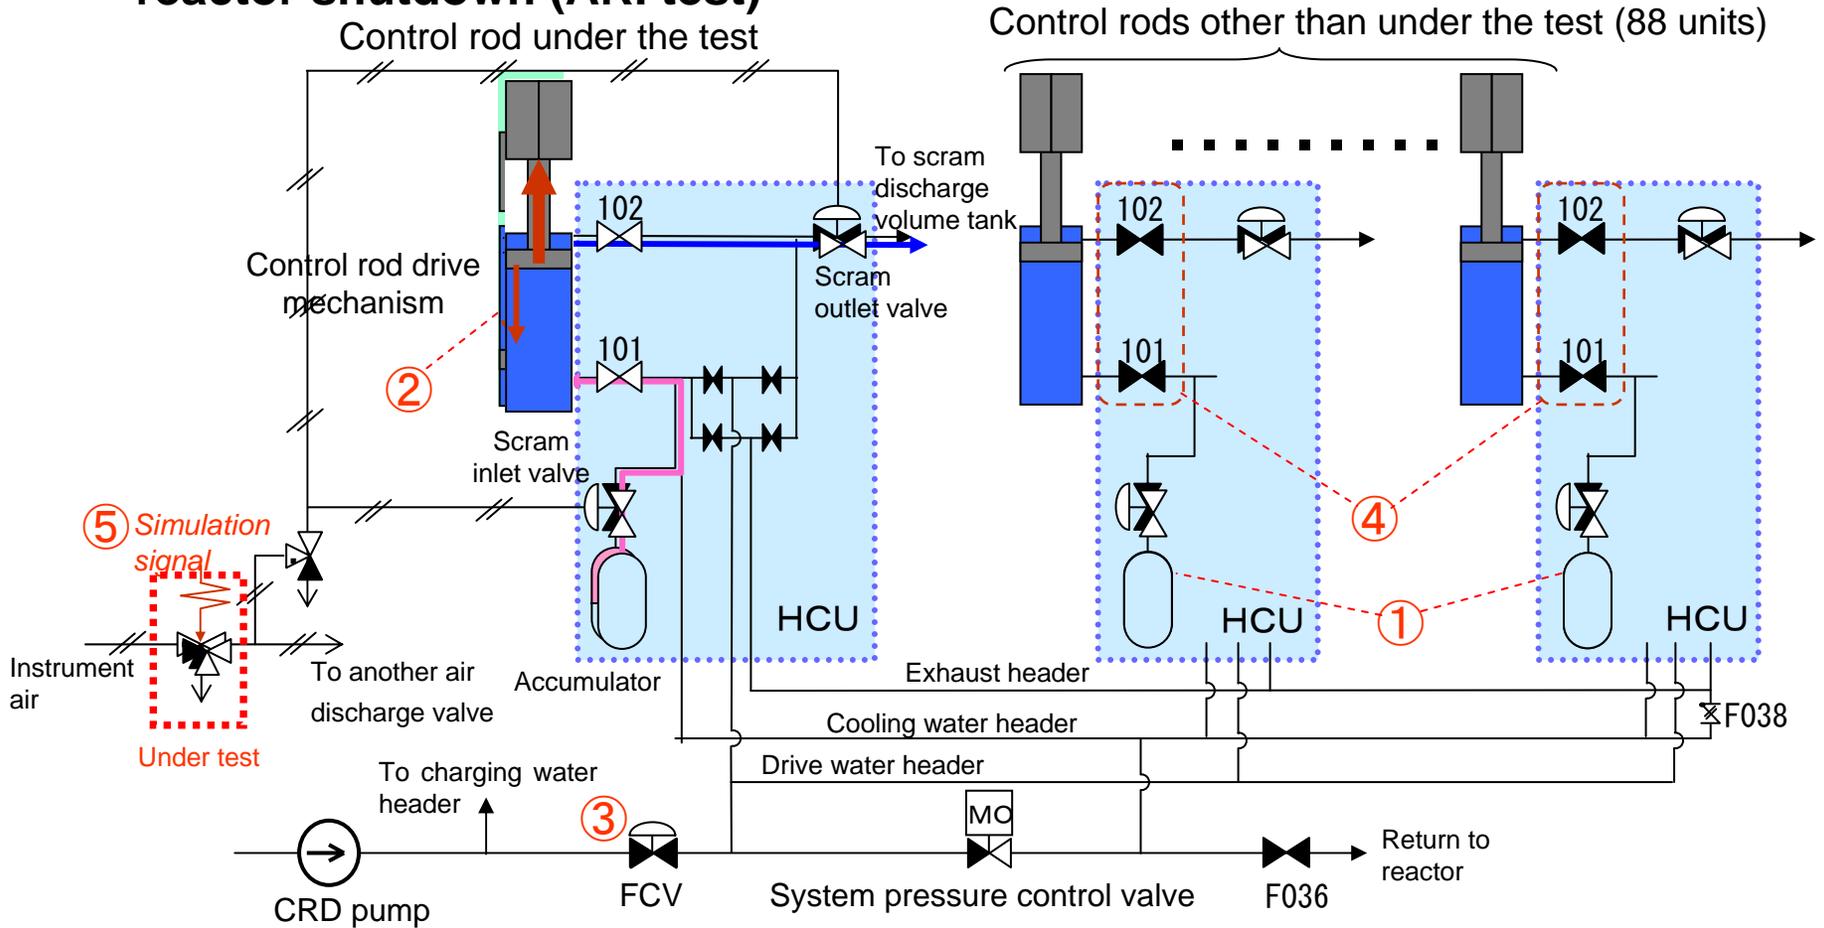
Test which caused Criticality Event (2)

- Method of the test to verify the modification for enhancing the function of reactor shutdown (ARI test)

- Blow the accumulator discharging water of the control rods other than under the test
- Fully withdraw the control rod under the test
- Set the flow of the control rod drive water to zero
- Isolate the control rod drive mechanism other than under the test (88 units) (Close the isolation valves (101, 102))
- Put in the simulation signal to the control rod drive under test (1 unit) for scram

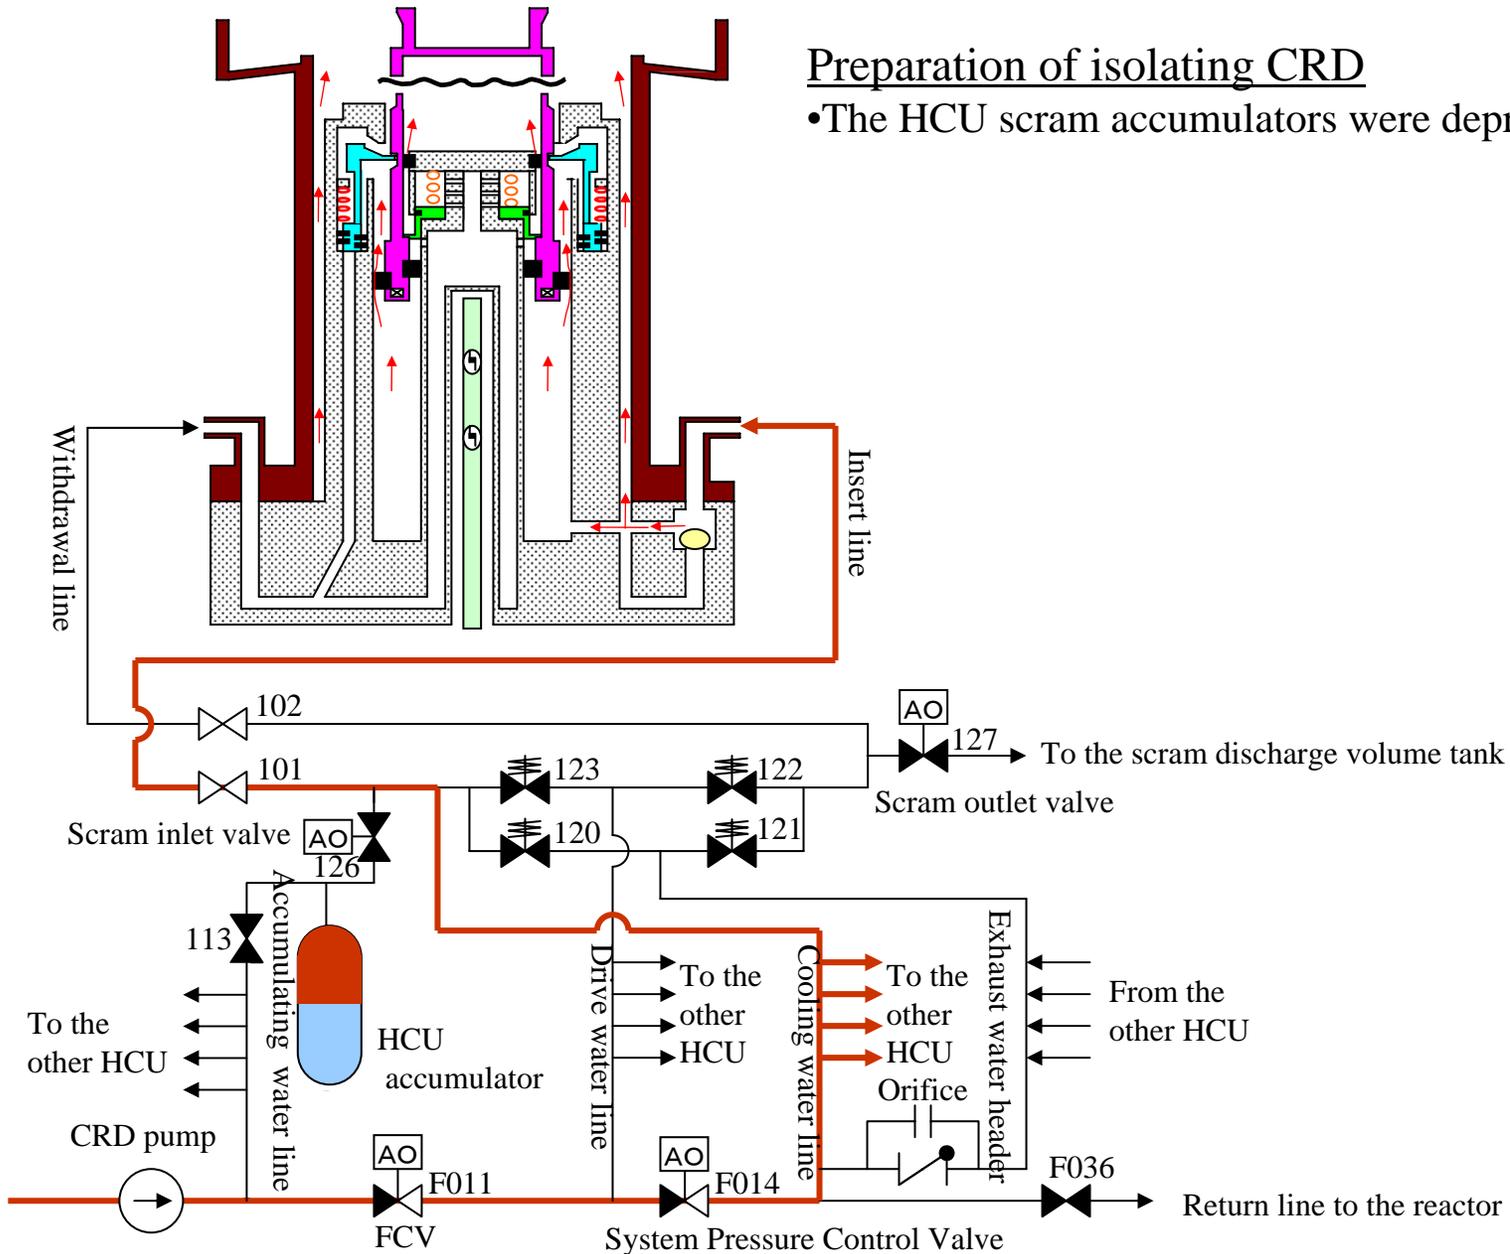
Mechanism of Control Rod Withdrawal (2)

Preparation of isolating CRD

- The HCU scram accumulators were depressurized.

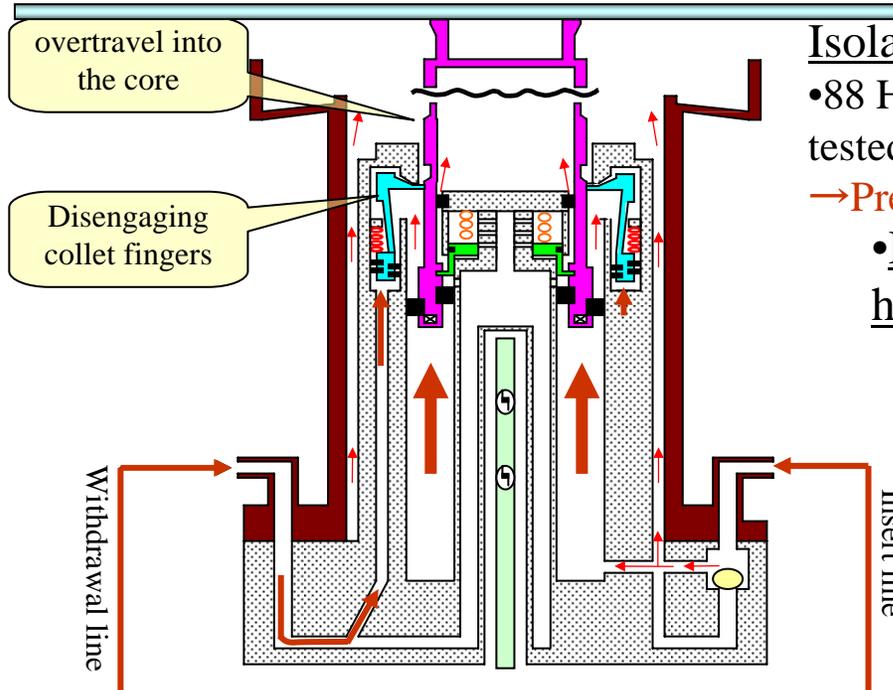
Mechanism of Control Rod Withdrawal (3)

Isolating 88 CRDs

- 88 HCU's were isolated by turns except for a HCU which was tested.
