CHALLENGES AND SOLUTIONS

METAL AND RADIONUCLIDE AVAILABILITY IN TREATED COAL MINING WASTES FROM SANTA CATARINA STATE - BRAZIL

**ZULEICA C. CASTILHOS**<sup>1,4</sup>; Renata C. J. Alamino<sup>1</sup>; Ricardo G. Cesar<sup>2</sup>; Erica F. Souza<sup>3</sup>; Ana C. Ribeiro-Duthie<sup>1</sup>; Claudio L. Schneider<sup>1</sup>

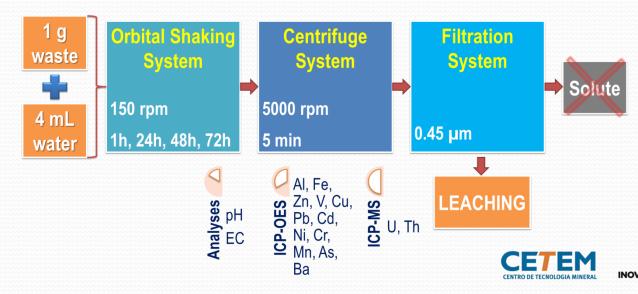
- A tailing from a coal mine situated in Santa Catarina (SC) State received a mineral processing treatment consisting of the separation of the particles according to their density, generating 3 fractions: (i) heavy one, (ii) mixed one and (iii) light one; with high, intermediate and low pyrite contents, respectively. This study aimed to evaluate the mixed fraction, which is the largest and will be deposited on soil.
- Leaching were evaluated in triplicate by mixing the waste samples with water type 2 as shown bellow:
