OSART Good Practices

OPERATIONS

Control of plant configuration

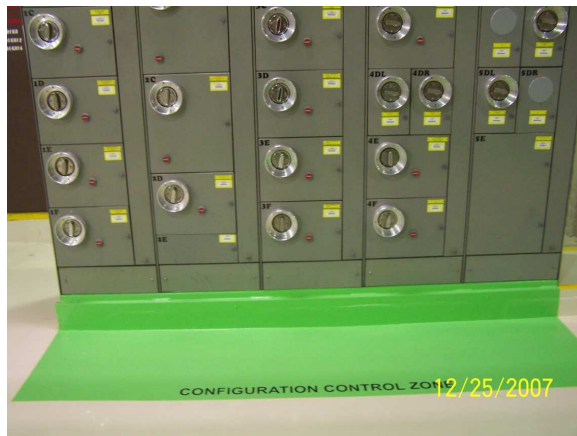
- 60 cm (two-foot) wide zone areas were painted around sensitive equipment. Susceptible valves, breakers, and hand switches were also fitted with removable and permanent covers that prevent unintended manipulation. Of particular note is the use of station fabricated guards to prevent inadvertent operation of rotary handled breakers.

Operations management has improved equipment configuration control by reducing inadvertent bumping and improper operation of susceptible plant equipment and incorporating configuration control defenses throughout the planning and execution process. This effort included the introduction of several physical and administrative barriers and also human behavior related improvements.

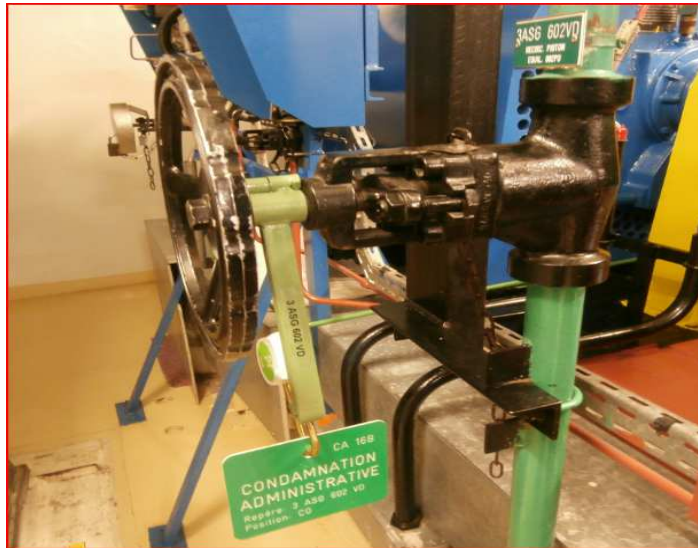
The Plant has installed a metal jig on the normally open valves of the motor-driven auxiliary feedwater pumps. Once in place, this jig guarantees that the valve is open.

As a result of fleet-wide Operating Experience (weakness identified in this area at another French plant), the Plant designed these devices for safety lockouts.

This tool can be readily utilized and manufactured by site maintenance.

This tool may also be utilized by field operators during isolation and tagging activities.

The tool is clearly visible and allows the operator to readily identify gaps in the application of this jig. Use of this jig complements the safety lockout without overcomplicating it.

The valve safety position as open is physically guaranteed, preventing damage to the pump. It also eliminates human error as regards valve position.
