OSART Good Practices

TECHNICAL SUPPORT

Plant modification system

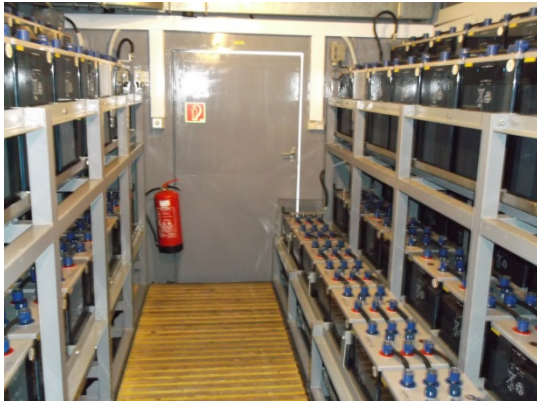
The batteries are built into a container that has temperature control, ventilation and it is seismically reinforced.

The interior of the battery plant

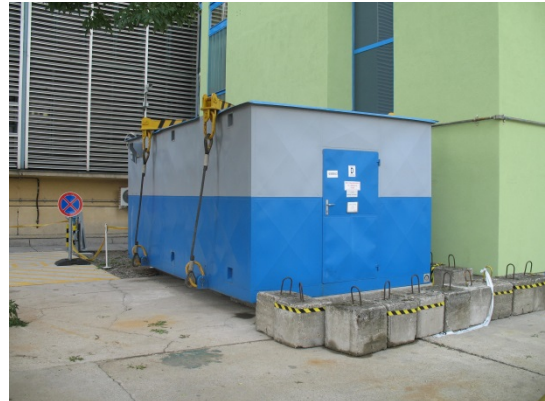
The electrical technical section and the electrical maintenance section have set up a container size mobile battery unit that can be moved by crane.

Container battery plant

During the replacement of the unit safety batteries, the mobile battery unit was moved to the relevant Unit with a mobile crane and connected to the safety system through the connecting distributor cell of the safety battery plant. Following testing the safety system could fully operate without time limitation during which time the reconstruction works were successfully carried out.

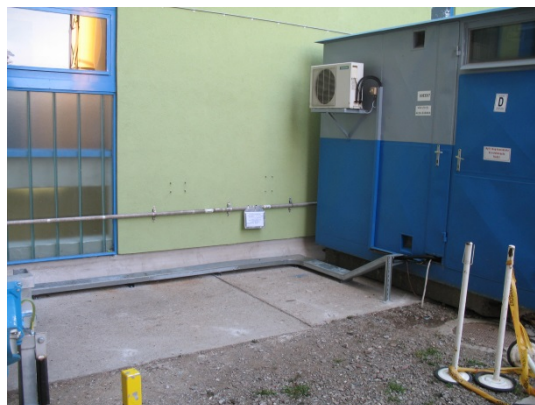
The temporary cable

Reserve cables and quick connection points were installed for all Units for the mobile battery unit to power each safety-related battery at the designated container locations. The mobile battery unit is stored at the site of the electrical maintenance section, where periodic maintenance is provided on it. In any failure of a safety battery or in case of emergency the mobile battery unit can be set up to replace any damaged safety battery within 24 hours.

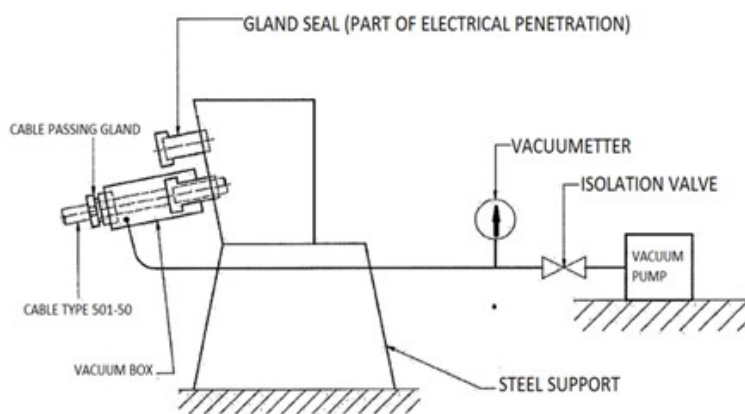
Figure 1 – Schematic of leak rate test rig

To verify the leak tightness of the penetration, a box is fitted around the penetration and a vacuum pump is used to establish a differential pressure of 38 kPa, simulating RBLRT pressure test.

While vacuum is maintained by a pump, leakage through the penetration is determined by measuring self-maintaining vacuum inside the box for a period of time. This unique method of testing individual penetrations is the first of a kind for CANDU plants.

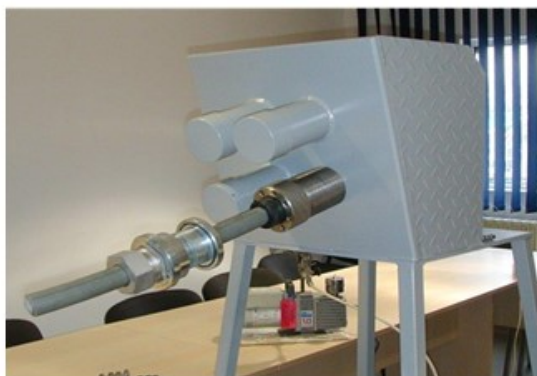
Figure 2 - Penetration mock-up

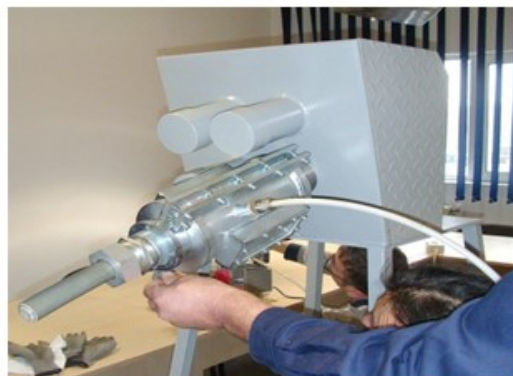
Figure 3 - Mock-up with vacuum box installed

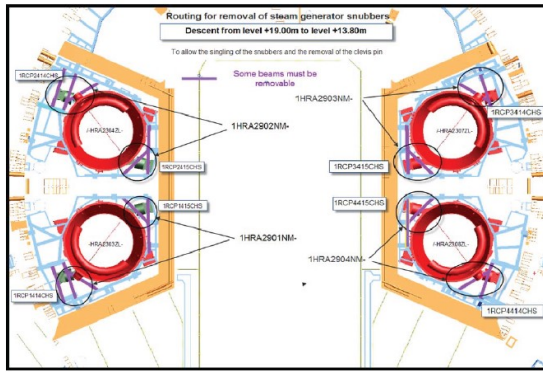
Steam Generator snubbers (weight: 2.5t, length: 2m) have to be maintained every 20 years. This maintenance is not possible at the location on the Steam Generators, and the designer didn't take into account the maintenance requirements for the future. The main difficulties came from the lack of lifting devices (polar crane hook cannot access to snubbers) for handling snubbers outside the reactor building, from the transportation in areas where there are many pipes and where metal floors are not designed to support the weight of a snubber.

Location of 8 snubbers

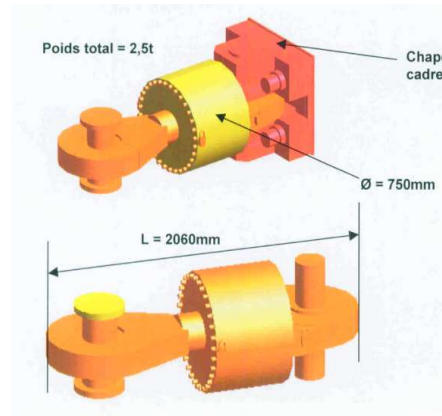
snubbers' size : 2.5t, 2000mm

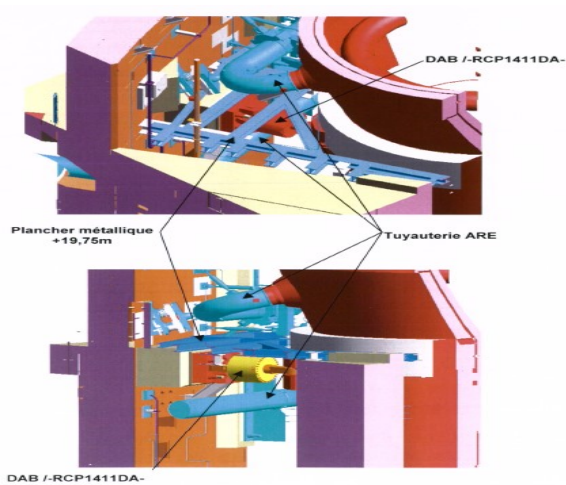
This issue was discussed and both parties finally agreed on the proposal presented below:

Step1 : Install additional 6 cranes, remove some beams and re-route pipes of DER SAR SAT RES system to handle down the snubbers inside the SG compartment from level +19.00m to the platform at +9,38m

SG snubbers replacement

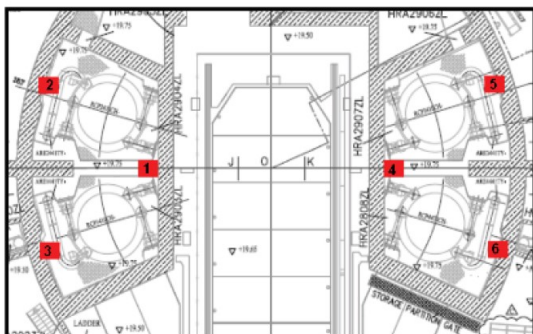
Location of additional 6 cranes,

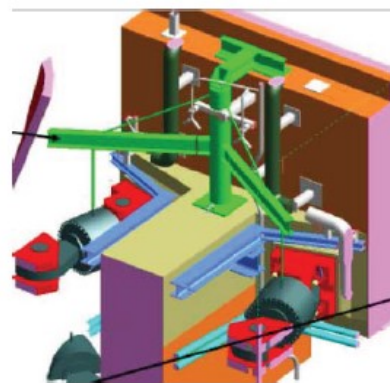
Design for cranes 1 and 4

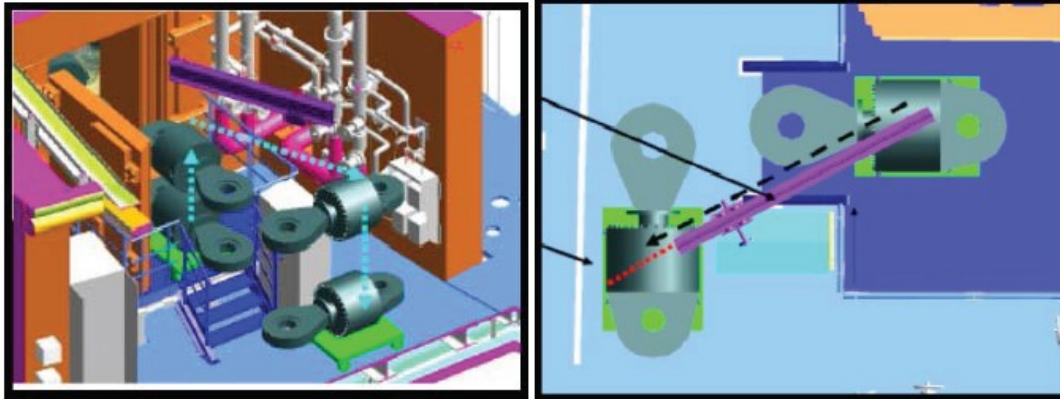
Step2 : Transport the snubber from the SG compartment to the annular space via 2 additionally installed monorails

This monorail needs to be enlarged and increased the capacity in order to handle the snubber.
